**SOUTH DAKOTA STATE HISTORIC PRESERVATION OFFICE
HISTORIC SITES SURVEY STRUCTURE FORM**

*SURVEY DATE: December 16, 2013 *ADDRESS: 31594 469th Ave.
*SURVEYOR: Jim Stone *COUNTY: Clay
*CITY: Burbank

CURRENT FUNCTION: Vacant FOUNDATION: Poured concrete
CURRENT SUBFUNCTION: Straw storage ROOF MATERIAL: Cedar shingles
HISTORIC FUNCTION: Livestock barn ROOF SHAPE: Gambrel roof
HISTORIC SUBFUNCTION: Hay storage STRUCTURAL SYSTEM: Balloon framing
STYLE: Gambrel roof barn
OCCUPIED: No TYPE: Livestock barn
Yes with
ACCESSIBLE: permission WALLS: 2x6 studs, 1x10
#106 drop siding

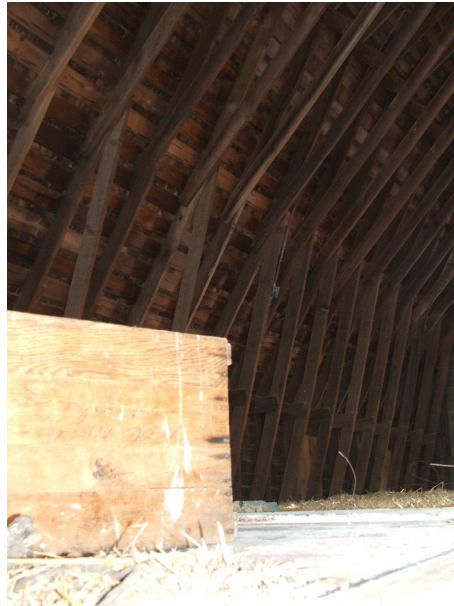
ROLL NUMBER: 5
PHOTO NUMBER: 5

**Hayloft, looking NW, 2x6
rafters with 2x6 bracing
from center of lower
rafter down to floor and
exterior wall, 4' O. C.**

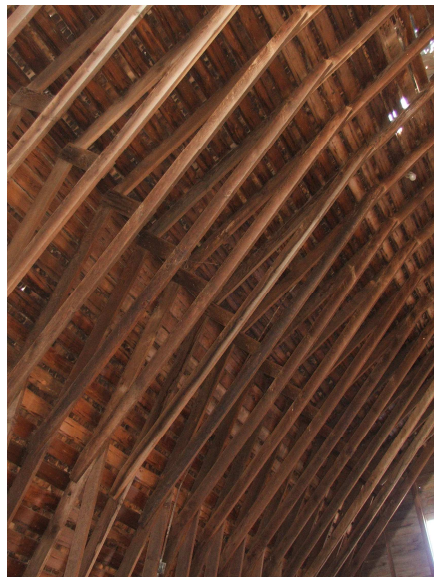
ROLL NUMBER: 6
PHOTO NUMBER: 6

**First floor, looking NW,
2x6 rafters with 2x6
bracing at roof hip, 2' O.
C.**

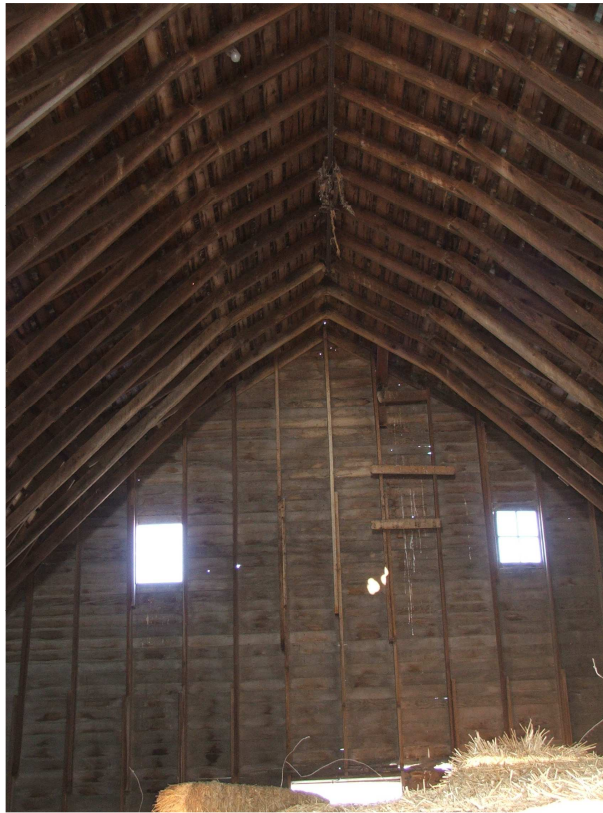
ROLL NUMBER: _____
PHOTO NUMBER: 7

CAMERA DIRECTION: Hayloft, looking North,
2x6 rafters and North
gable end.
