SITE INFORMATION

*SURVEY DATE: _June 12, 2012	*ADDRESS: 45339 300th Street					
*SURVEYOR: Jim Stone	*COUNTY: Clay					
	*CITY: Wakonda					
LOCATION DESCRIPTION: From the intersection of South Dakota Highway 50 bi-pass and South						
Dakota Highway 19, 15 miles North to 302 nd Street, turn left (West, 9 miles to 453 rd Ave, turn right (North)						
2 miles to 300 th Street, turn right and about ½ mile, turn right (South) into farm.						
LEGAL DESCRIPTION: Lot A, E ½ NW ¼, 20 – 95 – 53 Star Twp.						
*QUARTER 1: NW 1/4	OWNED NAME: Downin Conceptour					
	OWNER NAME: <u>Dennis Ganschow</u> OWNER ADDRESS: 45339 300 th Street					
*QUARTER 2: (*TOWNSHIP: Star						
*RANGE: 53	OWNER CITY: Wakonda OWNER STATE: South Dakota					
	OWNER ZIP: 57073 QUAD NAME:					
ACRES: 7.3 OWNER CODE 1: P	QUAD NAME:					
OWNER CODE 3: F S L P						
HISTORIC SIGNIFICANCE

STRUCTURE DETAILS					
SHPO ID:					
*PROPERTY NAME:					
OTHER NAME:					
O MER NAME.					
CURRENT FUNCTION:	Storage	FOUNDA	TION:	Poured concrete	
				Asphalt shingles	
CURRENT SUBFUNCTION:		ROOF MATE	DIAI -	over cedar shingles	
HISTORIC FUNCTION:	Livestock barn	ROOF SI			
HISTORIC SUBFUNCTION:	Hay and grain sto				
				Gothic roof

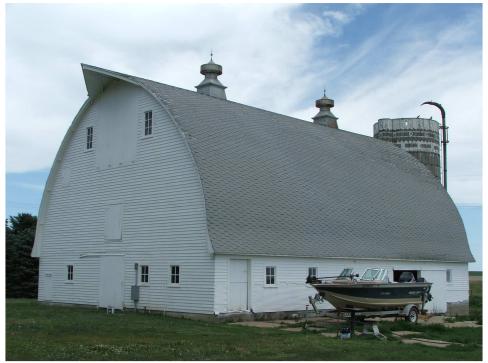
PHOTOGRAPHER: Jim Stone ROLL NUMBER:
DATE OF PHOTO: June 12, 2012 PHOTO NUMBER: 1
CAMERA DIRECTION: Looking NE, SW corner

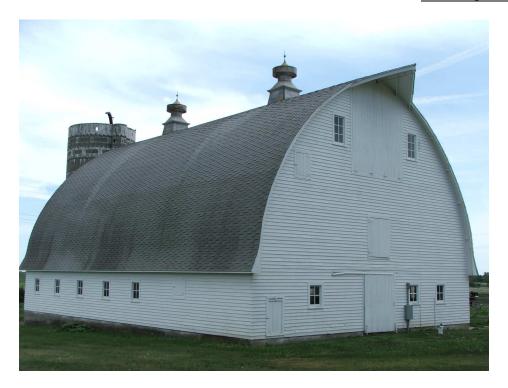
PHOTOGRAPHER: Jim Stone ROLL NUMBER: DATE OF PHOTO: June 12, 2012 PHOTO NUMBER: 2

CAMERA DIRECTION: Looking SE, NW corner

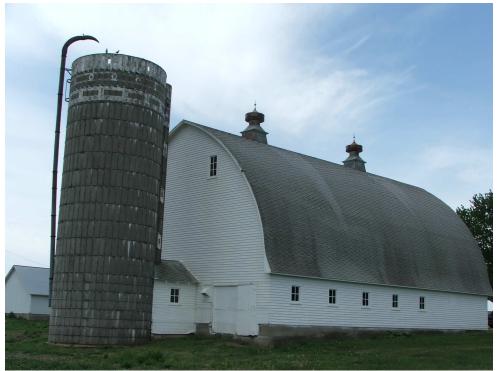
PHOTOGRAPHER: Jim Stone ROLL NUMBER:
DATE OF PHOTO: June 12, 2012 PHOTO NUMBER: 3
CAMERA DIRECTION: Looking SW, NE corner

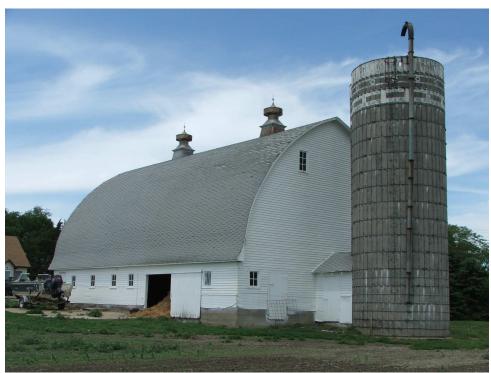
PHOTOGRAPHER: Jim Stone ROLL NUMBER: DATE OF PHOTO: June 12, 2012 PHOTO NUMBER: 4

CAMERA DIRECTION: Looking NW, SE corner

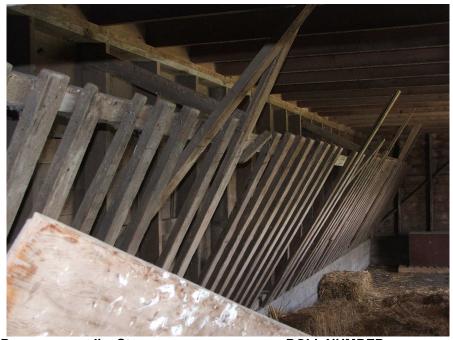
First floor, SE 16' x 42', 42' hay feed rack on

CAMERA DIRECTION: North wall

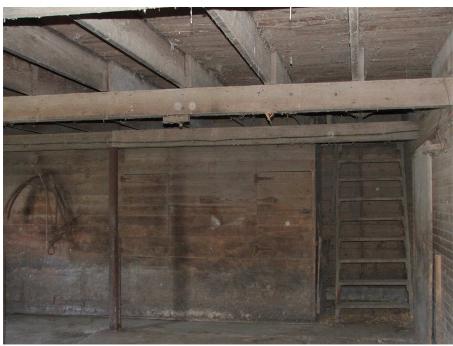
First floor, West side, looking North, granary

CAMERA DIRECTION: and stair case

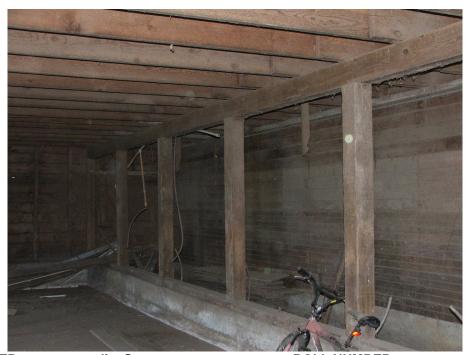
First floor, NE 24'x42', looking East, 42' grain CAMERA DIRECTION: and silage feed bunk
