SITE INFORMATION				
*SURVEY DATE: September	3, 2013 *ADDRESS: 46629 311 th Street			
*SURVEYOR:Jim Stone	*COUNTY: Clay			
	*CITY: Vermillion			
LOCATION DESCRIPTION: From Verm	illion, intersection of South Dakota Highway 50 bi-pass and			
University Road, North about 7 miles to 311th Street, turn right (East) about 1-1/4 miles, on the right				
(South) side.				
LEGAL DESCRIPTION: E ½, NW ¼, 16 – 93 – 51 Prairie Center Twp.				
*QUARTER 1: <u>NW 1/4</u>	OWNER NAME: Paul T. Nelson Family Trust			
*QUARTER 2:	OWNER ADDRESS: 31079 467th Ave.			
*TOWNSHIP: Prairie Center	OWNER CITY: Vermillion			
*RANGE:	OWNER STATE: So. Dak.			
*SECTION:16	OWNER ZIP: <u>57069</u>			
ACRES: 81.38	QUAD NAME:			
OWNER CODE 1: P				
OWNER CODE 2:				
OWNER CODE 3:				
LUCTORIC CICNUTICANCE				
HISTORIC SIGNIFICANCE				
*DOE: REGISTER NAME:				
*DOE DATE: MULTIPLE PROPERTY NAME:				
REASON INELIGIBLE:				
	CATEGORY:			
NOMINATION STATUS:	SIGNIFICANCE LEVEL 1: N S L

STRUCTURE DETAILS

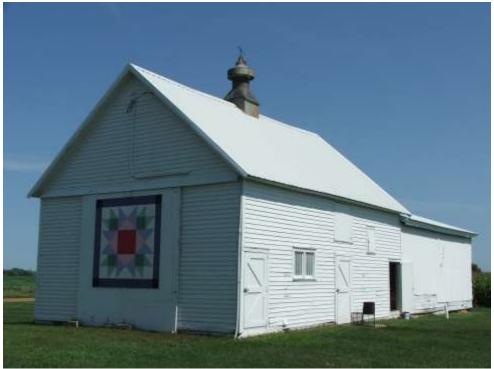
PHOTOGRAPHER: Jim Stone ROLL NUMBER: DATE OF PHOTO: September 3, 2013 PHOTO NUMBER: 1

CAMERA DIRECTION: Looking NE, SW corner

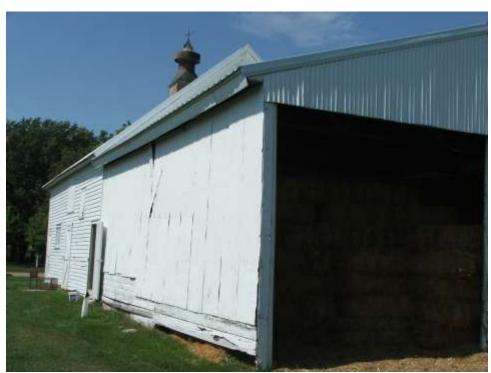
PHOTOGRAPHER: Jim Stone ROLL NUMBER: DATE OF PHOTO: September 3, 2013 PHOTO NUMBER: 2
CAMERA DIRECTION: Looking NW, SE corner

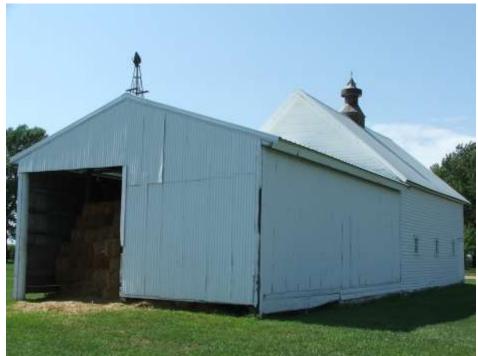
PHOTOGRAPHER: Jim Stone ROLL NUMBER: DATE OF PHOTO: September 3, 2013 PHOTO NUMBER: 3

CAMERA DIRECTION: Looking SW, NE corner

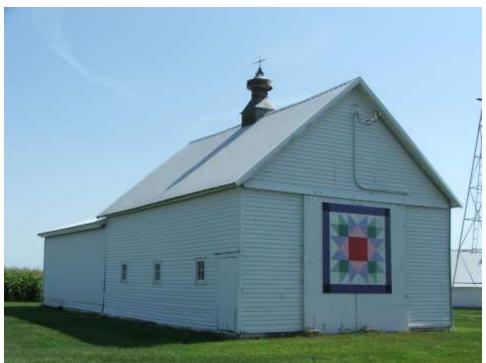
PHOTOGRAPHER: Jim Stone ROLL NUMBER: DATE OF PHOTO: September 3, 2013 PHOTO NUMBER: 4

CAMERA DIRECTION: Looking SE, NW corner

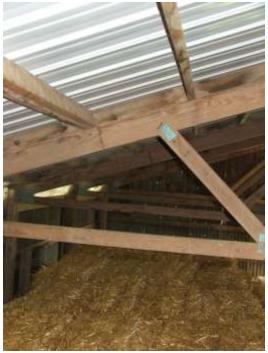
Hayloft, looking East into pole barn addition, CAMERA DIRECTION: manufactured trusses.

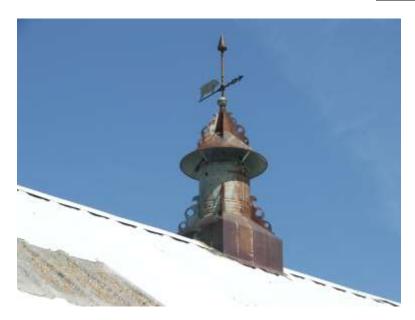
Hog barn just South of original barn, looking NE, very old galvanized

CAMERA DIRECTION: metal cupola.
