**SOUTH DAKOTA STATE HISTORIC PRESERVATION OFFICE
HISTORIC SITES SURVEY STRUCTURE FORM**

*SURVEY DATE: November 27, 2012 *ADDRESS: 30624 464th Ave.
*SURVEYOR: Jim Stone *COUNTY: Clay
*CITY: Centerville

CURRENT FUNCTION:	<u>Calving and cattle</u>	FOUNDATION:	<u>Poured concrete foundation</u>
CURRENT SUBFUNCTION:	<u>Storage</u>	ROOF MATERIAL:	<u>Cedar shingles</u>
HISTORIC FUNCTION:	<u>Livestock barn</u>	ROOF SHAPE:	<u>Gothic round</u>
HISTORIC SUBFUNCTION:	<u>Hay storage</u>	STRUCTURAL SYSTEM:	<u>Balloon framing Wisconsin dairy barn</u>
		STYLE:	<u>barn</u>
OCCUPIED:	<u>Yes</u>	TYPE:	<u>Dairy barn 8" concrete block, 2x8 studs with 1x6 #106 drop siding on Hayloft gable ends</u>
		WALLS:	<u>ends</u>
ACCESSIBLE:	<u>Yes with permission</u>		
		SIGNIFICANT PERSON:	<u>A. M. Lindstrom & A. O. Lindstrom</u>
STORIES:	<u>2</u>	CULTURAL AFFILIATION:	<u>Swedish</u>
*DATE OF CONSTRUCTION:	<u>1954</u>

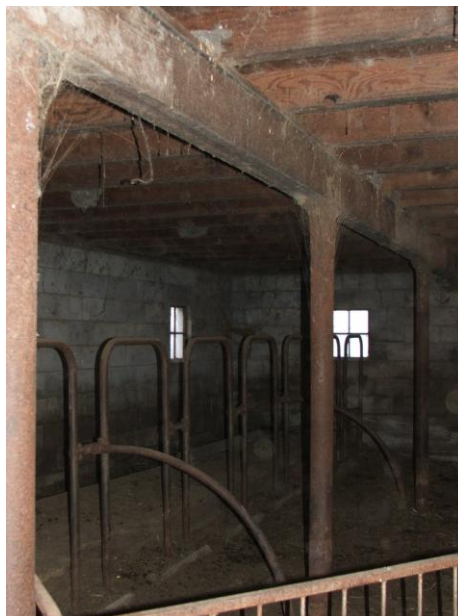
ROLL NUMBER: _____
PHOTO NUMBER: 5

CAMERA DIRECTION: First floor, looking NW, 7
milk cow stanchions on
West wall

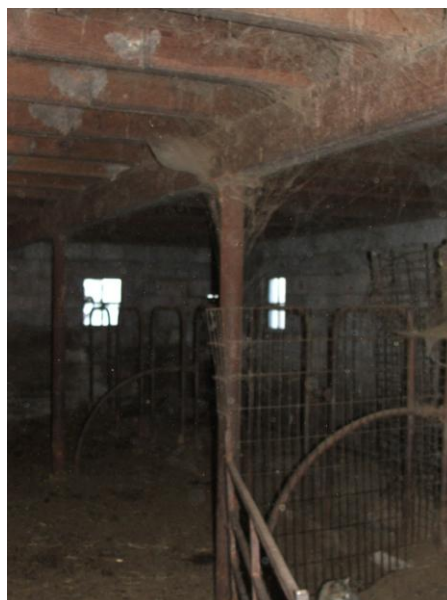
ROLL NUMBER: _____
PHOTO NUMBER: 6

CAMERA DIRECTION: First floor, looking NE, 7
milk cow stanchions on
East wall

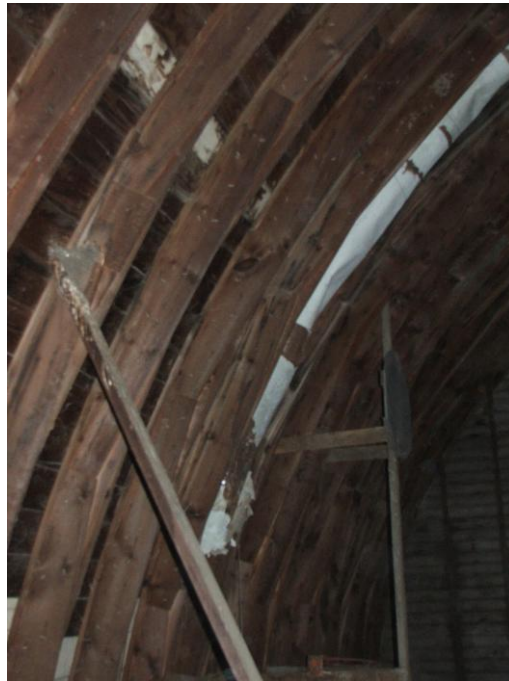
ROLL NUMBER: _____
PHOTO NUMBER: 7

**Hayloft, looking NW, site
built rafters, 3 ply 1x8
cedar w/ 1x4 on back
side**

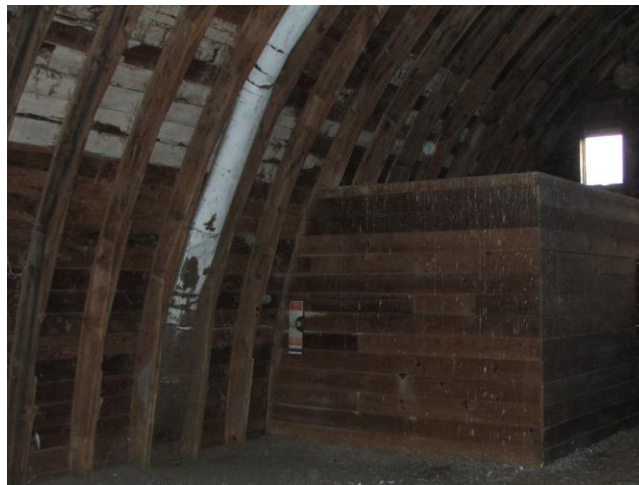
ROLL NUMBER: _____
PHOTO NUMBER: 8

**Hayloft, looking SE, 12"
metal ductwork up to
cupola to ventilate first
floor. Note 14' x 10'
granary in SE corner**
