**SOUTH DAKOTA STATE HISTORIC PRESERVATION OFFICE
HISTORIC SITES SURVEY STRUCTURE FORM**

*SURVEY DATE: February 15, 2014 *ADDRESS: 46970 So. Dak. Hwy 50
*SURVEYOR: Jim Stone *COUNTY: Clay
*CITY: Burbank

CURRENT FUNCTION: Vacant FOUNDATION: Poured concrete
 CURRENT SUBFUNCTION: Vacant ROOF MATERIAL: Asphalt shingles
 HISTORIC FUNCTION: Livestock barn ROOF SHAPE: over cedar shingles
 HISTORIC SUBFUNCTION: Hay and grain storage STRUCTURAL SYSTEM: Gable roof
 OCCUPIED: Yes STYLE: Balloon framing
 Yes with Livestock barn
 permission 2x6 studs, 1x6 # 106
 ACCESSIBLE: drop siding

STORIES: 2 SIGNIFICANT PERSON: Abraham Chaussee
 *DATE OF CONSTRUCTION: 1890 to 1910 CULTURAL AFFILIATION: French

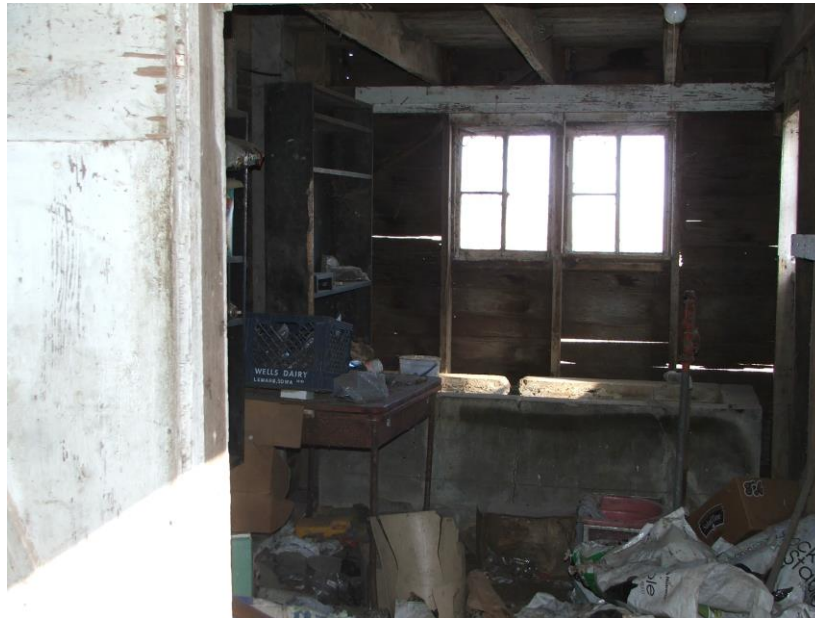
ROLL NUMBER: _____
PHOTO NUMBER: 5

CAMERA DIRECTION: First floor, looking East into milk room, note concrete tank, well water milk cooler.

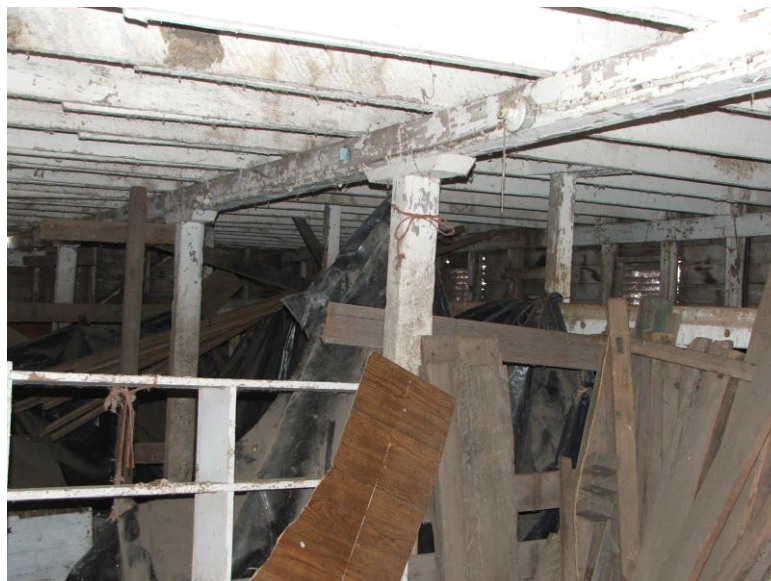
ROLL NUMBER: _____
PHOTO NUMBER: 6

CAMERA DIRECTION: First floor, looking NE, 4x6 posts, 6x6 beam and 2x8 floor joists, all rough sawn cottonwood.

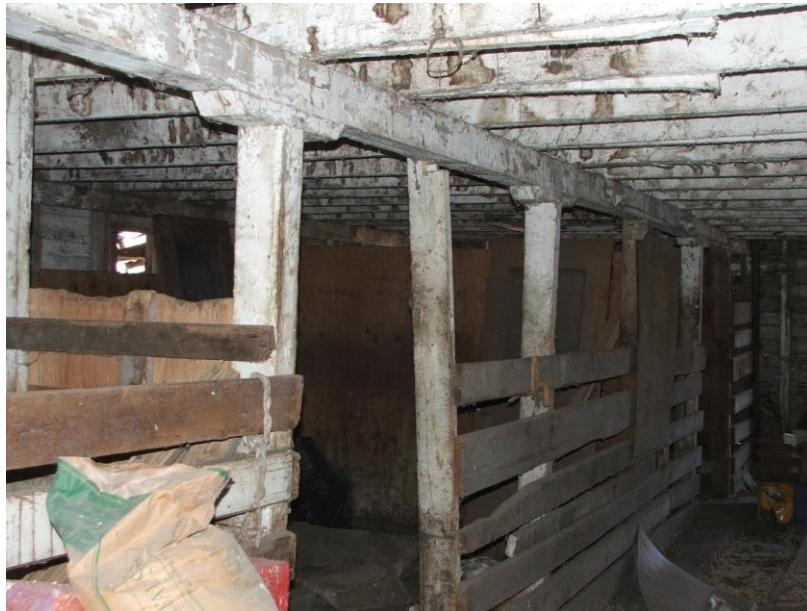
ROLL NUMBER: _____
PHOTO NUMBER: 7

**First floor, looking NW,
posts and beam, pens
were added where milk
cow stanchions were.**

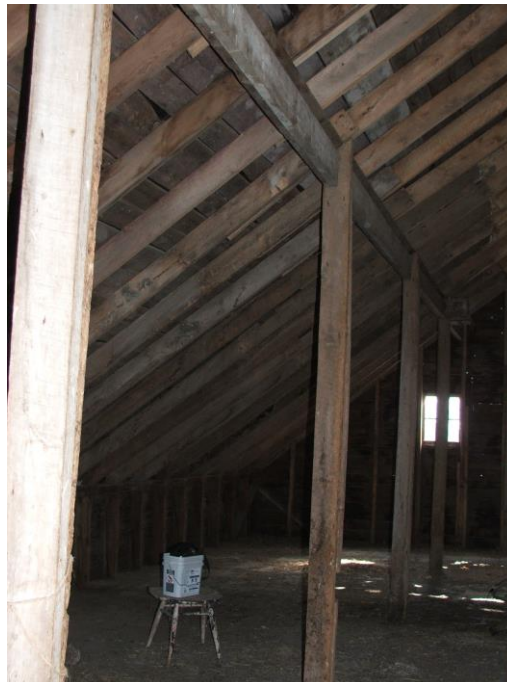
ROLL NUMBER: _____
PHOTO NUMBER: 8

**Hayloft, looking SE,
double 2x6 posts and
beam supporting 2x6
rafters.**

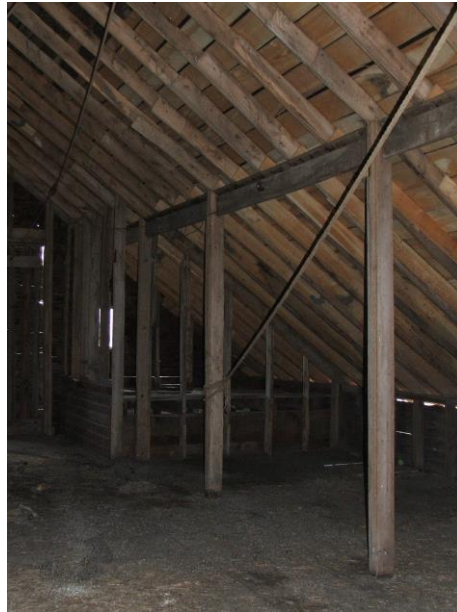
ROLL NUMBER: _____
PHOTO NUMBER: 9

CAMERA DIRECTION: Hayloft, looking SW,
double 2x6 posts and
beam supporting rafters,
note granary up into loft.

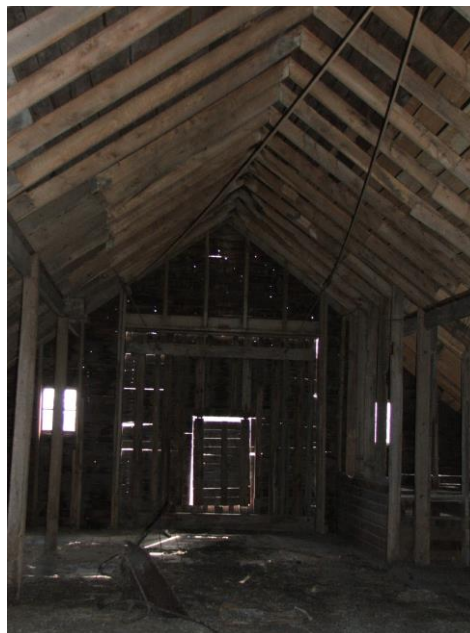
ROLL NUMBER: _____
PHOTO NUMBER: 10

CAMERA DIRECTION: Hayloft looking South,
large 10' x 10' hayloft
door, note rope to open
and close hayloft door.

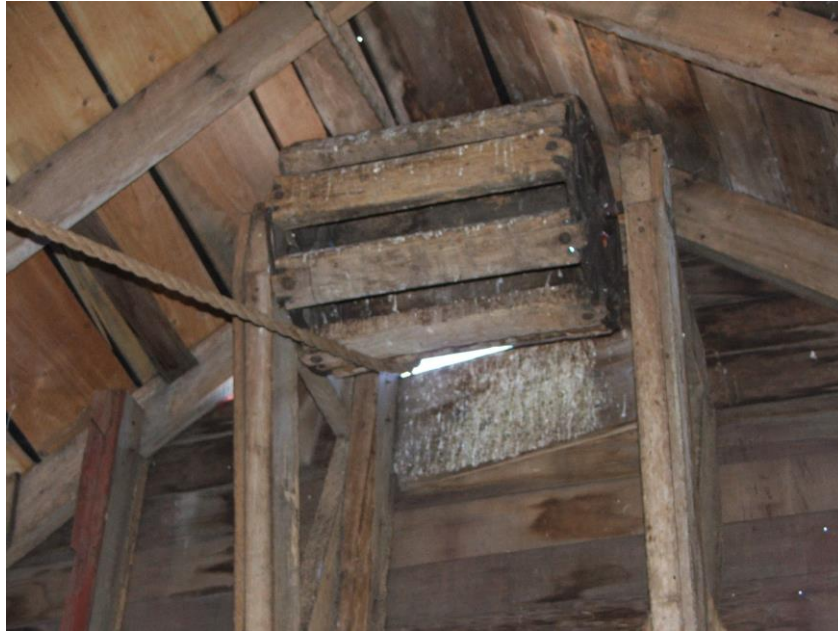
ROLL NUMBER: _____
PHOTO NUMBER: 11

CAMERA DIRECTION: Hayloft, looking up at North gable wall, large wooden drum for hayloft rope.
