""SITE INFORMA	ATION					
*SURVEY DA	TE: June 26,	2013 *ADDRESS:	45623 302nd Street			
*SURVEYO	OR: Jim Stor	re *COUNTY:	Clay			
		*CITY:	Wakonda			
		·	uth Dakota Highway 50 bi-pass and			
South Dakota Highway 19, North 15 miles to 302 <sup>nd</sup> Street, turn left (West) about 4-3/4 miles, left (South)						
side.						
LEGAL DESCRIPTION	N: <u>NW ¼, 35 – </u>	95 – 53 Star Twp.				
			Edward Lamont, Teresa K.,			
*QUARTER 1: _	NW 1/4	OWNER NAME:	Douglas J. & Ruth A. Hessman			
*QUARTER 2: _		OWNER ADDRESS:	P. O. Box 520			
*TOWNSHIP: _	Star	OWNER CITY:	Wakonda			
*RANGE: _	53	OWNER STATE:	South Dakota			
*SECTION: _	35	OWNER ZIP:	57073			
ACRES: _	155.69	QUAD NAME:				
OWNER CODE 1:	Р					
OWNER CODE 2:						
OWNER CODE 3:						
HISTORIC SIGNII	FICANCE					
*DO	DE:	REGISTER NA	REGISTER NAME:			
*DOE DAT			OPERTY NAME:			
REASON INELIGIBLE:						
			CATEGORY:			
NOMINATION STATUS:		SIGNI	SIGNIFICANCE LEVEL 1: N S L

#### STRUCTURE DETAILS

SHPO ID:		_				
*PROPERTY NAME:						
OTHER NAME:						
CURRENT FUNCTION:	Goat barn	FOUNDATIO	N: Poured concrete Asphalt shingles over			
CURRENT SUBFUNCTION:	Storage	ROOF MATERIA				
HISTORIC FUNCTION:	Livestock barn	ROOF SHAF	E: Gambrel roof

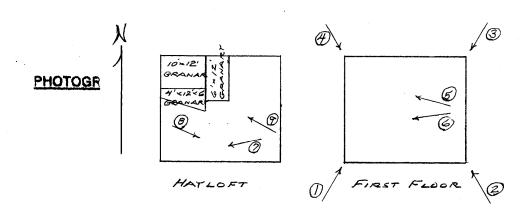
#### SKETCH MAP RAFTERS 8'x10' GRANAR ZX6 HIP BRACE T'ac. Z×6 BRACE 121246 BEAM ò DOUBLE 12) DOUBLE U) SINGLE HORSE STALLS MILK COW STAKES 3 32 FIRST FLOOR 2-6 STUDS 1-6 #106 BROP SIDING POURED CONCRETE FOUNDATION WEST ELEVATION

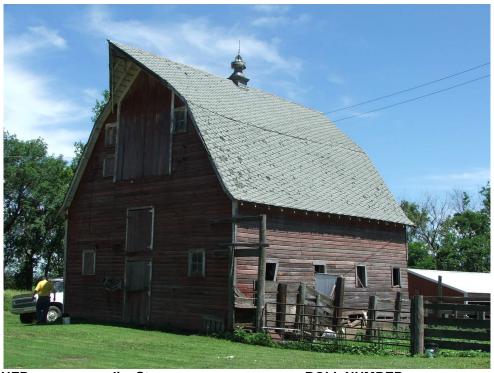
PHOTOGRAPHER: Jim Stone ROLL NUMBER: DATE OF PHOTO: June 26, 2013 PHOTO NUMBER: 1
CAMERA DIRECTION: Looking NE, SW corner

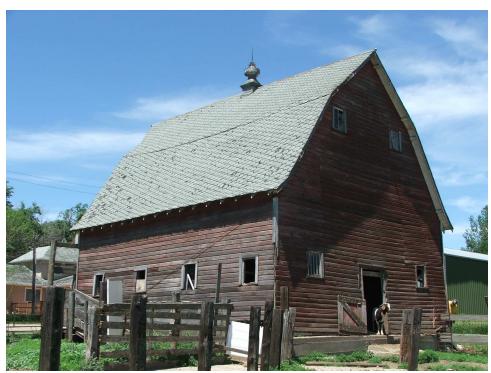
DATE OF PHOTO: June 26, 2013 PHOTO NUMBER: 2

CAMERA DIRECTION: Looking NW, SE corner

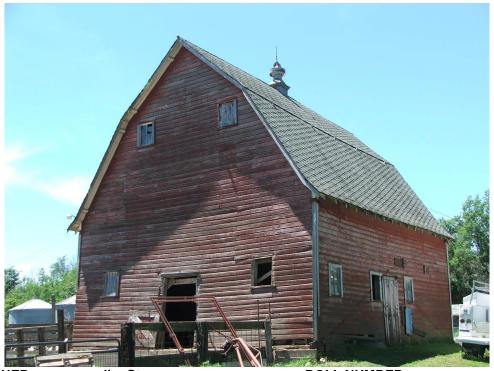
PHOTOGRAPHER: Jim Stone ROLL NUMBER: DATE OF PHOTO: June 26, 2013 PHOTO NUMBER: 3

CAMERA DIRECTION: Looking SW, NE corner

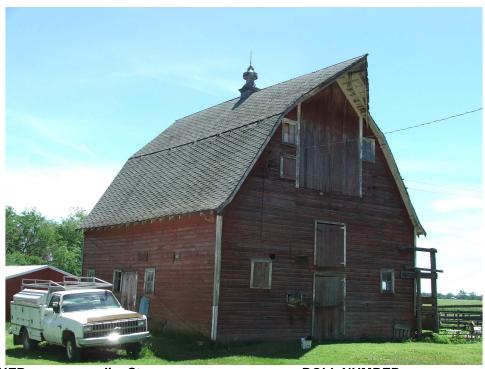
PHOTOGRAPHER: Jim Stone ROLL NUMBER: DATE OF PHOTO: June 26, 2013 PHOTO NUMBER: 4
CAMERA DIRECTION: Looking SE, NW corner

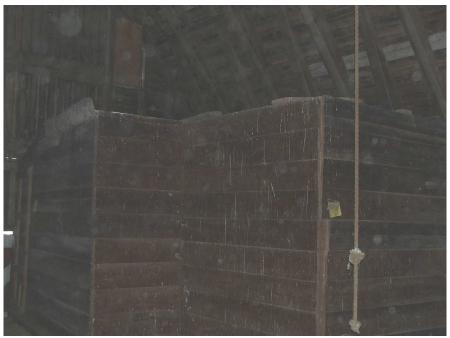
Hayloft, looking NW, three granaries in the

CAMERA DIRECTION: NW corner
