**SOUTH DAKOTA STATE HISTORIC PRESERVATION OFFICE
HISTORIC SITES SURVEY STRUCTURE FORM**

*SURVEY DATE: July 9, 2012 *ADDRESS: 31751 455th Ave.
*SURVEYOR: Jim Stone *COUNTY: Clay
*CITY: Meckling

CURRENT FUNCTION: <u>Livestock barn</u>	FOUNDATION: <u>Poured concrete</u>
CURRENT SUBFUNCTION: <u>Storage</u>	ROOF MATERIAL: <u>Steel over cedar shingles</u>
HISTORIC FUNCTION: <u>Livestock barn</u>	ROOF SHAPE: <u>Gambrel</u>
HISTORIC SUBFUNCTION: <u>Hay storage</u>	STRUCTURAL SYSTEM: <u>Balloon framing</u>
OCCUPIED: <u>Yes</u>	STYLE: <u>Gambrel roof barn</u>
ACCESSIBLE: <u>Yes with permission</u>	TYPE: <u>Livestock barn</u>
	WALLS: <u>2x6, 1x6 #106 drop siding</u>

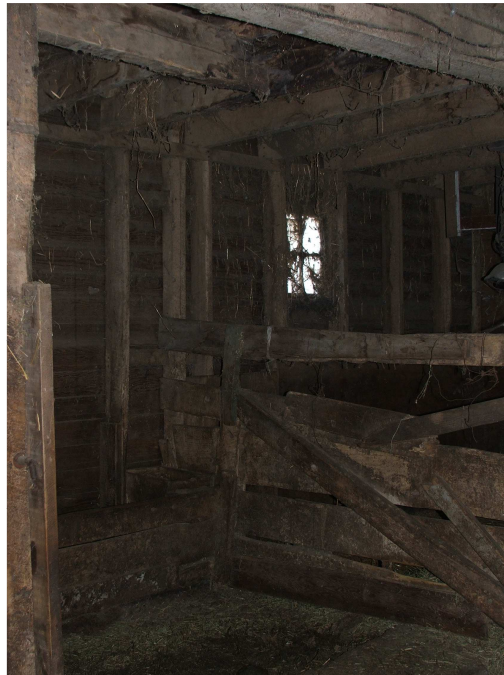
ROLL NUMBER: 5
PHOTO NUMBER: 5

CAMERA DIRECTION: First floor, looking NE,
milk cow stall

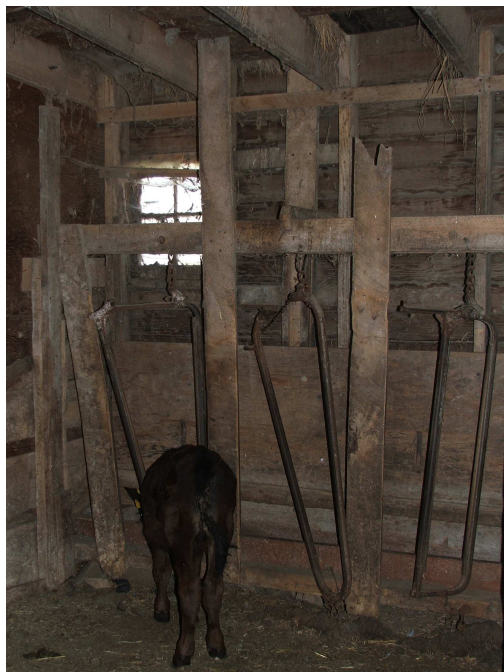
ROLL NUMBER: 6
PHOTO NUMBER: 6

CAMERA DIRECTION: First floor, looking North,
three milk cow
stanchions

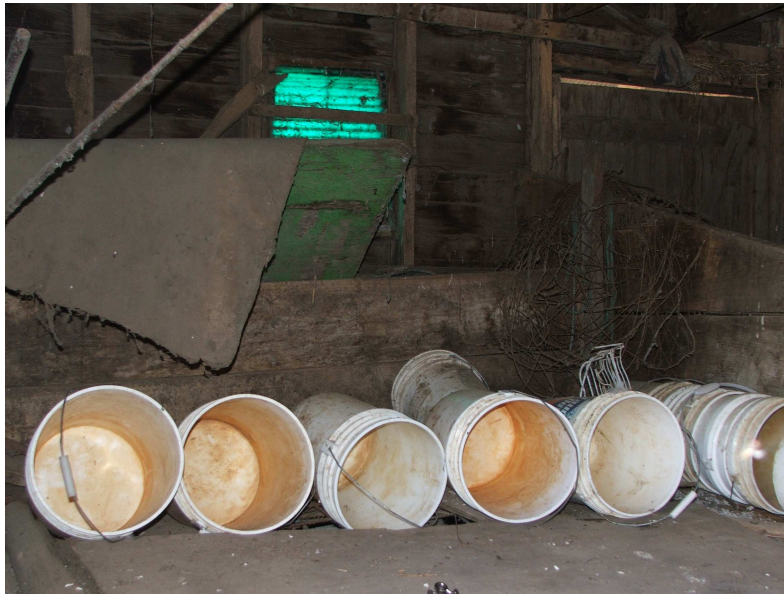
ROLL NUMBER: _____
PHOTO NUMBER: 7

CAMERA DIRECTION: First floor, looking South, only horse stall left

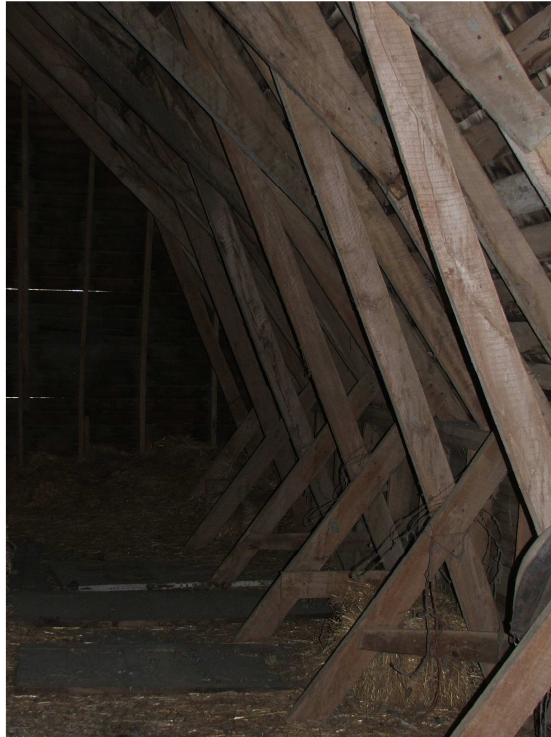
ROLL NUMBER: _____
PHOTO NUMBER: 8

CAMERA DIRECTION: Hayloft, looking West, lower rafter & wall bracing

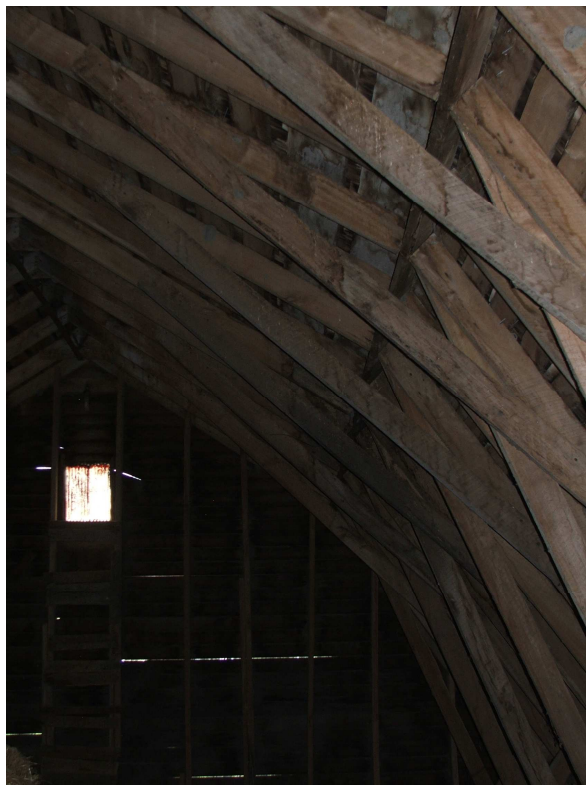
ROLL NUMBER: _____
PHOTO NUMBER: 9
CAMERA DIRECTION: Hayloft, looking West,
upper rafter bracing
