**SOUTH DAKOTA STATE HISTORIC PRESERVATION OFFICE
HISTORIC SITES SURVEY STRUCTURE FORM**

CURRENT FUNCTION:	<u>Shop</u>	FOUNDATION:	<u>Poured concrete foundation</u>
CURRENT SUBFUNCTION:	<u>Storage</u>	ROOF MATERIAL:	<u>cedar shingles</u>
HISTORIC FUNCTION:	<u>Livestock barn</u>	ROOF SHAPE:	<u>Gambrel</u>
HISTORIC SUBFUNCTION:	<u>Hay storage</u>	STRUCTURAL SYSTEM:	<u>Balloon framing</u>
		STYLE:	<u>Gambrel roof barn</u>
OCCUPIED:	<u>Yes</u>	TYPE:	<u>Livestock barn</u>
	<u>Yes with</u>		<u>2x6 studs, 1x6 #106</u>
ACCESSIBLE:	<u>permission</u>	WALLS:	<u>drop siding</u>
STORIES:	<u>2</u>	SIGNIFICANT PERSON:	<u>Andrew Salberg</u>
	<u>Re-built</u>		
*DATE OF CONSTRUCTION:	<u>1930's</u>	CULTURAL AFFILIATION:	<u>Swedish</u>

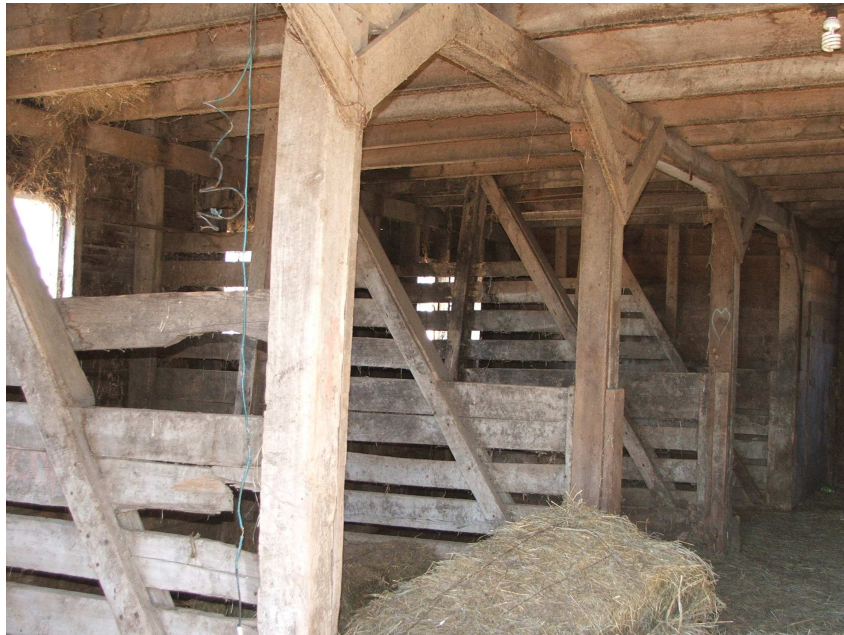
ROLL NUMBER: _____
PHOTO NUMBER: 5

CAMERA DIRECTION: First floor, West side,
looking NW, horse stalls
on West wall.

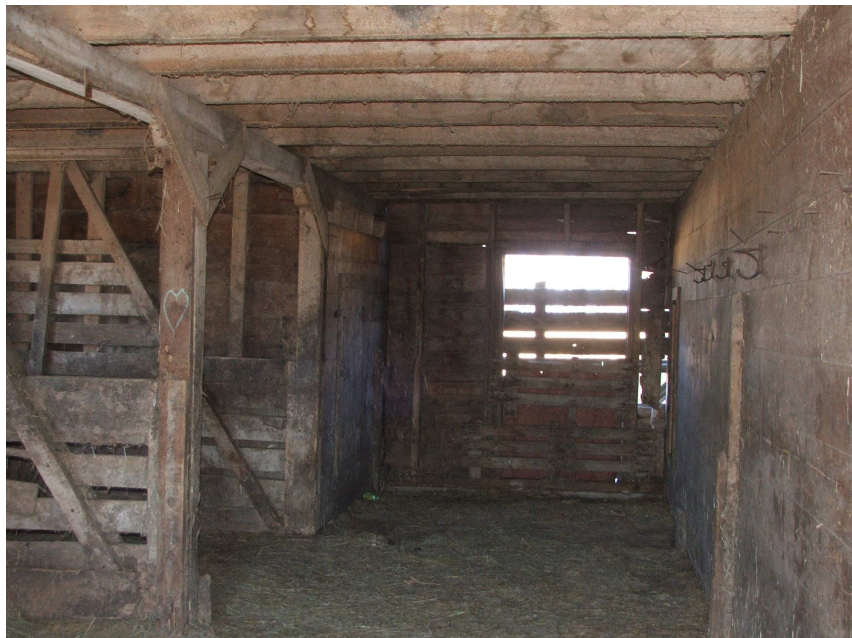
ROLL NUMBER: _____
PHOTO NUMBER: 6

CAMERA DIRECTION: First floor, West side,
looking North, granary in
NW corner, solid wall on
the right.

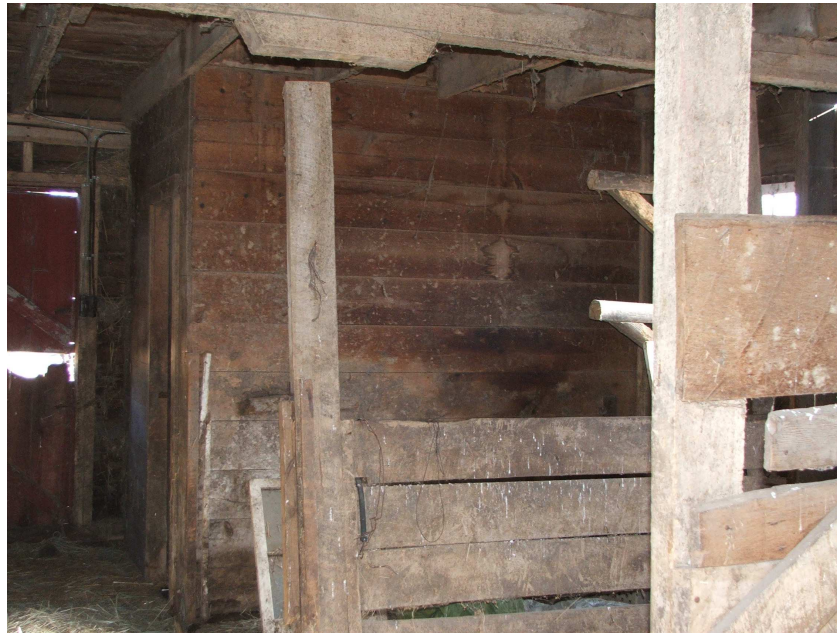
ROLL NUMBER: _____
PHOTO NUMBER: 7

First floor, East side,
looking SE, milk cow
stalls and milk room in

CAMERA DIRECTION: SE corner.

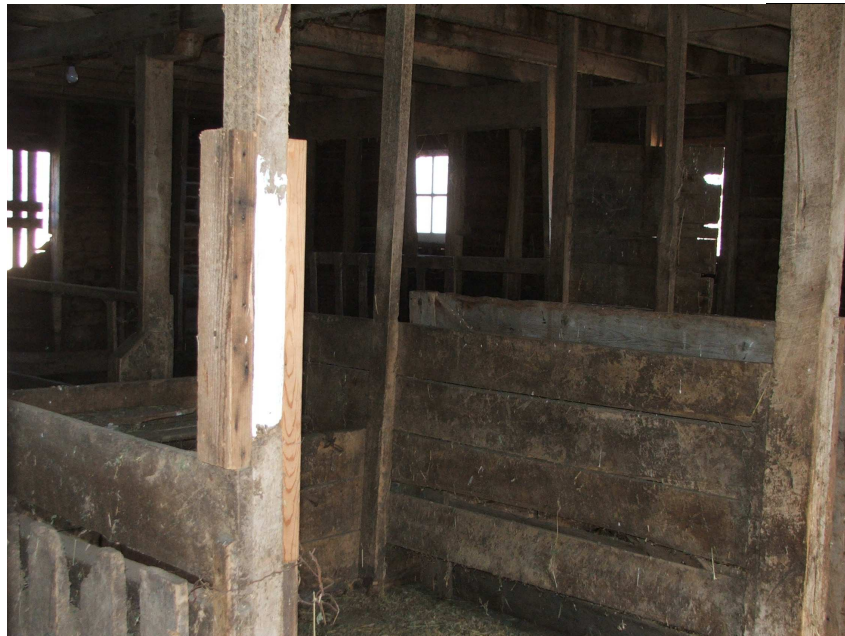
ROLL NUMBER: _____
PHOTO NUMBER: 8

First floor, East side,
looking NE, milk cow
stalls on North side of

CAMERA DIRECTION: alley.

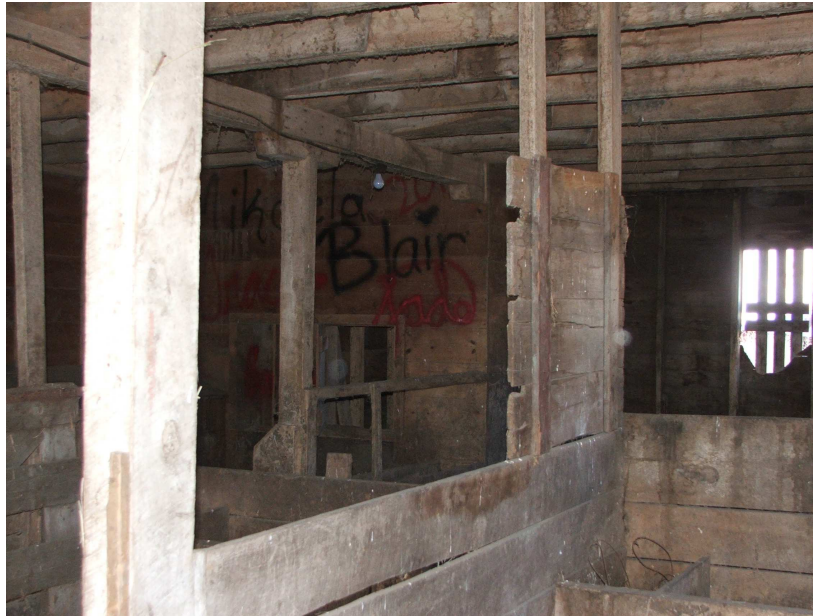
ROLL NUMBER: _____
PHOTO NUMBER: 9

CAMERA DIRECTION: First floor, East side, looking NW, calf pen and double granary in the NW corner of East side.

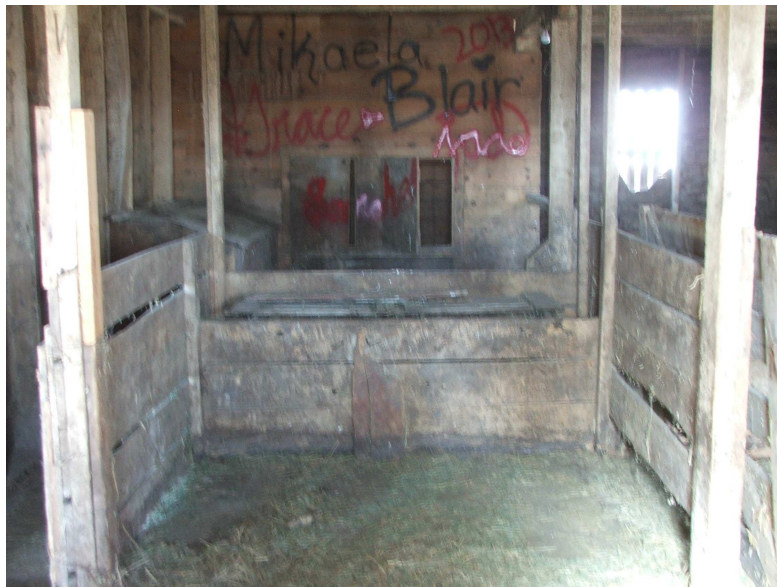
ROLL NUMBER: _____
PHOTO NUMBER: 10

CAMERA DIRECTION: First floor, East side, looking North, milk cow stall and double granary in the NW corner of East side.

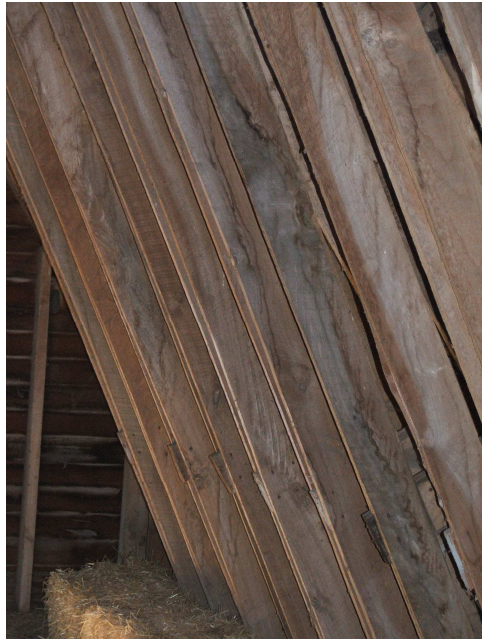
ROLL NUMBER: _____
PHOTO NUMBER: 11

**Hayloft, looking NE,
double 1x6 braces from
center of lower rafter
down to floor.**

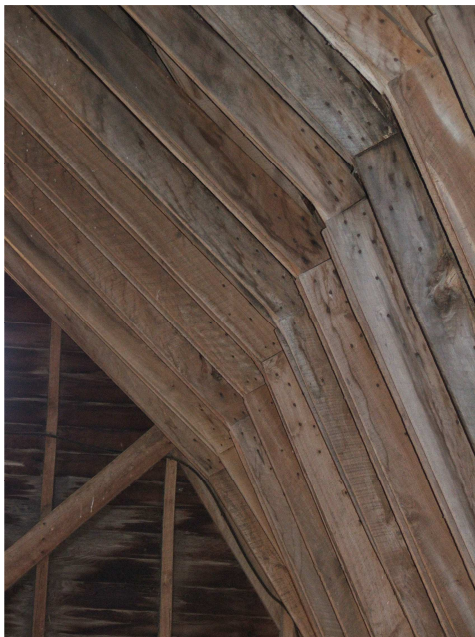
ROLL NUMBER: _____
PHOTO NUMBER: 12

**Hayloft, looking NE,
double 1x6 bracing up to
center of top rafter and
down to floor.**

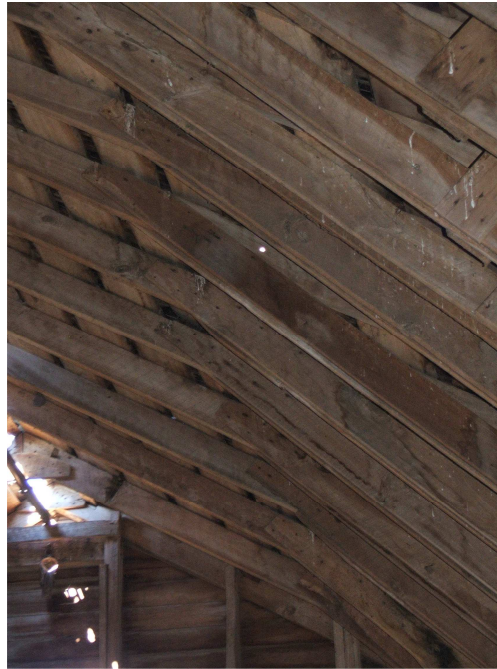
ROLL NUMBER: _____
PHOTO NUMBER: 13

CAMERA DIRECTION: Hayloft, looking NE,
double 1x6 bracing from
center of top rafter down,
note bracing from hip
out to 1x6 bracing.
