**SOUTH DAKOTA STATE HISTORIC PRESERVATION OFFICE
HISTORIC SITES SURVEY STRUCTURE FORM**

*SURVEY DATE: October 25, 2013 *ADDRESS: 46775 313th Street
*SURVEYOR: Jim Stone *COUNTY: Clay
*CITY: Vermillion

CURRENT FUNCTION: <u>Vacant</u>	FOUNDATION: <u>Native stone and poured concrete</u>
CURRENT SUBFUNCTION: <u>Vacant</u>	ROOF MATERIAL: <u>Cedar shingles</u>
HISTORIC FUNCTION: <u>Horse barn</u>	ROOF SHAPE: <u>Gambrel roof</u>
HISTORIC SUBFUNCTION: <u>Hay & grain storage</u>	STRUCTURAL SYSTEM: <u>Balloon framing</u>
OCCUPIED: <u>No</u>	STYLE: <u>Gambrel roof barn</u>
ACCESSIBLE: <u>Yes with permission</u>	TYPE: <u>Horse barn</u>
	<u>2x6 studs, 1x8 shiplap, 1/2"x6" cedar lap siding</u>
STORIES: <u>2</u>	WALLS: _____
*DATE OF CONSTRUCTION: <u>1925</u>	SIGNIFICANT PERSON: <u>Andrew Stensaas</u>
	CULTURAL AFFILIATION: <u>Norwegian</u>

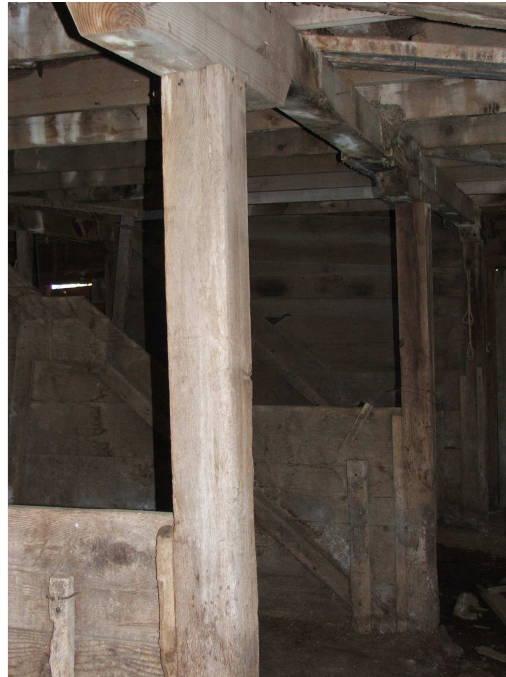
ROLL NUMBER: _____
PHOTO NUMBER: 5

CAMERA DIRECTION: First floor, looking SE at double horse stalls on West side

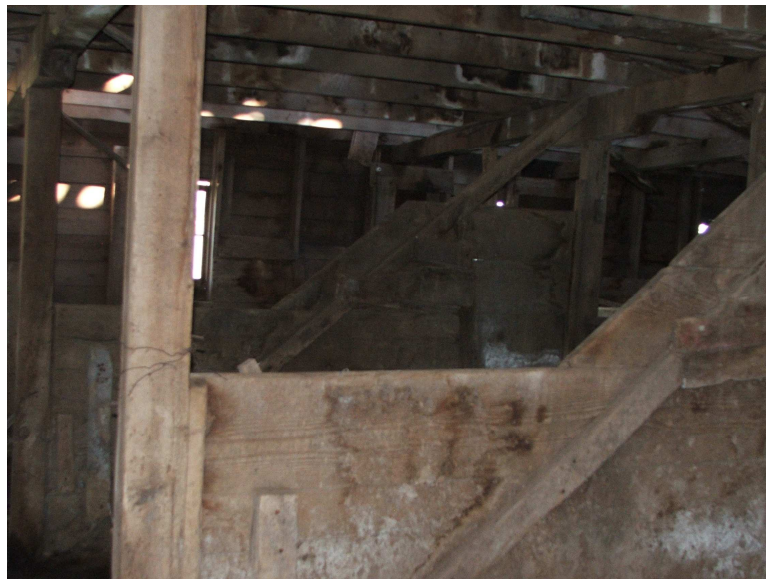
ROLL NUMBER: _____
PHOTO NUMBER: 6

CAMERA DIRECTION: First floor, looking NE, 6x6 posts, 4x6 beam, 2x8 floor joists, double horse stalls on West side.

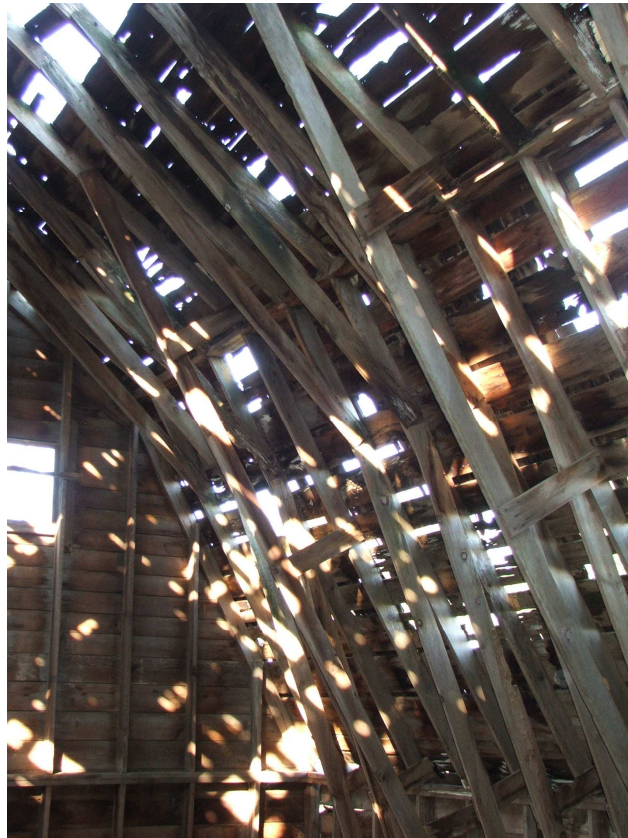
ROLL NUMBER: _____
PHOTO NUMBER: 7

Hayloft, looking NW, 2x6 rafters, double 2x6 beam at the hip, 2x6 bracing from top and bottom rafters down to exterior wall at hayloft floor level, and 2x6 bracing on each hip.
