#### SITE INFORMATION

\*SURVEY DATE: <u>July 20, 2012</u>

\*ADDRESS: <u>30641 466<sup>th</sup> Ave.</u>

#### STRUCTURE DETAILS

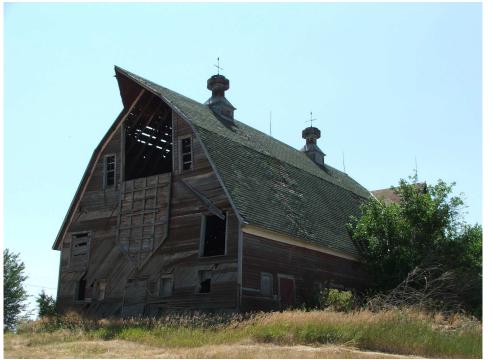
3 CAMERA DIRECTION: Looking SW, NE corner

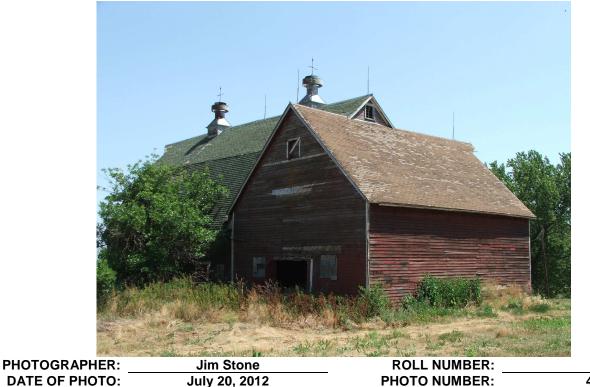
July 20, 2012 **PHOTO NUMBER:** 4 CAMERA DIRECTION: Looking SE, NW corner

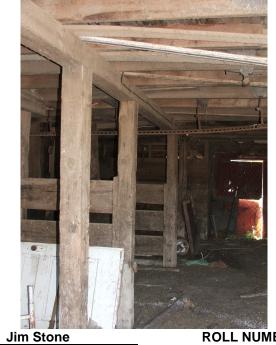
First floor, West barn, looking South, horse CAMERA DIRECTION: stalls
