""SITE INFORMATION	1									
*SURVEY DATE:	June 21, 2013	*ADDRESS:	45534 299	45534 299 th Street						
*SURVEYOR:	Jim Stone	*COUNTY:	Clay							
		*CITY:	Wakonda							
LOCATION DESCRIPTION: From Vermillion, the intersection of South Dakota Highway 50 bi-pass and										
South Dakota Highway 19, North 20 miles to South Dakota Highway 46, turn left (West) about 5 miles to										
457th Ave., turn left (South) about 1/4 mile, left (East) side.										
LEGAL DESCRIPTION: W 1/2, NW 1/4, 1 – 95 – 53 Star Twp.										
LEGAL DESCRIPTION: W 1/2, NW 1/4, 1 - 95 - 53 Star Twp.										
*QUARTER 1: NW	1/4	OWNER NAME:	James K. I	James K. Holm						
*QUARTER 2:		OWNER ADDRESS:	29722 457 ^t	29722 457 th Ave.						
*TOWNSHIP: St	ar	OWNER CITY:	Wakonda	Wakonda						
*RANGE: 53	3	OWNER STATE:	South Dak	ota						
*SECTION:1	*SECTION:1									
ACRES:76.	.44	QUAD NAME:								
OWNER CODE 1: P										
OWNER CODE 2:

STRUCTURE DETAILS

SHPO ID:		<u></u>					
*PROPERTY NAME:							
OTHER NAME:							
CURRENT FUNCTION:	Storage	FOUNDATIO	N: Poured concrete				
CURRENT SUBFUNCTION:	Storage	ROOF MATERIA	Steel roofing over L: cedar shingles				
HISTORIC FUNCTION:	Livestock barn		OF SHAPE: Gambrel

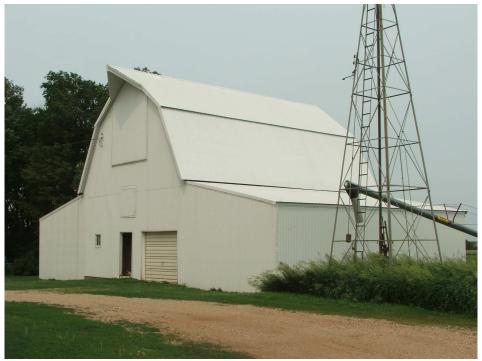
PHOTOGRAPHER: Jim Stone ROLL NUMBER: DATE OF PHOTO: June 21, 2013 PHOTO NUMBER: 1

CAMERA DIRECTION: Looking NE, SW corner

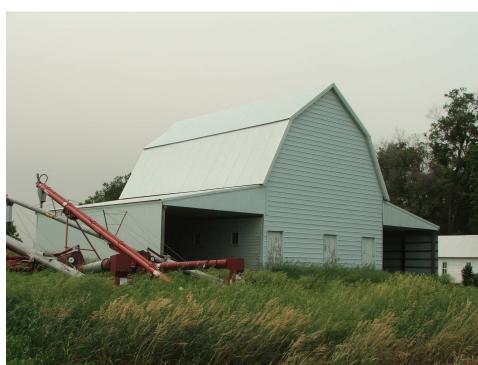
PHOTOGRAPHER: Jim Stone ROLL NUMBER: DATE OF PHOTO: June 21, 2013 PHOTO NUMBER: 2
CAMERA DIRECTION: Looking NW, SE corner

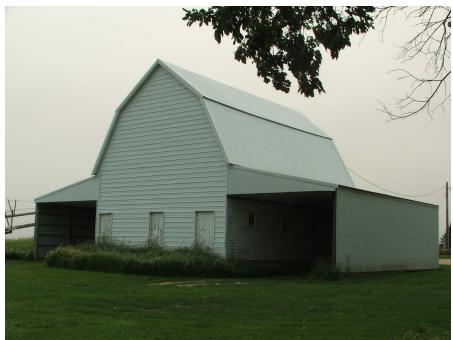
PHOTOGRAPHER: Jim Stone ROLL NUMBER: DATE OF PHOTO: June 21, 2013 PHOTO NUMBER: 3

CAMERA DIRECTION: Looking SW, NE corner

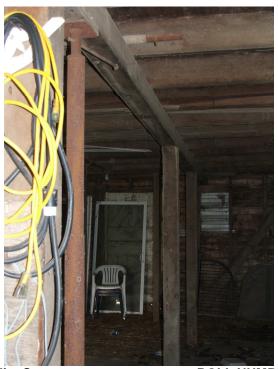
PHOTO NUMBER: 4

First floor, looking NE, 6x6 posts, 6x6 beam, 2x8

CAMERA DIRECTION: floor joists.
