""SITE INFORMATION

STRUCTURE DETAILS				
SHPO ID:				
*PROPERTY NAME:		-		
OTHER NAME:				
• · · · · · · · · · · · · · · · · · · ·				
			Large native rock and poured	
CURRENT FUNCTION:	Vacant	FOUNDATION:	concrete foundation	
CURRENT SUBFUNCTION:	Vacant	ROOF MATERIAL:	Cedar shingles	
HISTORIC FUNCTION:	Livestock barn	ROOF SHAPE:	Gable	
HISTORIC SUBFUNCTION:		STRUCTURAL SYSTEM:	Balloon framing	
HISTORIC SUBFUNCTION.	пау and grain storage	=		
	NI.	STYLE:	Gable roof barn	
OCCUPIED:	No	TYPE:	Livestock barn 2x6 studs, with 16"	
	Yes with		vertical siding and	
ACCESSIBLE:	permission	WALLS:	½"x6" lap siding	
STORIES:	2	SIGNIFICANT PERSON:	Anton Jensen	
*DATE OF CONSTRUCTION:		ILTURAL AFFILIATION:	?

light over 8"x 10" four light (horizontal brace 8' O.C.	double hung windows or	n the South wall. Rafters are 2x	6's with a 2x6	
*PHYSICAL NOTES: Barn is	s in very poor condition.			
*UTM ZONE:		*RESTRICTED: Y o	or N	
			71 I N	
*UTM EASTING: *UTM NORTHING:				
CINITACIALITING.

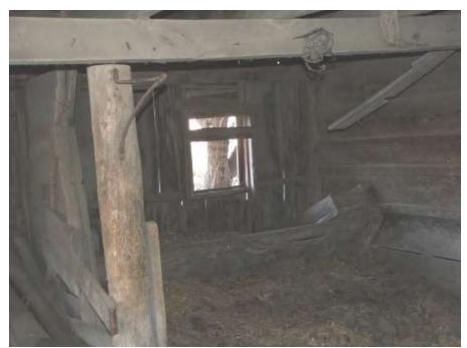
First floor, North end, looking SE, only double

CAMERA DIRECTION: horse stall still in place.

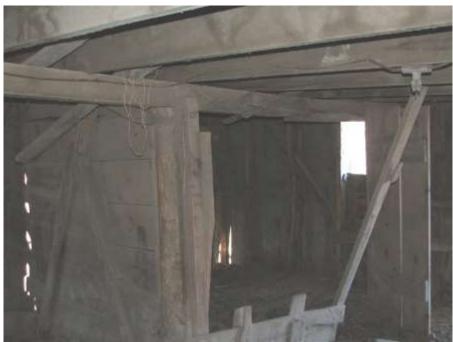
First floor, looking NW, granary in the NW

CAMERA DIRECTION: corner.

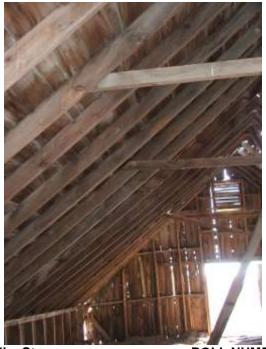
Hayloft, looking SE, 2x6 rafters, 2x6 stud walls

CAMERA DIRECTION: with girts 4' O. C.

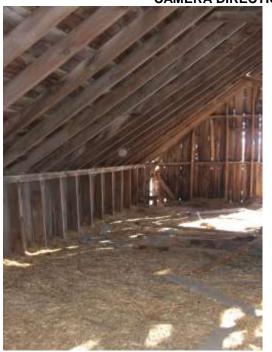
PHOTO NUMBER: 8

Hayloft, looking SE, 2x6 rafters and 2x6 cross

CAMERA DIRECTION: _ bracing 8' O. C.

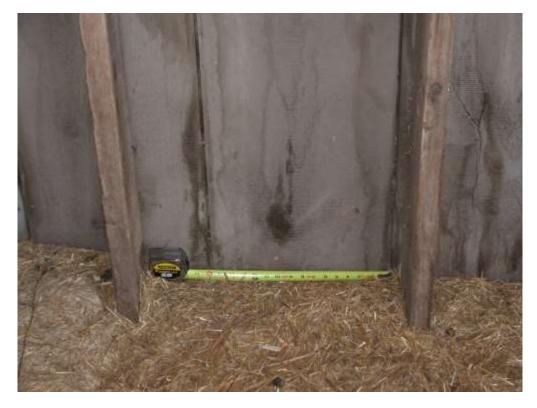
Hayloft, looking East, 7/8"x 16" vertical rough sawn siding. I have never seen 16" wide

CAMERA DIRECTION: vertical siding.
