**SOUTH DAKOTA STATE HISTORIC PRESERVATION OFFICE
HISTORIC SITES SURVEY STRUCTURE FORM**

*SURVEY DATE: November 25, 2013 *ADDRESS: 31229 Saginaw Ave.
*SURVEYOR: Jim Stone *COUNTY: Clay
*CITY: Vermillion

CURRENT FUNCTION: Vacant FOUNDATION: Poured concrete
 CURRENT SUBFUNCTION: Storage ROOF MATERIAL: Steel roofing over cedar shingles
 HISTORIC FUNCTION: Livestock barn ROOF SHAPE: Gable roof
 HISTORIC SUBFUNCTION: Hay and grain storage STRUCTURAL SYSTEM: Balloon framing
 OCCUPIED: No STYLE: Gable roof barn
Yes with TYPE: Livestock barn
 ACCESSIBLE: permission WALLS: 2x4 studs, and 1x6 #106 drop siding

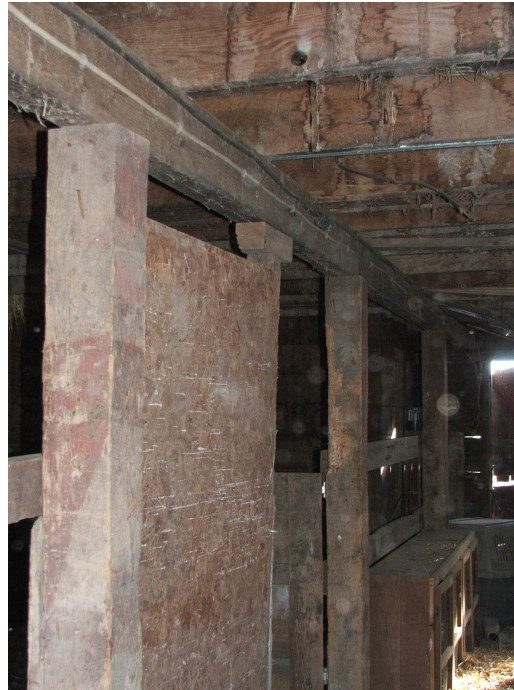
ROLL NUMBER: 5
PHOTO NUMBER: 5

CAMERA DIRECTION: First floor, looking SE, 6x6 posts, double 2x6 beam and 2x8 joists for the hayloft floor.

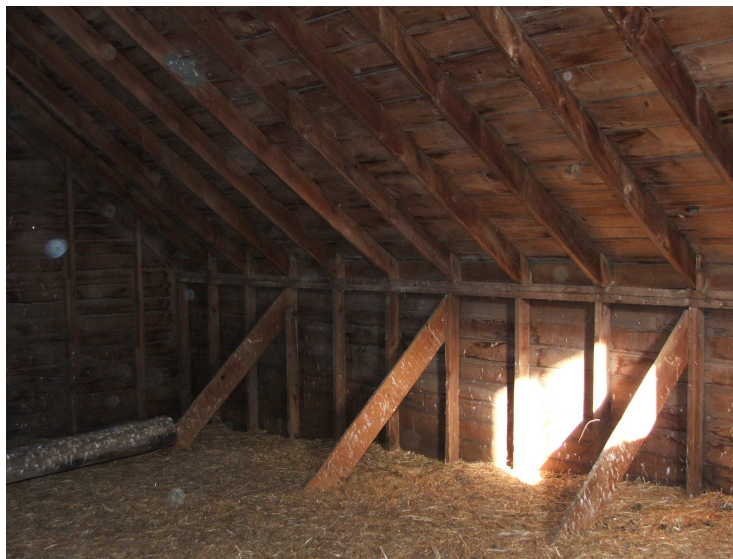
ROLL NUMBER: 6
PHOTO NUMBER: 6

CAMERA DIRECTION: Hayloft, looking NE, 2x6 rafters and 1x8 bracing from top of wall down to floor, 6' O. C.

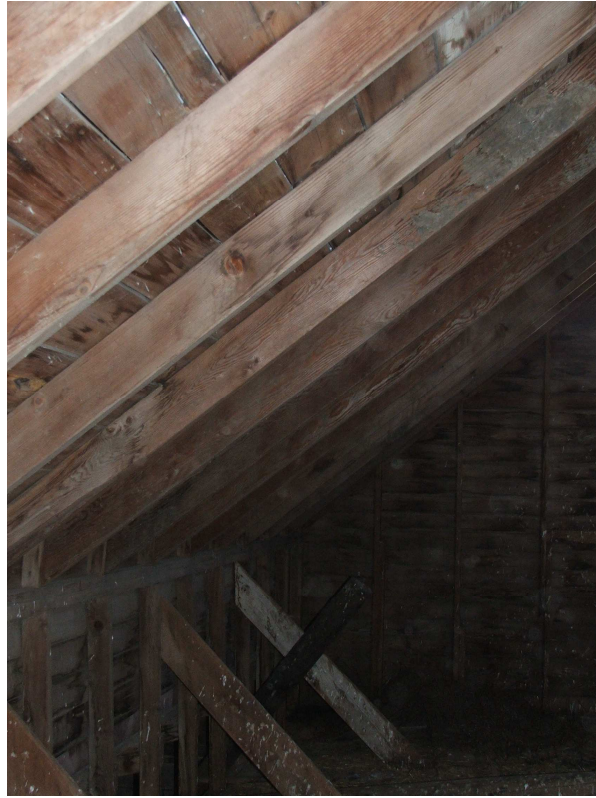
ROLL NUMBER: _____
PHOTO NUMBER: 7

CAMERA DIRECTION: Hayloft, looking NW, 2x6
rafters and 1x8 bracing
on West wall.
