#### **```SITE INFORMATION**

\*SURVEY DATE: May 16, 2013

#### STRUCTURE DETAILS

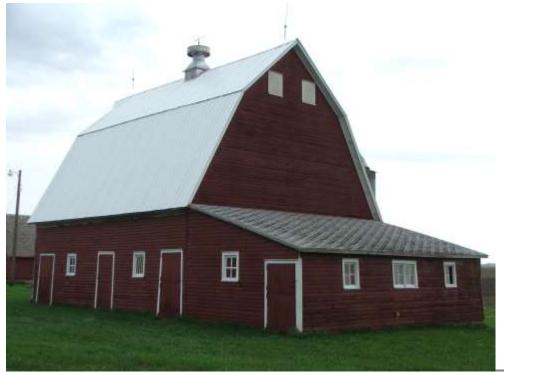
DATE OF PHOTO:
 May 16, 2013
 PHOTO NUMBER:
 1

CAMERA DIRECTION:
 Looking NE, SW corner

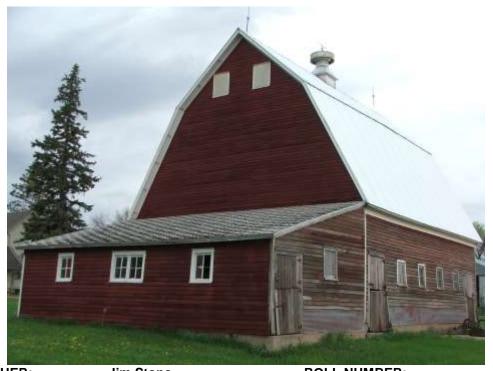
PHOTOGRAPHER:	Jim Stone	ROLL NUMBER:	
DATE OF PHOTO:	May 16, 2013	PHOTO NUMBER:	2
		CAMERA DIRECTION:	Looking NW, SE corner

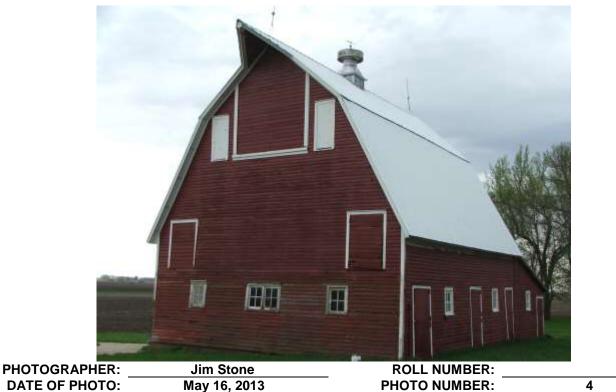
PHOTO NUMBER: 4 CAMERA DIRECTION: Looking SE, NW corner

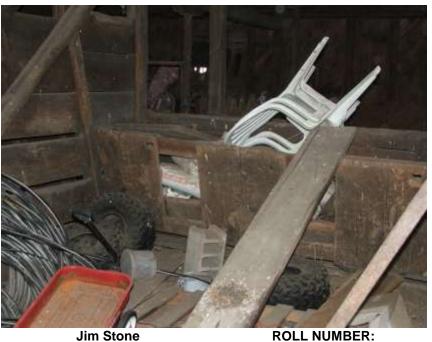
5

First floor, looking SE, double horse stall on North side.

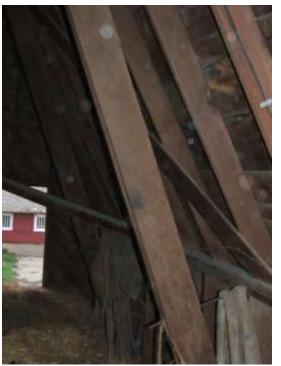
9
Hayloft, looking NE,
double 2x8's bracing
from hip down to floor,
behind each post, 10' –
8' – 8' – 10' O. C.
