#### STRUCTURE DETAILS

SHPO ID:							
*PROPERTY NAME:							
OTHER NAME:							
<b>CURRENT FUNCTION:</b>	Shop	FOUNDATION:	Poured concrete				
			Steel over cedar				
CURRENT SUBFUNCTION:	Storage	ROOF MATERIAL:	shingles				
HISTORIC FUNCTION:	Livestock barn	ROOF SHAPE:	Gable				
HISTORIC SUBFUNCTION:	Hay storage	STRUCTURAL SYSTEM:	Balloon framing				
			Gable roof barn				
OCCUPIED:	Yes	TYPE:	Livestock barn				
			2x6 studs, sheathing ½"x6"				
	Yes with		cedar lap siding				
ACCESSIBLE:	permission	WALLS:	and steel roofing				
STORIES:	2	SIGNIFICANT PERSON:	Charrlin				
*DATE OF CONSTRUCTION:	1914	CULTURAL AFFILIATION:	?				
ALTERED/MOVED NOTES:	Original site. Any e	evidence of horse stalls and milk cov	w stanchions has				
been removed. Roof has bee	n covered with stee	l roofing. Walls covered with vertica	al and horizontal				
steel roofing. Center area of barn has been remodeled into a shop. 2x8 floor joists have been removed

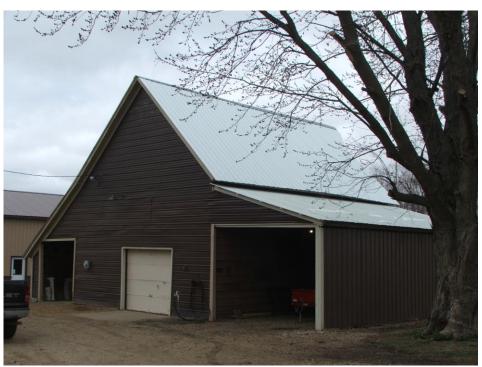
DATE OF PHOTO: April 15, 2013 PHOTO NUMBER: 1

CAMERA DIRECTION: Looking NE, SW corner

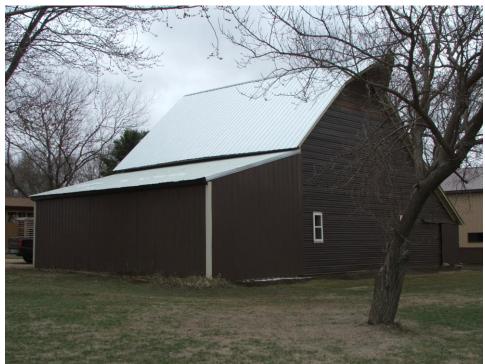
PHOTOGRAPHER: Jim Stone ROLL NUMBER:
DATE OF PHOTO: April 15, 2013 PHOTO NUMBER: 2
CAMERA DIRECTION: Looking NW, SE corner

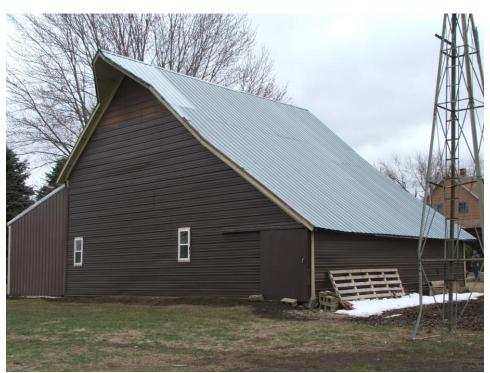
PHOTOGRAPHER: Jim Stone ROLL NUMBER: DATE OF PHOTO: April 15, 2013 PHOTO NUMBER: 3

CAMERA DIRECTION: Looking SW, NE corner

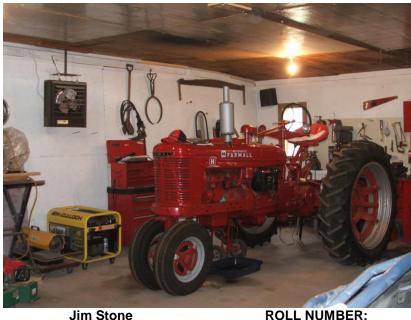
First floor, West lean-to, looking NW, wall is lined,

CAMERA DIRECTION: 2x6 rafters.
