**SOUTH DAKOTA STATE HISTORIC PRESERVATION OFFICE
HISTORIC SITES SURVEY STRUCTURE FORM**

*SURVEY DATE: May 10, 2014 *ADDRESS: 31362 463rd Ave.
*SURVEYOR: Jim Stone *COUNTY: Clay
*CITY: Vermillion

CURRENT FUNCTION:	<u>Vacant</u>	FOUNDATION:	<u>Original native stone, replaced with brick</u>
CURRENT SUBFUNCTION:	<u>Vacant</u>	ROOF MATERIAL:	<u>Cedar shingles</u>
HISTORIC FUNCTION:	<u>Horse barn</u>	ROOF SHAPE:	<u>Gable roof</u>
HISTORIC SUBFUNCTION:	<u>Hay and grain storage</u>	STRUCTURAL SYSTEM:	<u>Balloon framing</u>
		STYLE:	<u>Western Feeder barn</u>
OCCUPIED:	<u>Yes</u>	TYPE:	<u>Livestock barn</u>
	<u>Yes with</u>		<u>2x6 studs, 1x6 #106</u>
ACCESSIBLE:	<u>permission</u>	WALLS:	<u>drop siding</u>
STORIES:	<u>2</u>	SIGNIFICANT PERSON:	<u>A. O. Hancock</u>
*DATE OF CONSTRUCTION:	<u>1910 to 1920</u>	CULTURAL AFFILIATION:	<u>?</u>

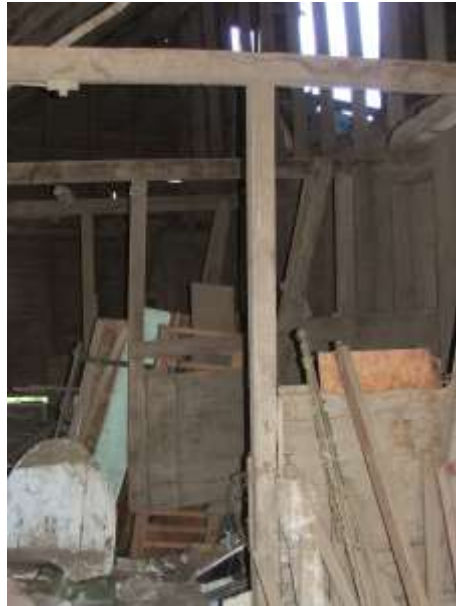
ROLL NUMBER: _____
PHOTO NUMBER: 5

CAMERA DIRECTION: First floor, looking NE in West lean-to, 7' wide double horse stalls

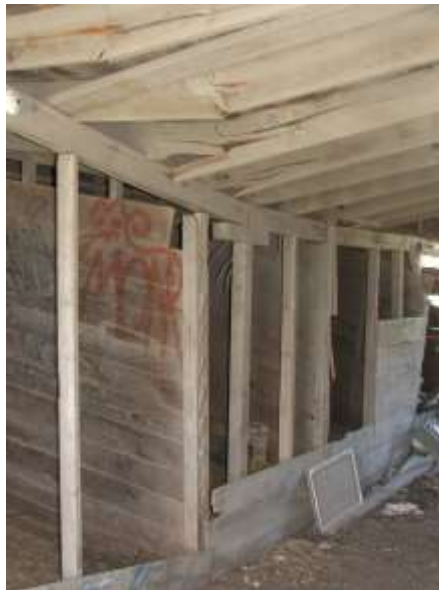
ROLL NUMBER: _____
PHOTO NUMBER: 6

OTHER NOTES: 2X6 stud walls with 1x6 #106 drop siding on all four exterior walls. Windows are 8"x10" four light. Rafters are 2x6's on both lean-tos and the center part of the barn with no bracing. Foundation walls have collapsed under the first floor in the Northwest part of the center 20' causing the floor to fall down and breaking a lot of the hayloft floor joists above the same area.

CAMERA DIRECTION: First floor, looking NW, East solid wall on the East side of drive alley, first floor and hayloft floor have collapsed.

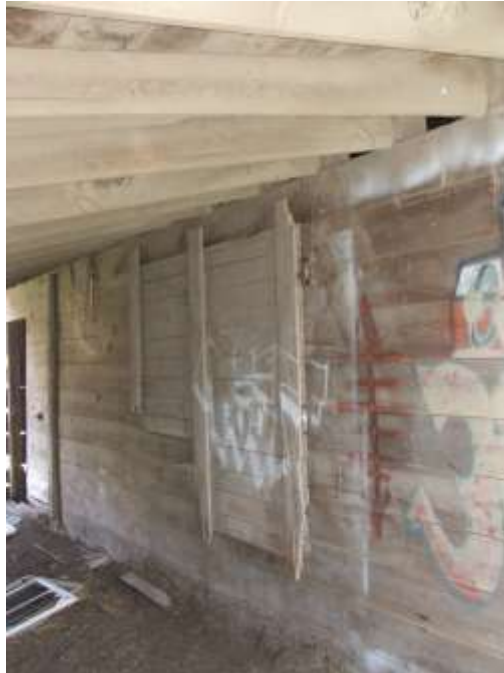
ROLL NUMBER: 7
PHOTO NUMBER: 7

**First floor, looking NE
at granaries on East
side of the center 20' of
barn**

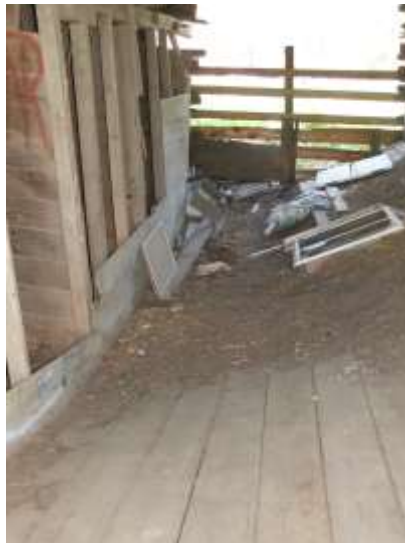
ROLL NUMBER: 8
PHOTO NUMBER: 8

**First floor, looking North,
brick foundation walls
collapsed and the floor
fell down about 3 feet.**

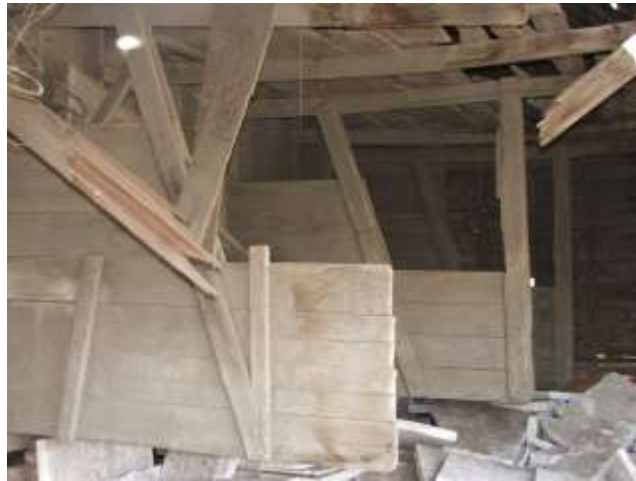
ROLL NUMBER: _____
PHOTO NUMBER: 9

CAMERA DIRECTION: First floor, looking NW in East lean-to, 9' wide double horse stalls

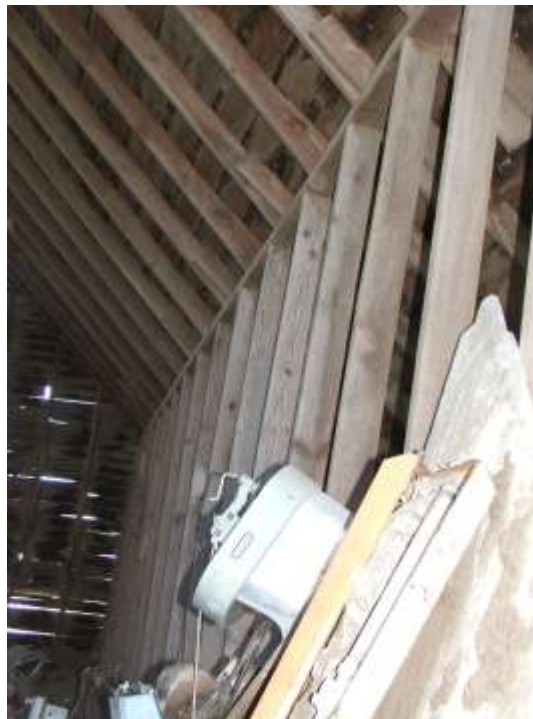
ROLL NUMBER: _____
PHOTO NUMBER: 10

CAMERA DIRECTION: Hayloft, looking SW, open 2x6 stud wall supporting the rafters between the center 20' barn and the West lean-to

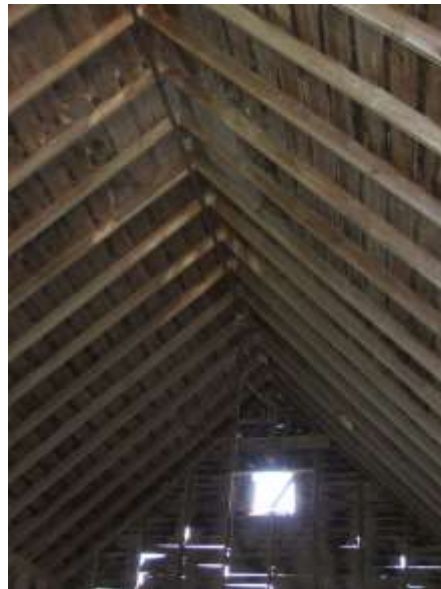
ROLL NUMBER: _____
PHOTO NUMBER: 11

CAMERA DIRECTION: Hayloft, looking South, 2x6 rafters and peak in hayloft.

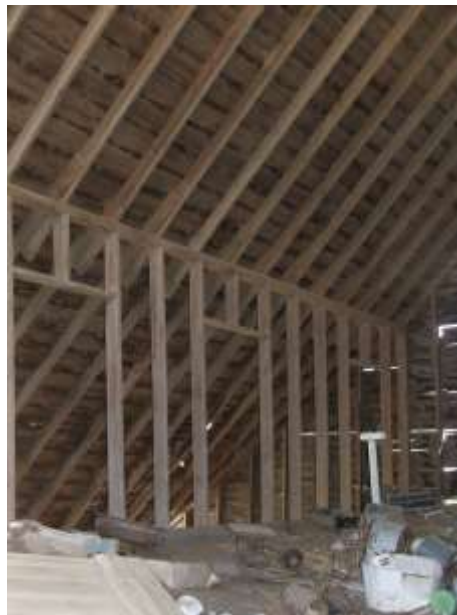
ROLL NUMBER: _____
PHOTO NUMBER: 12

CAMERA DIRECTION: Hayloft, looking SE, open 2x6 wall supporting the rafters between center 20' barn and the East Lean-to
