**SOUTH DAKOTA STATE HISTORIC PRESERVATION OFFICE
HISTORIC SITES SURVEY STRUCTURE FORM**

*SURVEY DATE: February 5, 2013 *ADDRESS: 30227 461st Ave.
*SURVEYOR: Jim Stone *COUNTY: Clay
*CITY: Beresford

CURRENT FUNCTION: Vacant FOUNDATION: Poured concrete
 CURRENT SUBFUNCTION: Storage ROOF MATERIAL: Steel roofing over cedar shingles
 HISTORIC FUNCTION: Livestock barn ROOF SHAPE: Gable
 HISTORIC SUBFUNCTION: Hay and grain storage STRUCTURAL SYSTEM: Balloon framing
 OCCUPIED: No STYLE: Gable roof barn
 ACCESSIBLE: Yes with permission TYPE: Livestock barn
 WALLETS: 2x6 studs, 1x8 sheathing & 1/2"x6" cedar lap siding

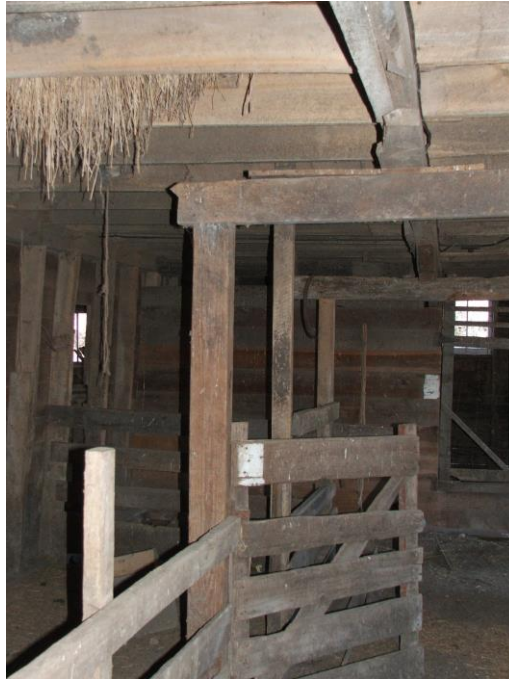
ROLL NUMBER: 5
PHOTO NUMBER: 5

**First floor, East side,
looking North, granary
on North wall**

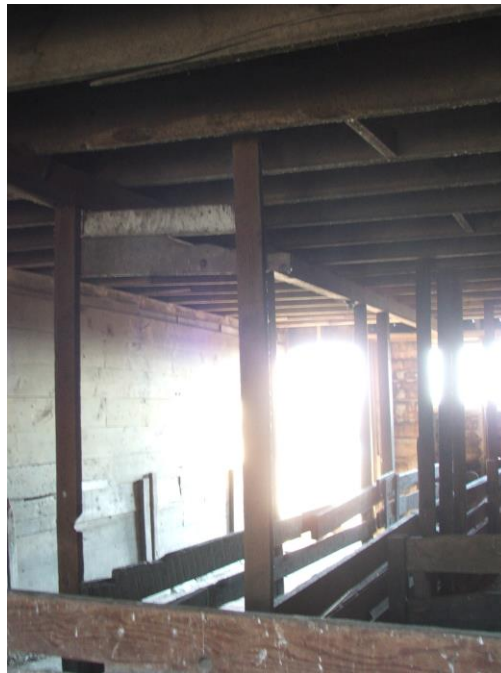
ROLL NUMBER: 6
PHOTO NUMBER: 6

**First floor, west side,
looking SE, 4x4 posts,
4x4 beam and 2x6 solid
wall dividing main barn**

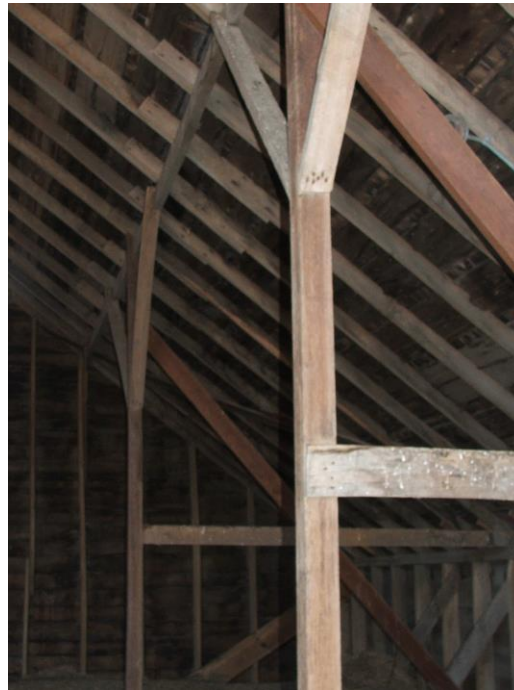
ROLL NUMBER: _____
PHOTO NUMBER: 7

**Hayloft, looking South,
two 4x4 posts and 2x6
beam supporting rafters.**

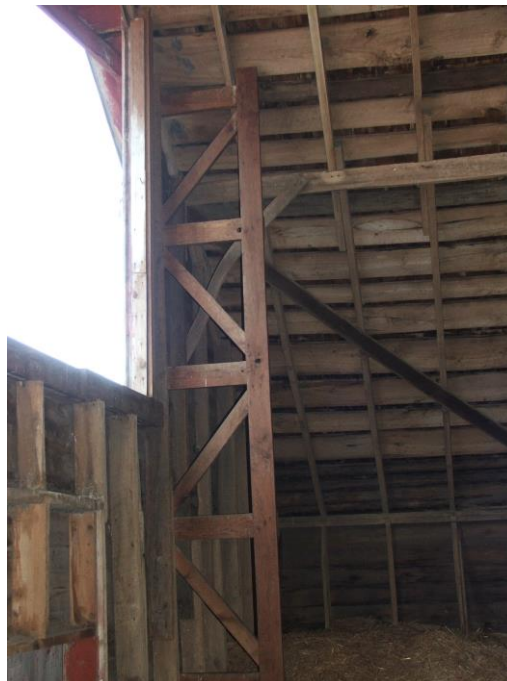
ROLL NUMBER: _____
PHOTO NUMBER: 8

**Hayloft, looking NE,
bracing for both gable
end walls in hayloft.**
