**SOUTH DAKOTA STATE HISTORIC PRESERVATION OFFICE
HISTORIC SITES SURVEY STRUCTURE FORM**

*SURVEY DATE: November 20, 2012 *ADDRESS: 30535 University Ave.
*SURVEYOR: Jim Stone *COUNTY: Clay
*CITY: Centerville

CURRENT FUNCTION: <u>Livestock barn</u>	FOUNDATION: <u>Poured concrete foundation</u>
CURRENT SUBFUNCTION: <u>Storage</u>	ROOF MATERIAL: <u>Asphalt shingles over cedar shingles</u>
HISTORIC FUNCTION: <u>Horse barn</u>	ROOF SHAPE: <u>Gambrel</u>
HISTORIC SUBFUNCTION: <u>Hay and grain storage</u>	STRUCTURAL SYSTEM: <u>Balloon framing</u>
OCCUPIED: <u>Yes</u>	STYLE: <u>Gambrel roof barn</u>
ACCESSIBLE: <u>Yes with permission</u>	TYPE: <u>Livestock barn</u>
	WALLS: <u>2x6 studs with 1x6 #106 drop siding</u>
STORIES: <u>2</u>	SIGNIFICANT PERSON: <u>Albert Anderson</u>
*DATE OF CONSTRUCTION: <u>1910 - 1920</u>	CULTURAL AFFILIATION: <u>Swedish ?</u>

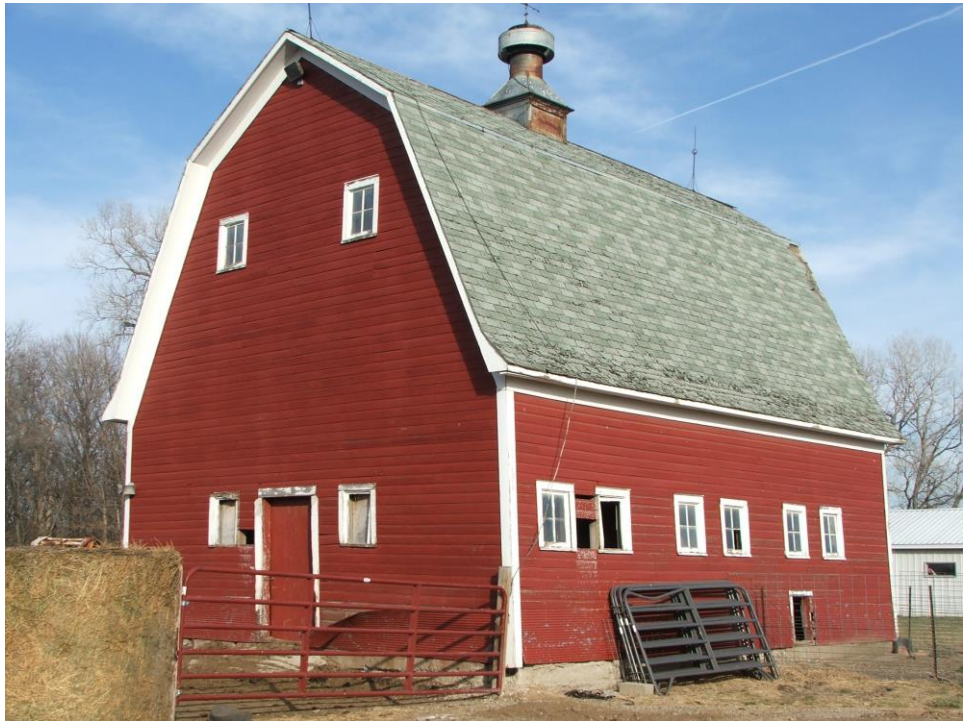
ROLL NUMBER: _____
PHOTO NUMBER: 1
CAMERA DIRECTION: Looking NE, SW corner

*PHYSICAL NOTES: Barn is in poor condition. Barn is leaning to the North, especially at West end. Hayloft is well braced, just need the first floor walls straightened and braced. Will need to be re-roofed soon.

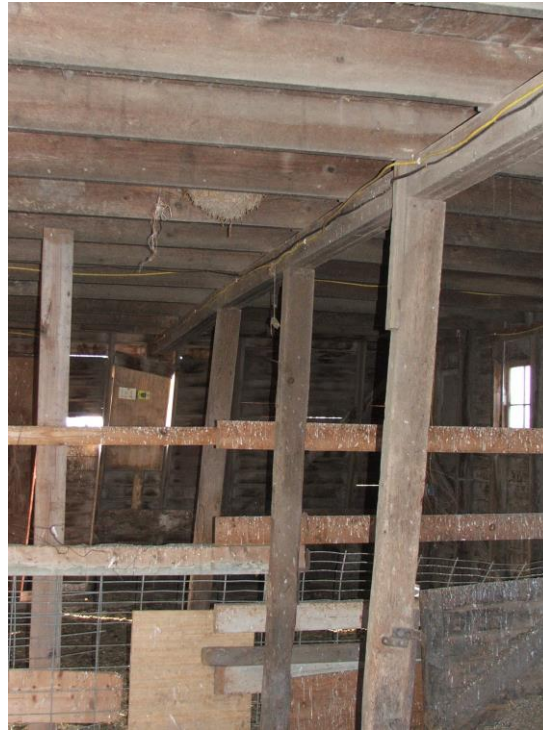
ROLL NUMBER: _____
PHOTO NUMBER: 5

CAMERA DIRECTION: First floor, looking West, 4x6 posts 5' O.C., (3) 2x6's beam and 2x8 floor joists

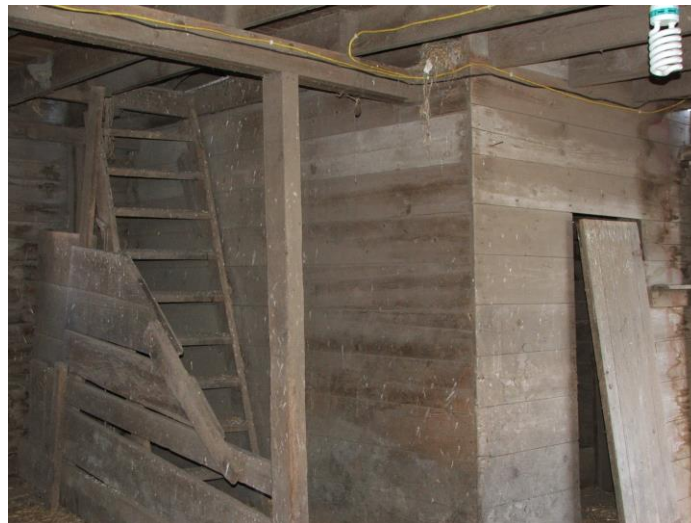
ROLL NUMBER: _____
PHOTO NUMBER: 6

CAMERA DIRECTION: First floor, looking NE, Granary and stairs in the NE corner

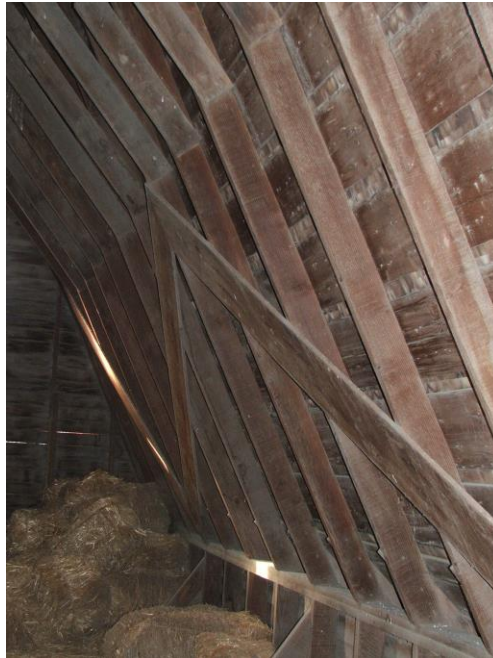
ROLL NUMBER: _____
PHOTO NUMBER: 7

CAMERA DIRECTION: Hayloft, looking West,
note 1x12 diagonal
bracing

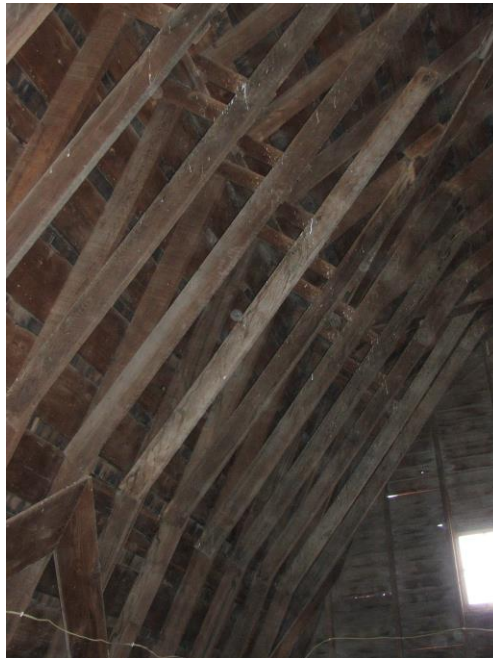
ROLL NUMBER: _____
PHOTO NUMBER: 8

CAMERA DIRECTION: Hayloft, looking North,
single 2x6 brace on each
hip, two 2x6's for beam
at the hip.
