STRUCTURE DETAILS

SHPO ID:							
*PROPERTY NAME:							
OTHER NAME:							
CURRENT FUNCTION:	Vacant		FOUNDA	TION:	Poured concrete		
CURRENT CURRUNCTION.	Ot a war wa			DIAL -	Steel roofing over		
CURRENT SUBFUNCTION:	Storage		ROOF MATE	-	cedar shingles		
HISTORIC FUNCTION:	Dairy barn		ROOF SHAPE:		Gable roof		
HISTORIC SUBFUNCTION:	Hay and grain stora	ge S	TRUCTURAL SY	-	Balloon framing

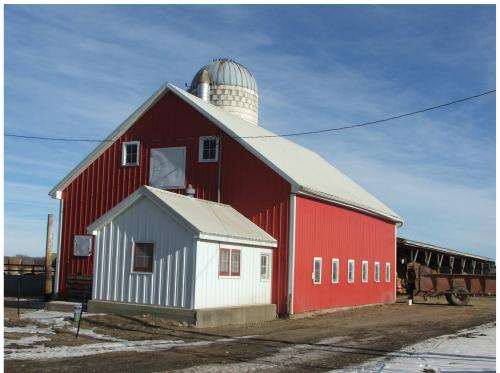
1

CAMERA DIRECTION: Looking NE, SW corner

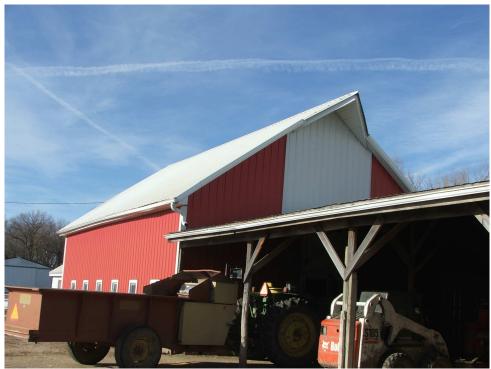
CAMERA DIRECTION: Looking NW, SE corner

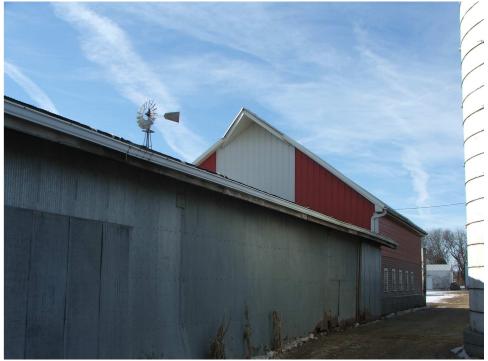
PHOTOGRAPHER: Jim Stone ROLL NUMBER:
DATE OF PHOTO: December 18, 2013 PHOTO NUMBER: 3
CAMERA DIRECTION: Looking SW, NE corner

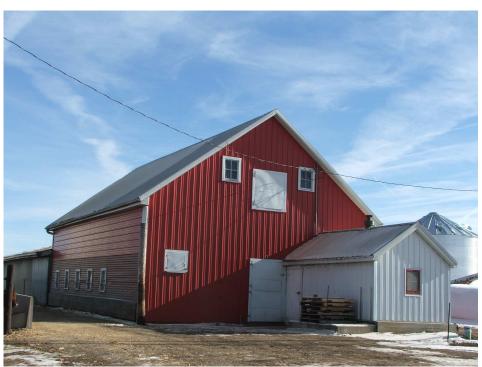
CAMERA DIRECTION: Looking SE, NW corner

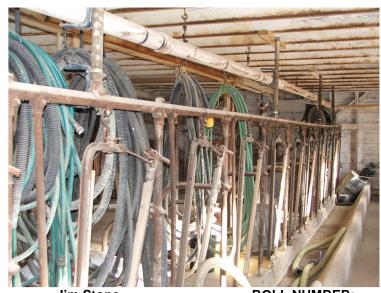
First floor, looking NE, at 11 milk cow stanchions and concrete feed trough

CAMERA DIRECTION: on South wall.

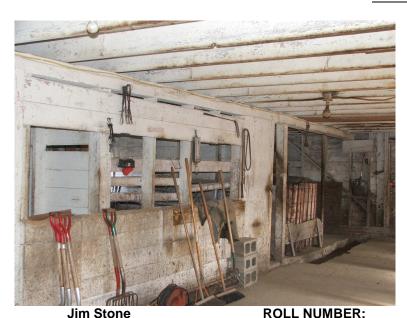
First floor, looking NE, 6x6 posts, 6x6 beam, one steel pipe post athe East end where 4 milk cow stanchions are. Cow and calf pens & granary

CAMERA DIRECTION: are on the North wall

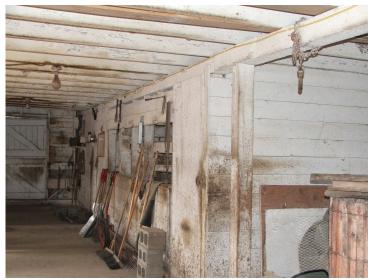
First floor, looking NW, calving pen, calf pen and granary on the North

CAMERA DIRECTION: wall.

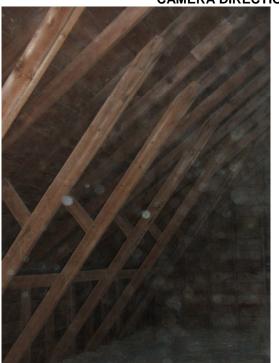
8

Hayloft, looking NE, 2x6 rafters and (2) 1x6 braces from the center of the rafters down to the

CAMERA DIRECTION: floor & ext. wall, 4' O. C.

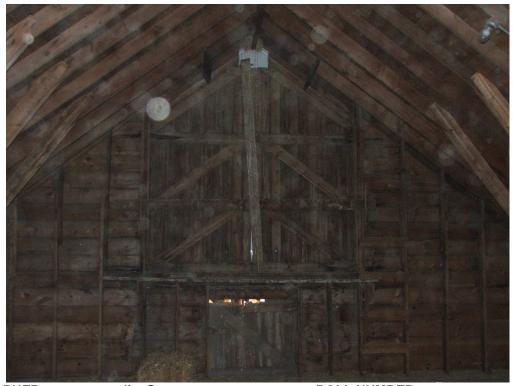
9 Hayloft, looking East,

CAMERA DIRECTION: large hayloft door.

East gable end wall and
