**SOUTH DAKOTA STATE HISTORIC PRESERVATION OFFICE
HISTORIC SITES SURVEY STRUCTURE FORM**

*SURVEY DATE: May 23, 2012 *ADDRESS: 46583 Clay Point St.
*SURVEYOR: Jim Stone *COUNTY: Clay
*CITY: Vermillion

CURRENT FUNCTION: <u>Vacant</u>	FOUNDATION: <u>Poured concrete</u>
CURRENT SUBFUNCTION: <u>Storage</u>	ROOF MATERIAL: <u>Steel roofing</u>
HISTORIC FUNCTION: <u>Livestock barn</u>	ROOF SHAPE: <u>Gambrel</u>
HISTORIC SUBFUNCTION: <u>Hay and grain storage</u>	STRUCTURAL SYSTEM: <u>Balloon framing</u>
	STYLE: <u>Gambrel roof barn</u>
OCCUPIED: <u>Yes</u>	TYPE: <u>Livestock barn</u>
	<u>2x6, sheathing,</u>
ACCESSIBLE: <u>Yes with permission</u>	WALLS: <u>1/2"x6" cedar lap siding</u>
STORIES: <u>2</u>	SIGNIFICANT PERSON: <u>Albert Ostlund</u>
*DATE OF CONSTRUCTION: <u>1936</u>	CULTURAL AFFILIATION: <u>Swedish</u>

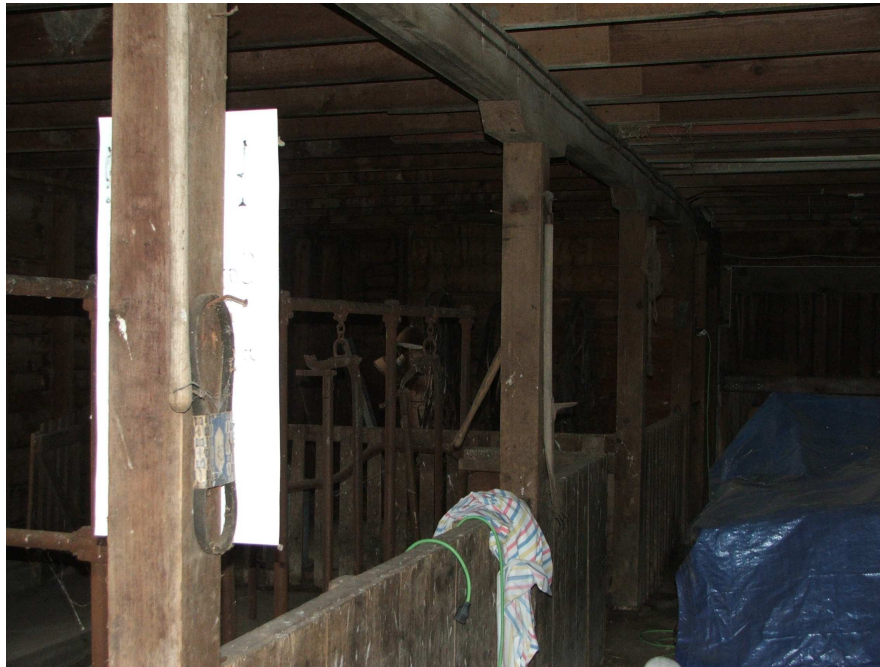
ROLL NUMBER: _____
PHOTO NUMBER: 5
CAMERA DIRECTION: First floor, looking
South, East post & beam

INTERIOR NOTES: 6x6 posts 8' O. C. with (3) 2x8's for a beam 12' in from the East wall. 32" in from the West wall (2) 2x6's with (2) 2x4's for a beam and 12' in from the West wall (2) 2x6's 4'-10" O. C. with (3) 2x8's for a beam. 2x8 floor joists 24" O. C.

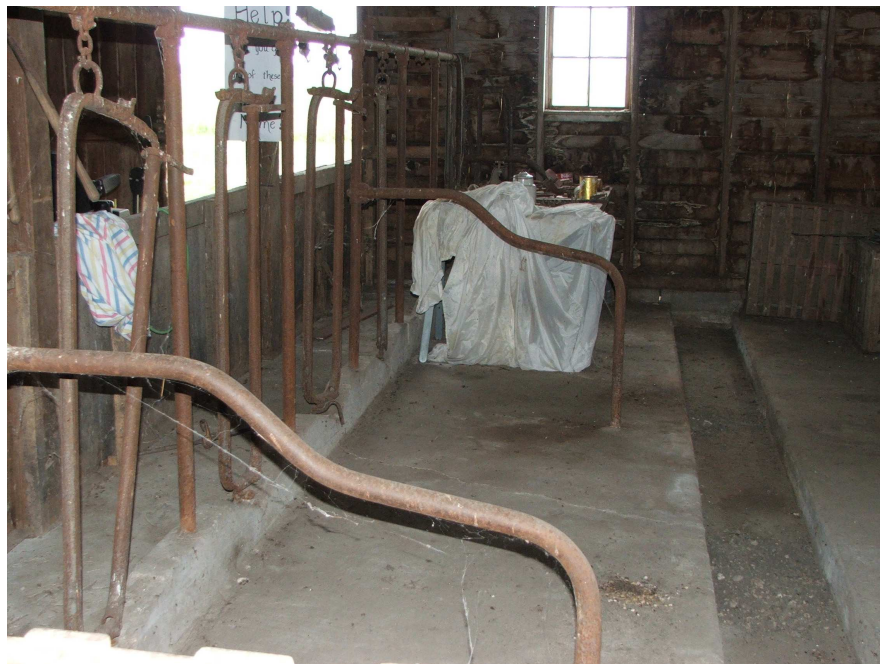
ROLL NUMBER: _____
PHOTO NUMBER: 6
CAMERA DIRECTION: First floor, Looking
North, milk cow
stanchions

*PHYSICAL NOTES: Barn in very good condition. Original milk cow stanchions are still in place. Six single horse stalls and 6'x10' granary still in place on the West side. 5'x8' milk room, calf pen and milk cow stanchions are along the East side. Rough sawn 2x8 floor in all horse stalls. Concrete floor in the rest of the barn with a gutter behind milk cows.

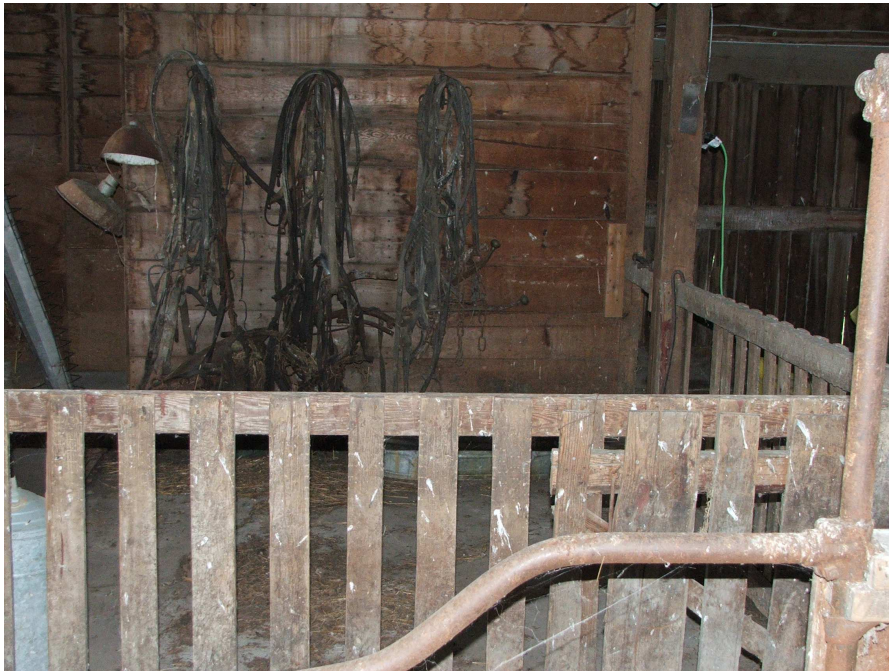
ROLL NUMBER: _____
PHOTO NUMBER: 7

CAMERA DIRECTION: First Floor, looking South, calf pens & milk room

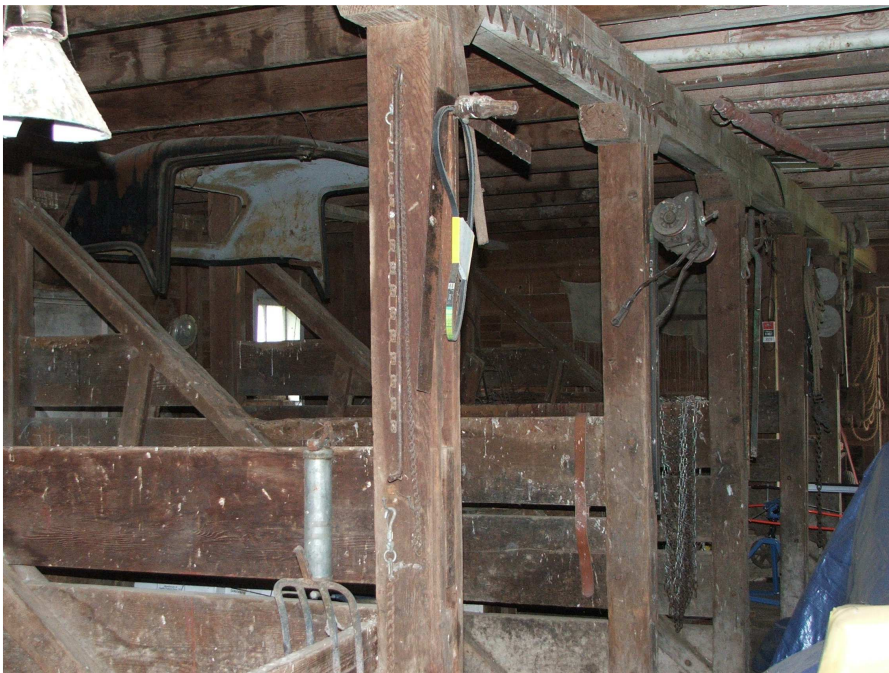
ROLL NUMBER: _____
PHOTO NUMBER: 8

CAMERA DIRECTION: First floor, looking North, single horse stalls

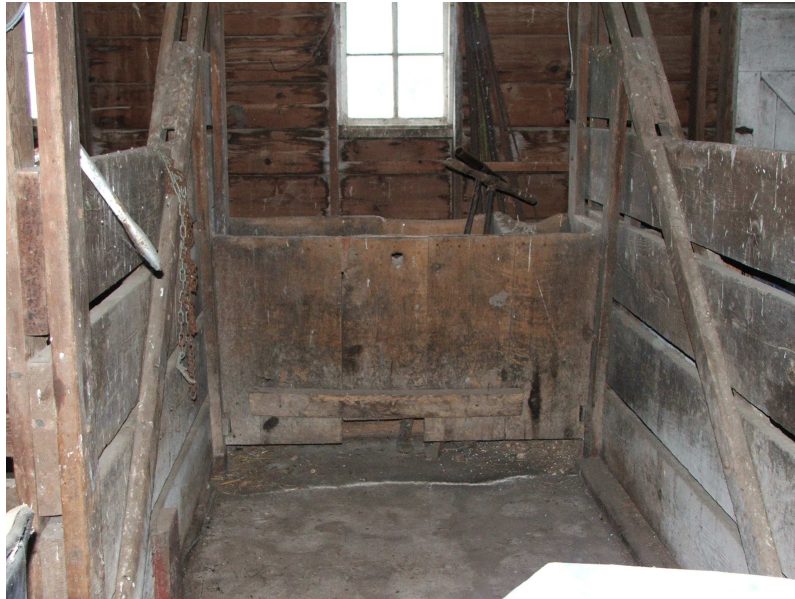
ROLL NUMBER: _____
PHOTO NUMBER: 9

CAMERA DIRECTION: First floor, looking West,
single horse stall

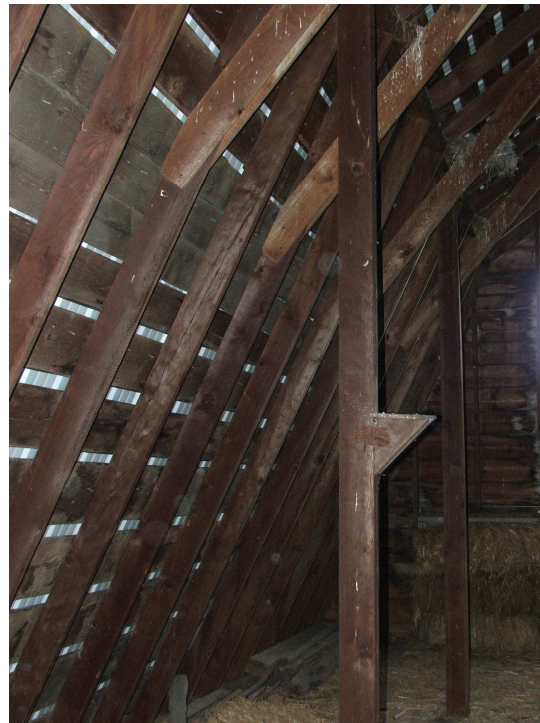
ROLL NUMBER: _____
PHOTO NUMBER: 10

OTHER NOTES: 2x6 walls 7'-7" high with 4x6 sill on the East and West walls. 2x6 walls 14' high in the center 12' on the gable ends. 2x6 walls on each side and 2x6 walls above the 14' walls. Horizontal sheathing with 1/2"x6" cedar lap siding. Rafters are 2x6. Roof hip is supported with (2) 2x6's 10' O. C. with (2) 2x6 for a beam. These 2x6 posts are nailed one each side of the floor joist and have short 2x6 spacer blocks in the hayloft. Windows are 9"x12" four light on the East and West. 9"x12" 6 light windows in the gable ends and in the hayloft. Metal cupola.

CAMERA DIRECTION: Hayloft, looking North,
2x6 post & beam
supporting roof hip
