**SOUTH DAKOTA STATE HISTORIC PRESERVATION OFFICE
HISTORIC SITES SURVEY STRUCTURE FORM**

*SURVEY DATE: April 3, 2013 *ADDRESS: 46711 298th Street
*SURVEYOR: Jim Stone *COUNTY: Clay
*CITY: Beresford

CURRENT FUNCTION: Storage FOUNDATION: Poured concrete
 CURRENT SUBFUNCTION: Storage ROOF MATERIAL: Steel roofing over spaced sheathing
 HISTORIC FUNCTION: Livestock barn ROOF SHAPE: Gambrel
 HISTORIC SUBFUNCTION: Hay & grain storage STRUCTURAL SYSTEM: Balloon framing
 OCCUPIED: Yes STYLE: Gambrel roof barn
 TYPE: Livestock barn
2x6 studs, 1x6 #106 drop siding and 26" horizontal steel roofing

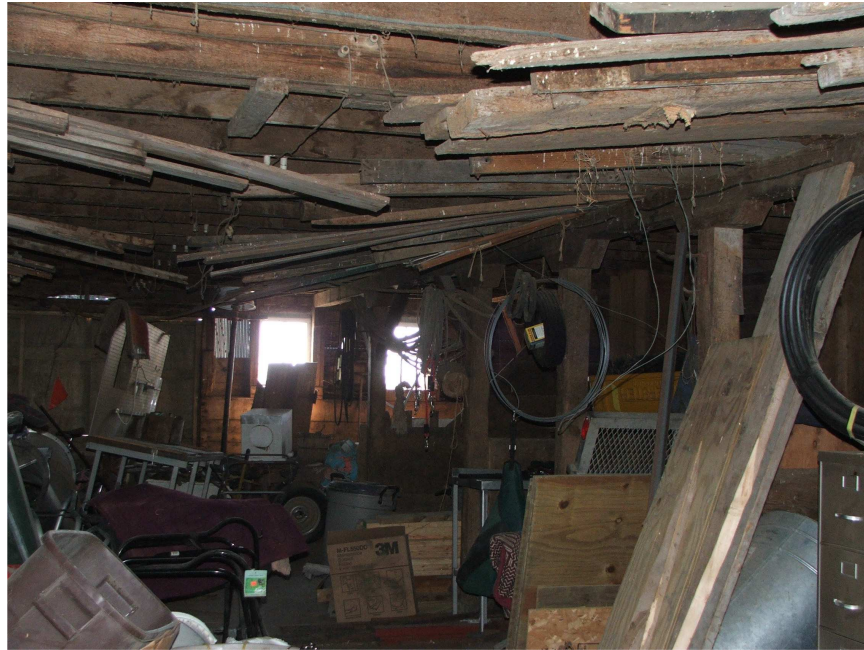
ROLL NUMBER: _____
PHOTO NUMBER: 5

CAMERA DIRECTION: First floor, looking SW,
center of barn, horse
stalls on the West wall.

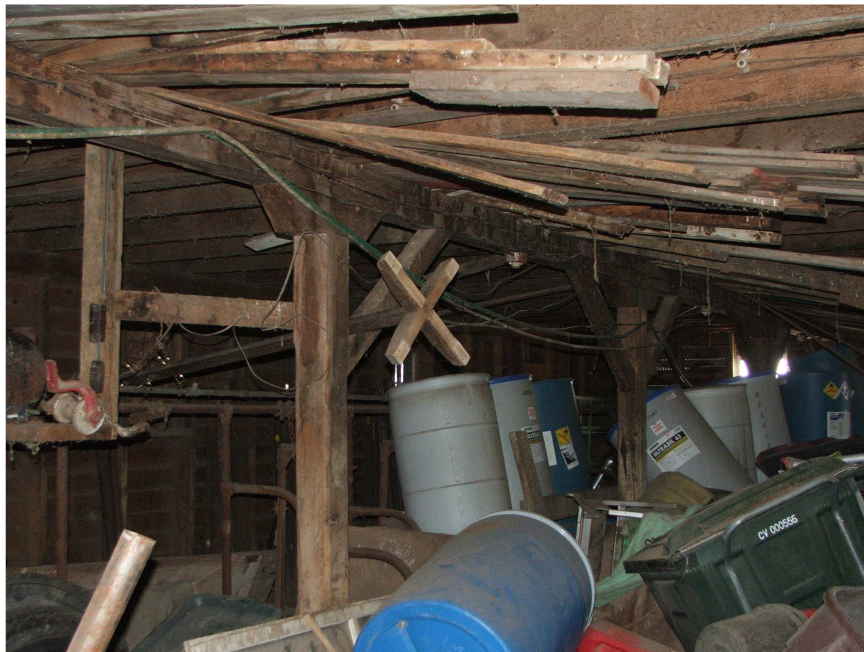
ROLL NUMBER: _____
PHOTO NUMBER: 6

CAMERA DIRECTION: First floor, looking SE in
center of barn, milk cow
stanchions on East wall

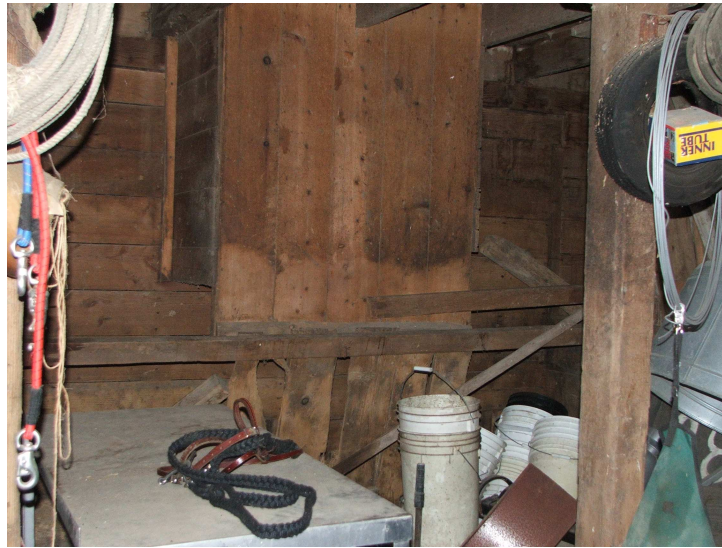
ROLL NUMBER: _____
PHOTO NUMBER: 7

CAMERA DIRECTION: First floor, looking West,
hay chute from hayloft
down into horse manger.

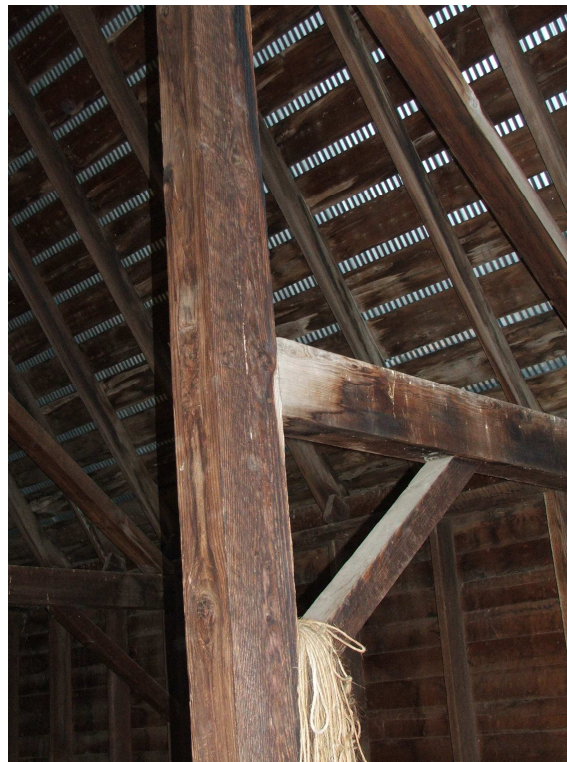
ROLL NUMBER: _____
PHOTO NUMBER: 8

CAMERA DIRECTION: Hayloft, looking NE, 6x8
posts supporting hip
with 4x6 beam, 8' x10'
granary in the NE corner.

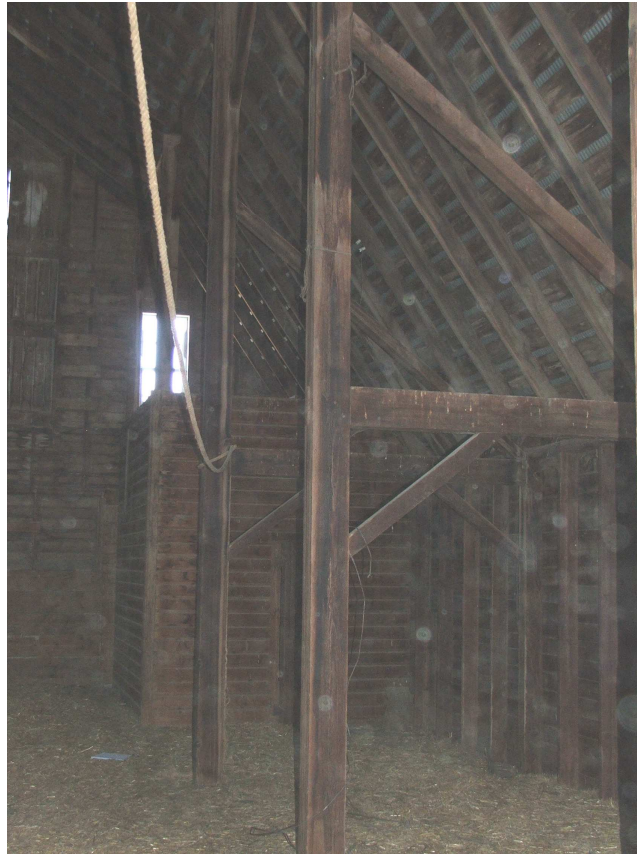
ROLL NUMBER: _____
PHOTO NUMBER: 9

CAMERA DIRECTION: Hayloft, looking NE, 6x8 posts with 6x8 beam back to top of wall, note the mortise and tendon.
