**SOUTH DAKOTA STATE HISTORIC PRESERVATION OFFICE
HISTORIC SITES SURVEY STRUCTURE FORM**

*SURVEY DATE: May 16, 2013 *ADDRESS: 30238 467th Ave.
*SURVEYOR: Jim Stone *COUNTY: Clay
*CITY: Beresford

CURRENT FUNCTION: Vacant FOUNDATION: Poured concrete
 CURRENT SUBFUNCTION: Storage ROOF MATERIAL: Steel roofing over cedar shingles
 HISTORIC FUNCTION: Livestock barn ROOF SHAPE: Gable
 HISTORIC SUBFUNCTION: Hay and grain storage STRUCTURAL SYSTEM: Balloon framing
 OCCUPIED: Yes STYLE: Gable roof barn
 Yes with TYPE: Livestock barn
 ACCESSIBLE: Yes with permission WALLS: 2x6 studs and 1x6 #106 drop siding

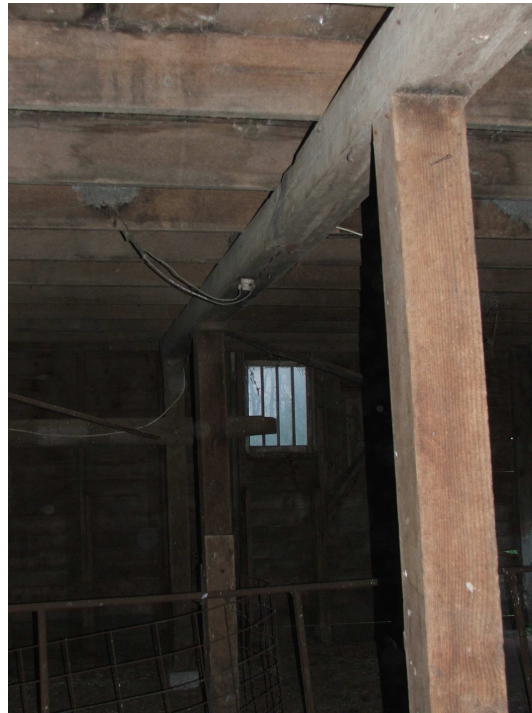
ROLL NUMBER: _____
PHOTO NUMBER: 5

CAMERA DIRECTION: First floor, looking NE, 6x6 posts, 6x6 beam and 2x8 floor joists

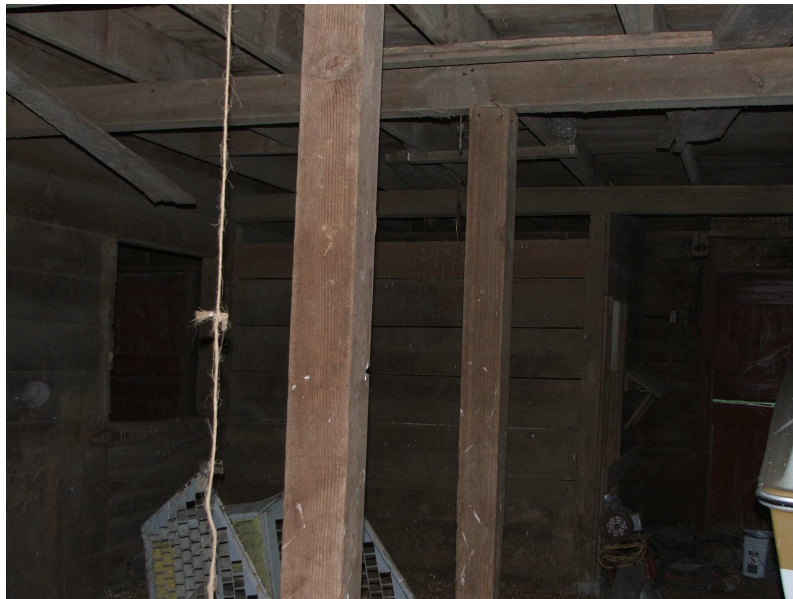
ROLL NUMBER: _____
PHOTO NUMBER: 6

CAMERA DIRECTION: First floor, looking West, posts and beams and granary on West wall

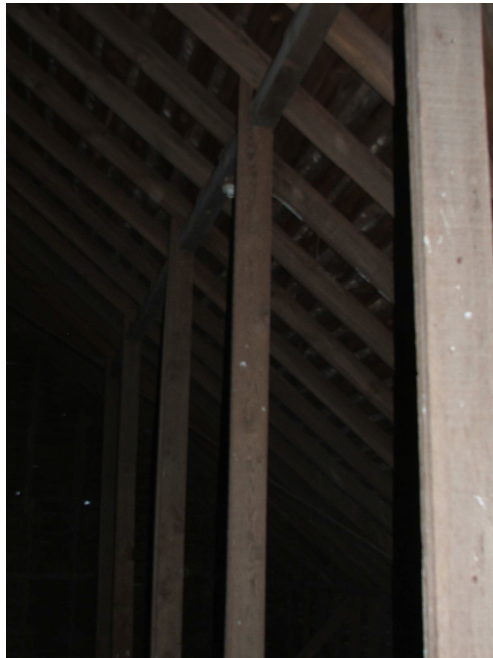
ROLL NUMBER: _____
PHOTO NUMBER: 7

**Hayloft, looking SW, 2x6
rafters with double 2x6
posts and 4x4
supporting center of
rafters**

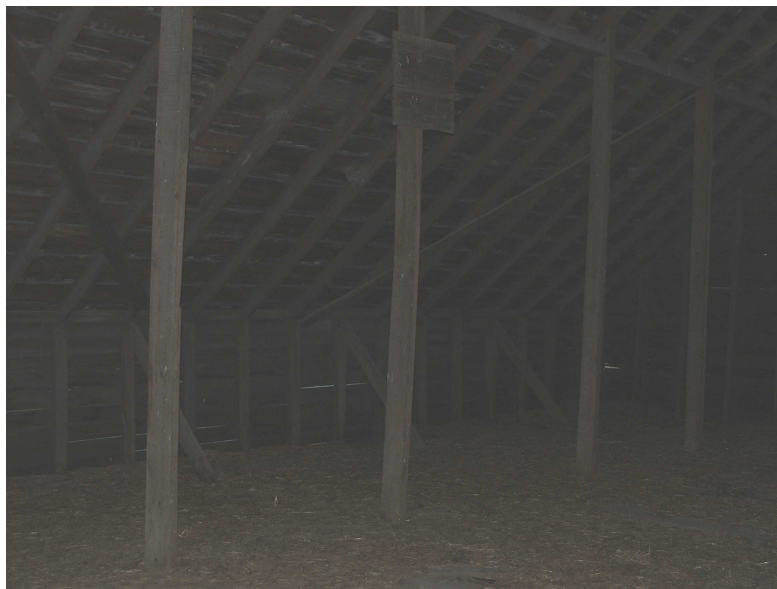
ROLL NUMBER: _____
PHOTO NUMBER: 8

**Hayloft, looking SE, 2x6
posts and 2x6 bracing
from top of wall down to
floor 8' O. C.**

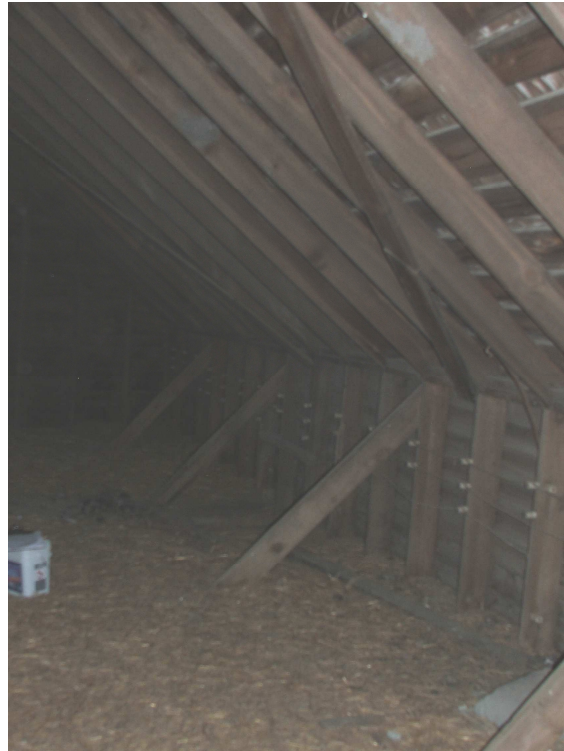
ROLL NUMBER: _____
PHOTO NUMBER: 9

CAMERA DIRECTION: Hayloft, looking SW, 2x6
bracing from top of wall
down to floor 8' O. C.,
note diagonal 2x6 brace
on bottom of rafters.
