SOUTH DAKOTA STATE HISTORIC PRESERVATION OFFICE
HISTORIC SITES SURVEY STRUCTURE FORM

*ADDRESS: 29912 SD Hwy 19
*COUNTY: Clay
*CITY: Centerville

HISTORIC FUNCTION: Livestock barn

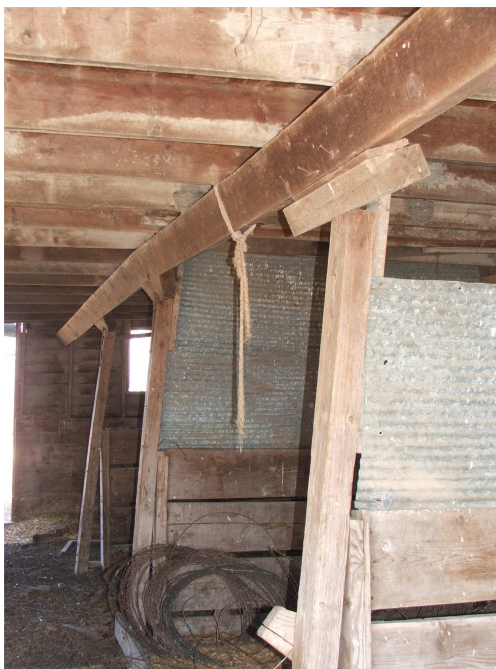
ROLL NUMBER: _____
PHOTO NUMBER: 5

CAMERA DIRECTION: First floor, looking NE at
4x6 posts, 4x6 beam, 2x8
floor joists and double
horse stalls on East wall.

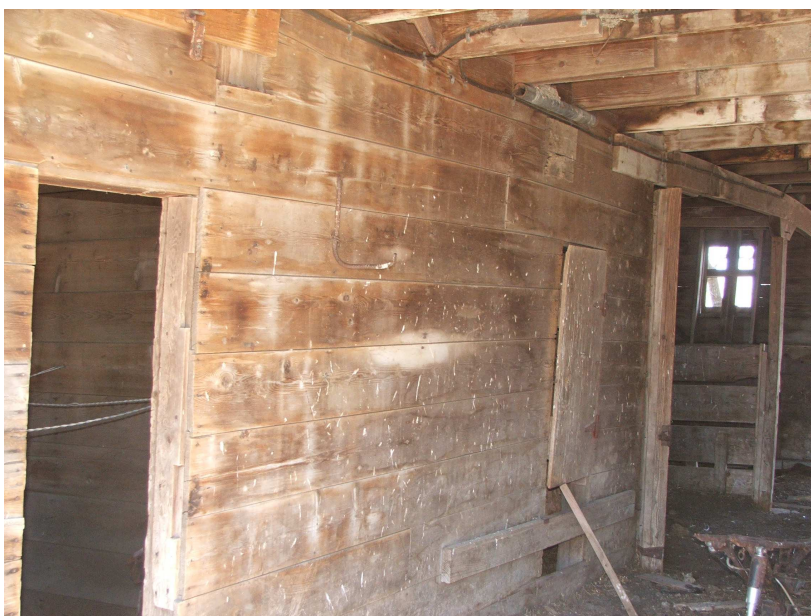
ROLL NUMBER: _____
PHOTO NUMBER: 6

CAMERA DIRECTION: First floor, looking NW,
granaries and (2) double
horse stalls on West
wall.

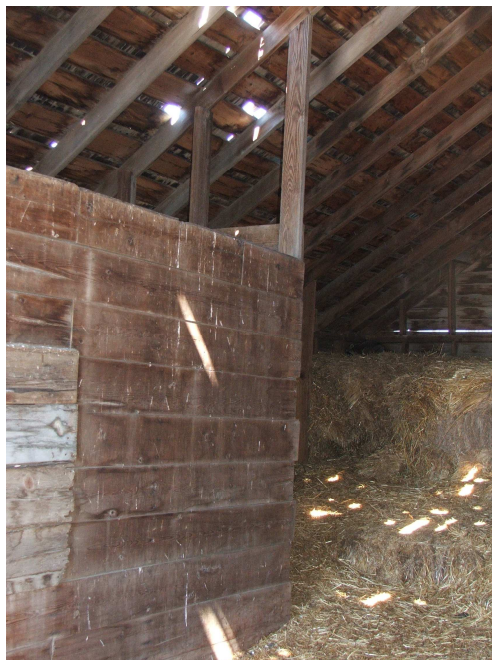
ROLL NUMBER: _____
PHOTO NUMBER: 7

CAMERA DIRECTION: Hayloft, looking SW, (2)
granaries in SW corner
of hayloft.

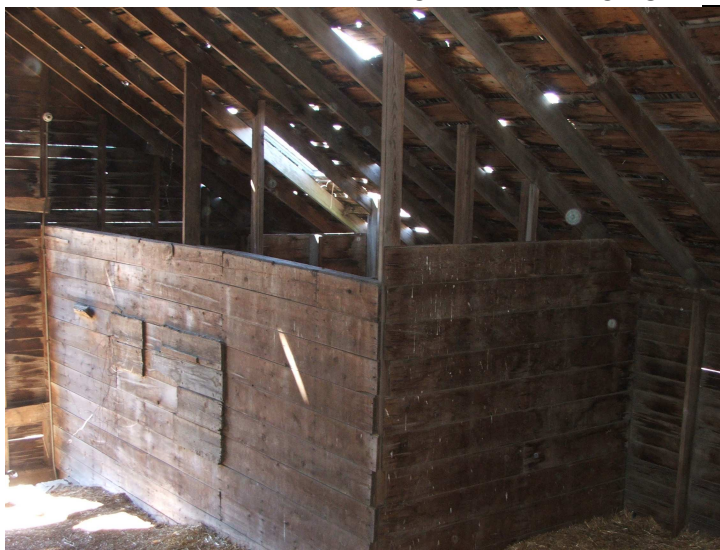
ROLL NUMBER: _____
PHOTO NUMBER: 8

CAMERA DIRECTION: Hayloft, looking NW,
granaries in the SW
corner and open hayloft
in the North half of
hayloft.
