**SOUTH DAKOTA STATE HISTORIC PRESERVATION OFFICE
HISTORIC SITES SURVEY STRUCTURE FORM**

*SURVEY DATE: August 8, 2013 *ADDRESS: 45324 305th Street
*SURVEYOR: Jim Stone *COUNTY: Clay
*CITY: Volin

<p>CURRENT FUNCTION: <u>Winter shelter for horses</u></p> <p>CURRENT SUBFUNCTION: <u>Storage</u></p> <p>HISTORIC FUNCTION: <u>Livestock barn</u></p> <p>HISTORIC SUBFUNCTION: <u>Hay & grain storage</u></p> <p>OCCUPIED: <u>No</u></p> <p>ACCESSIBLE: <u>Yes with permission</u></p> <p>STORIES: <u>2</u></p> <p>*DATE OF CONSTRUCTION: <u>Early 1900's</u></p>	<p>FOUNDATION: <u>Native stone with Portland cement mortar</u></p> <p>ROOF MATERIAL: <u>Cedar shingles</u></p> <p>ROOF SHAPE: <u>Gambrel roof</u></p> <p>STRUCTURAL SYSTEM: <u>Balloon framing</u></p> <p>STYLE: <u>Gambrel roof barn</u></p> <p>TYPE: <u>Livestock barn</u> <u>2x6 & 2x8 studs, diagonal sheathing on gable ends and 1/2"x6" cedar lap siding</u></p> <p>WALLS: _____</p> <p>SIGNIFICANT PERSON: <u>Andrew Jacobson</u></p> <p>CULTURAL AFFILIATION: <u>Danish</u></p>
--	---

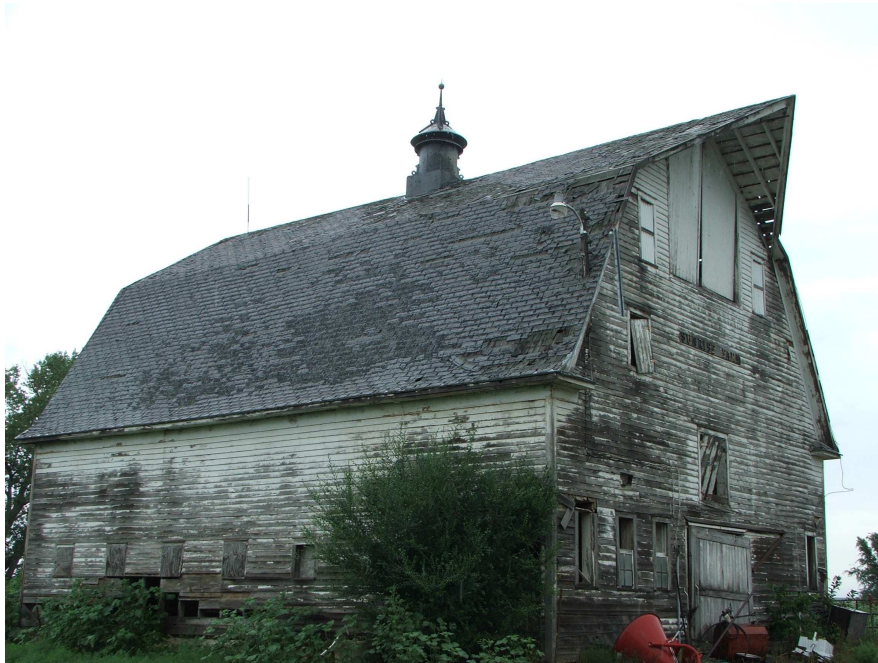
ROLL NUMBER: _____
PHOTO NUMBER: 1
CAMERA DIRECTION: Looking NE, SW corner

*PHYSICALNOTES : Barn is in poor condition, roof is leaking.

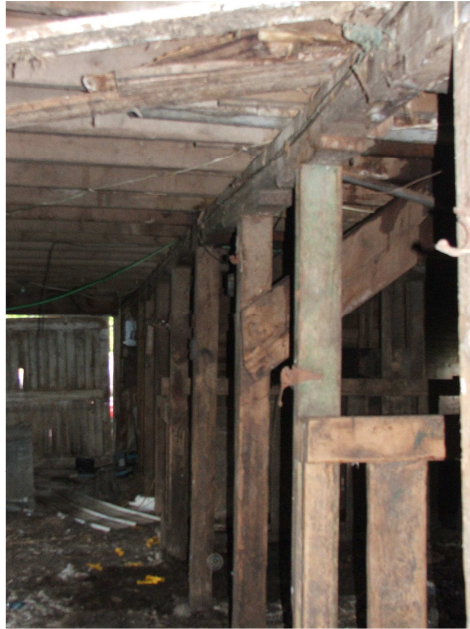
ROLL NUMBER: _____
PHOTO NUMBER: 5

CAMERA DIRECTION: First floor, Looking SW, 6x6 posts, 6x6 beam and 2x8 floor joists

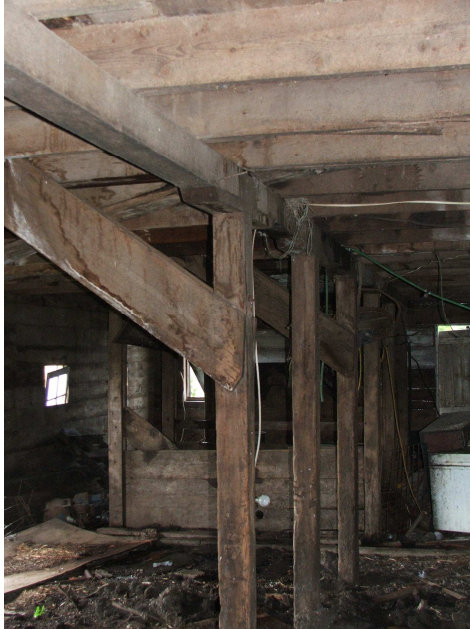
ROLL NUMBER: _____
PHOTO NUMBER: 6

ALTERED/MOVED NOTES: Original site. Most evidence of horse stalls has been removed. Four single horse stalls removed on the West side and four milk cow stanchions added at the North end and four more stanchions added on the South end of this area. See floor plan.

CAMERA DIRECTION: First floor, looking SE, 6x6 posts, 6x8 beam, 2x8 floor joists, horse stalls were between posts, part of horse stall in back.

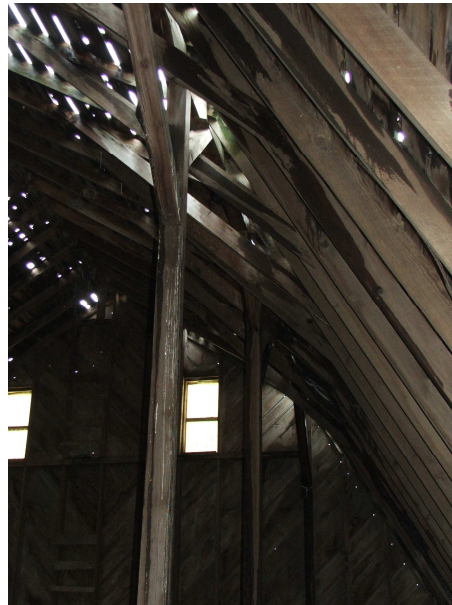
ROLL NUMBER: _____
PHOTO NUMBER: 7

Hayloft, looking NE, 6x6 posts, 6x6 beam, 2x6 rafters, 2x6 brace on rafter hip, 4' O. C.

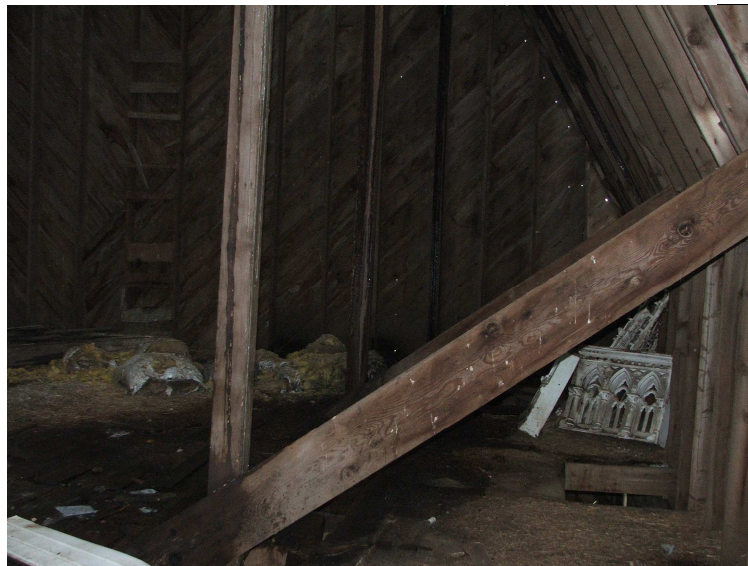
ROLL NUMBER: _____
PHOTO NUMBER: 8

Hayloft, looking NE, 6x6 posts, double 2x6 rafter behind each post, double 2x12's from bottom of double 2x6 rafter down to bottom of 6x6 post and through the floor to 6x6 post on first floor.

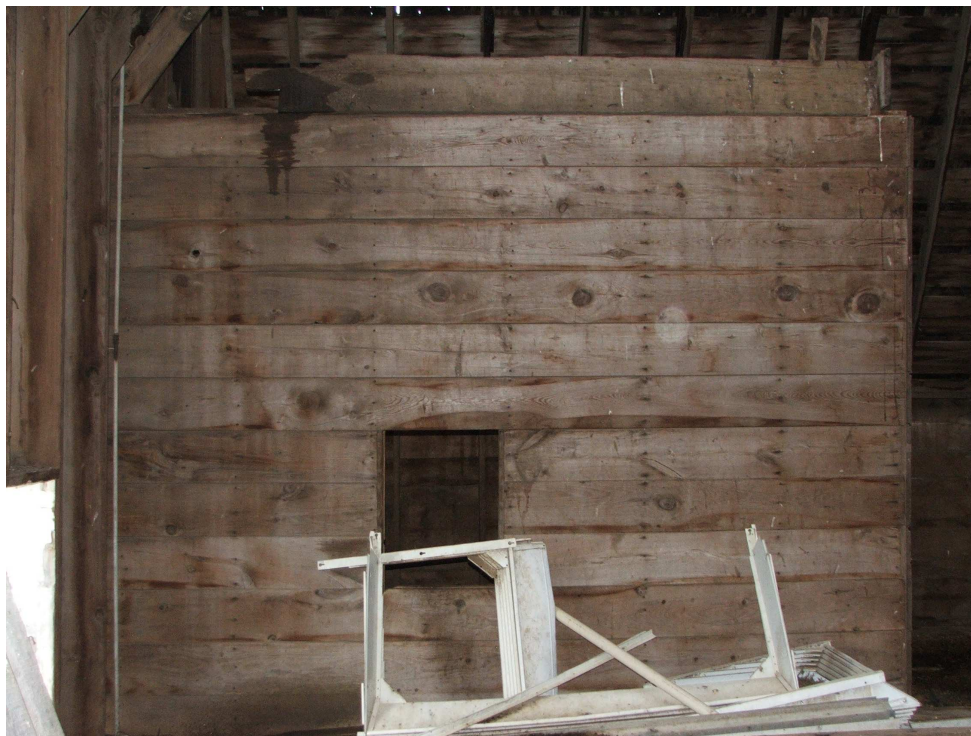
ROLL NUMBER: _____
PHOTO NUMBER: 9

CAMERA DIRECTION: Hayloft, looking West,
12' x12' granary in SW
corner of hayloft.
