#### SITE INFORMATION

\*SURVEY DATE: <u>March 23, 2012</u> \*SURVEYOR: Jim Stone

*ADDRESS:	31707 Meckling Road
*COUNTY:	Clay
*CITY:	Vermillion

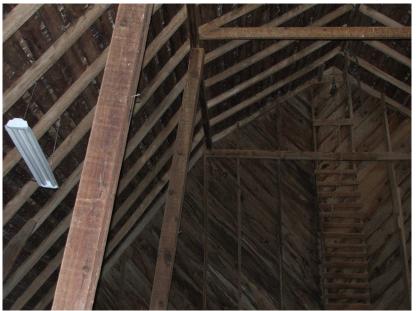
**ROLL NUMBER:** PHOTO NUMBER: 5 Hayloft, looking West,

note slanted 6x6 post & CAMERA DIRECTION: <u>6x6 beam supporting hip</u>
