SOUTH DAKOTA STATE HISTORIC PRESERVATION OFFICE
HISTORIC SITES SURVEY STRUCTURE FORM

*SURVEY DATE: January 18, 2013
*SURVEYOR: Jim Stone

*ADDRESS: 30387 470th Ave.
*COUNTY: Clay
*CITY: Beresford

CURRENT FUNCTION:	<u>Shop</u>	FOUNDATION:	<u>Poured concrete foundation</u>
			<u>Galv. Corri. steel over cedar shingles</u>
CURRENT SUBFUNCTION:	<u>Storage</u>	ROOF MATERIAL:	<u>shingles</u>
HISTORIC FUNCTION:	<u>Livestock barn</u>	ROOF SHAPE:	<u>Gable</u>
HISTORIC SUBFUNCTION:	<u>Hay storage</u>	STRUCTURAL SYSTEM:	<u>Balloon framing</u>
			<u>Western feeder barn</u>
		STYLE:	<u>barn</u>
OCCUPIED:	<u>Yes</u>	TYPE:	<u>Livestock barn</u>
	<u>Yes with</u>		<u>2x4 studs, 1x8 #106 drop siding</u>
ACCESSIBLE:	<u>permission</u>	WALLS:	
STORIES:	<u>2</u>	SIGNIFICANT PERSON:	<u>Axel Jensen</u>
*DATE OF CONSTRUCTION:	<u>About 1920</u>	CULTURAL AFFILIATION:	<u>Danish</u>

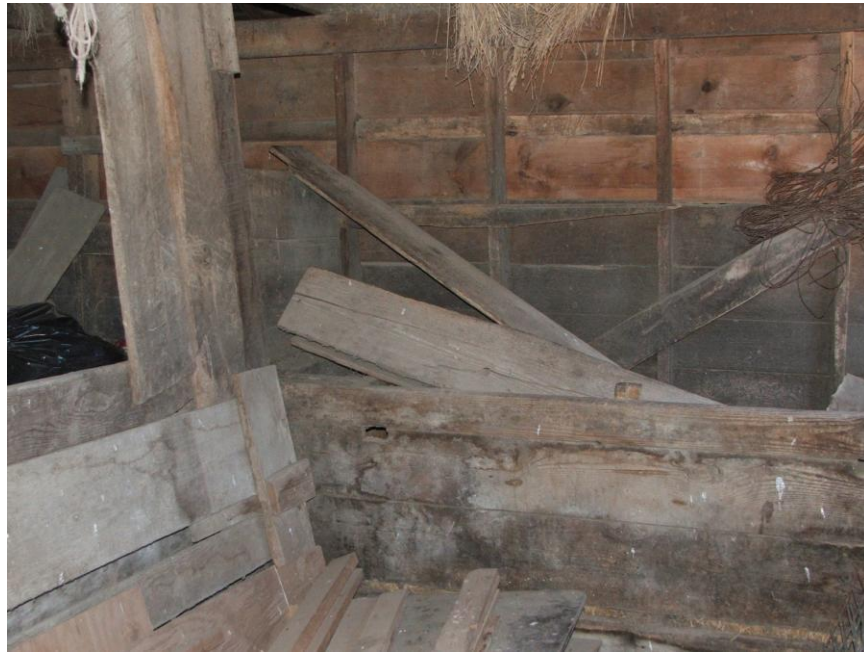
ROLL NUMBER: _____
PHOTO NUMBER: 5

CAMERA DIRECTION: First floor, looking South, horse stall in center of barn

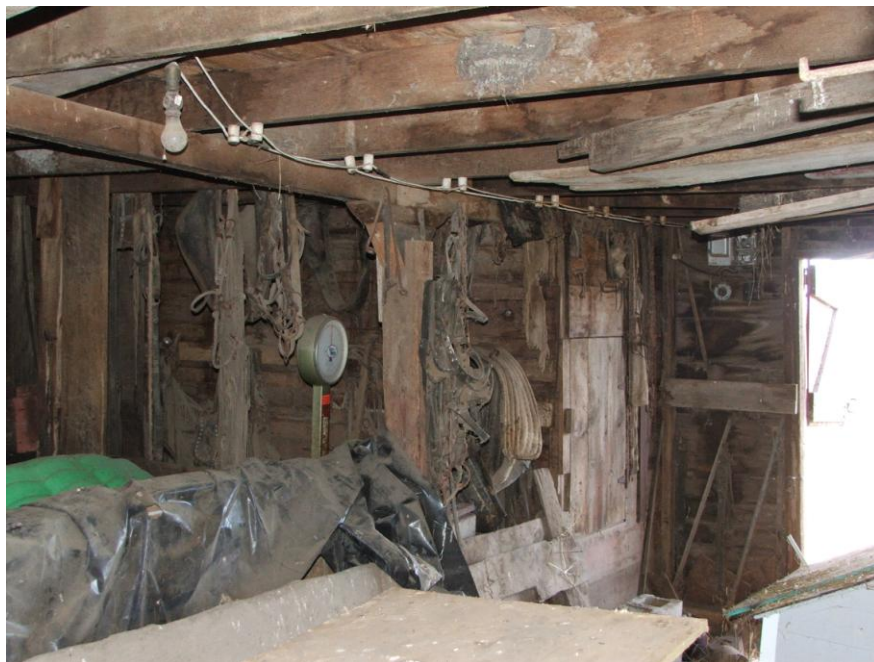
ROLL NUMBER: _____
PHOTO NUMBER: 6

CAMERA DIRECTION: First floor, looking NE, tack room and granary in the NE corner of center of barn

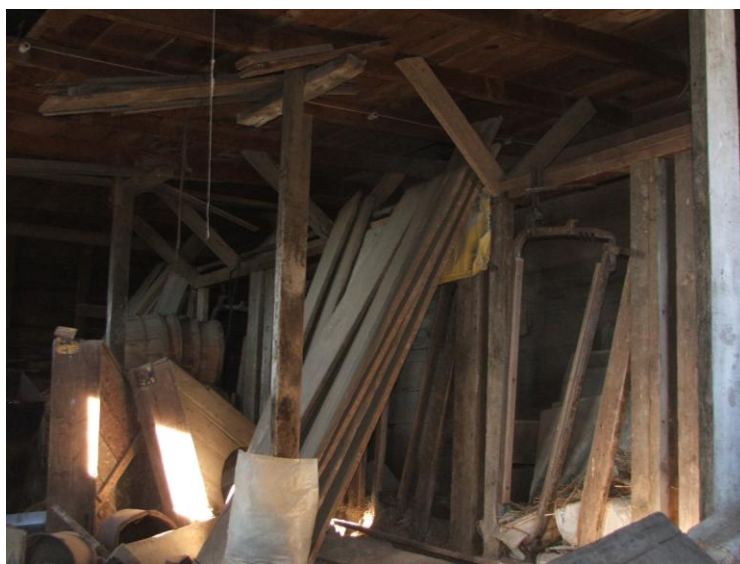
ROLL NUMBER: _____
PHOTO NUMBER: 7

CAMERA DIRECTION: First floor, South lean-to, looking NW, seven milk cow stanchions still in place.

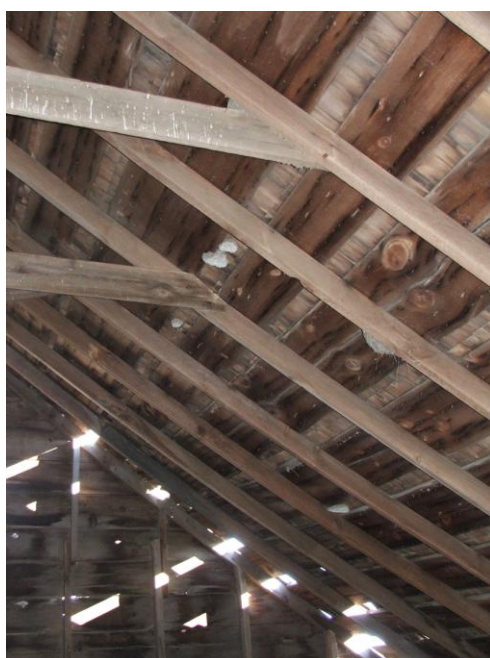
ROLL NUMBER: _____
PHOTO NUMBER: 8

CAMERA DIRECTION: Hayloft, looking SE, 2x4 rafters and 2x6 horizontal bracing 4' O.C.

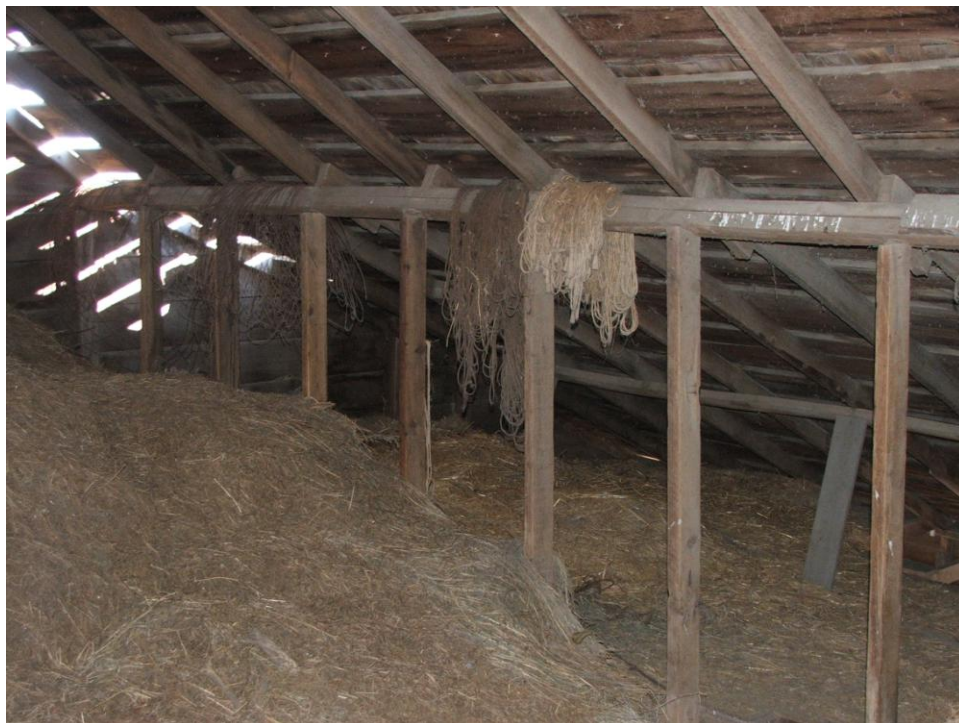
ROLL NUMBER: _____
PHOTO NUMBER: 9

CAMERA DIRECTION: Hayloft, looking SE, 5'
South wall and hayloft
over South lean-to.
