SOUTH DAKOTA STATE HISTORIC PRESERVATION OFFICE
HISTORIC SITES SURVEY STRUCTURE FORM

*ADDRESS: 30536 469th Ave.

HISTORIC FUNCTION: Livestock barn

TYPE: Livestock barn

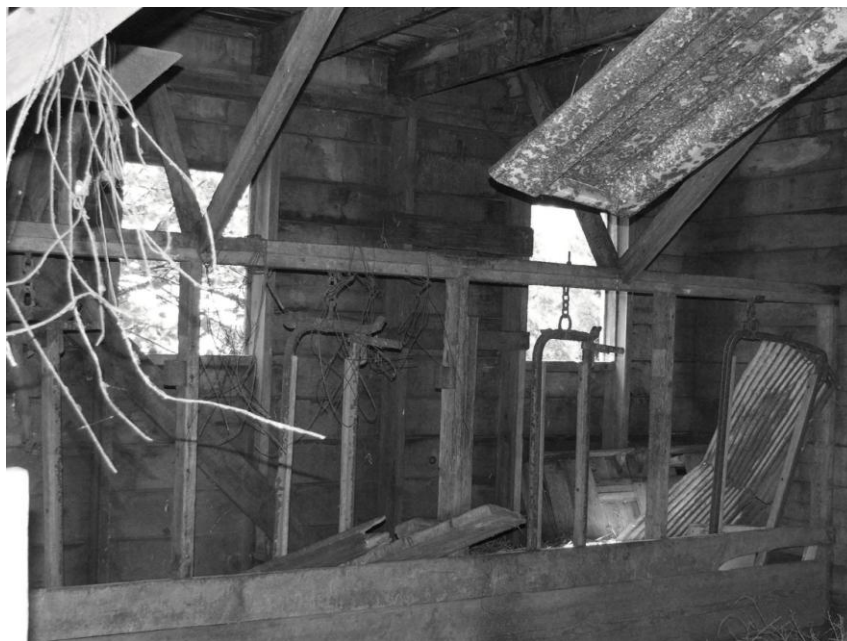
ROLL NUMBER: _____
PHOTO NUMBER: 5

ALTERED/MOVED NOTES: Original site. All horse stalls removed. 6 milk cow stanchions have
been removed. Calf pens removed and 4 milk cow stanchions moved to South wall. Metal cupola
is gone.

CAMERA DIRECTION: First floor, looking SW,
milk cow stanchions,
have been moved

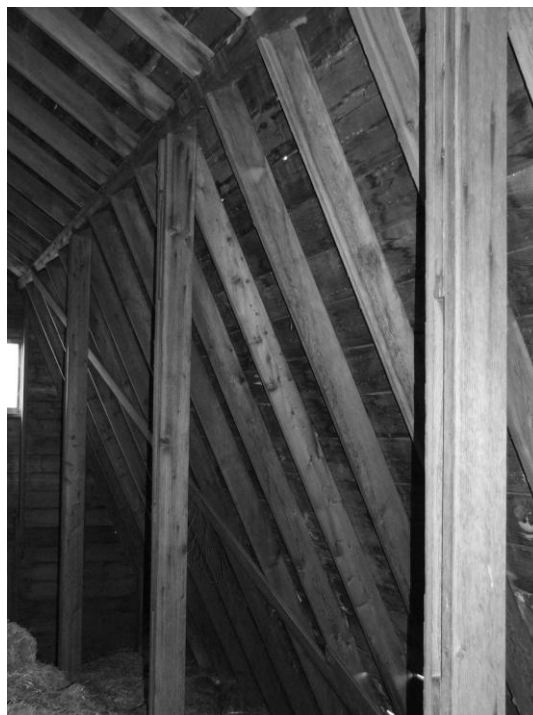
ROLL NUMBER: _____
PHOTO NUMBER: 6

CAMERA DIRECTION: Hayloft, looking West,
spaced 2x6 posts

supporting the roof hip

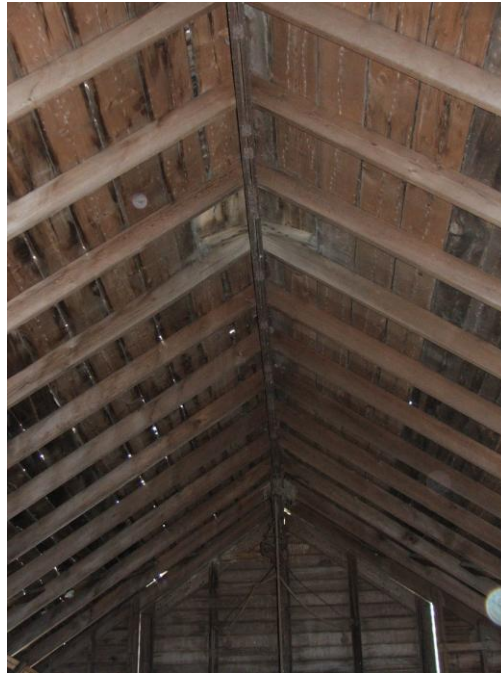
ROLL NUMBER: 7
PHOTO NUMBER: 7

CAMERA DIRECTION: Hayloft, looking West,
rafter framing and gable
end

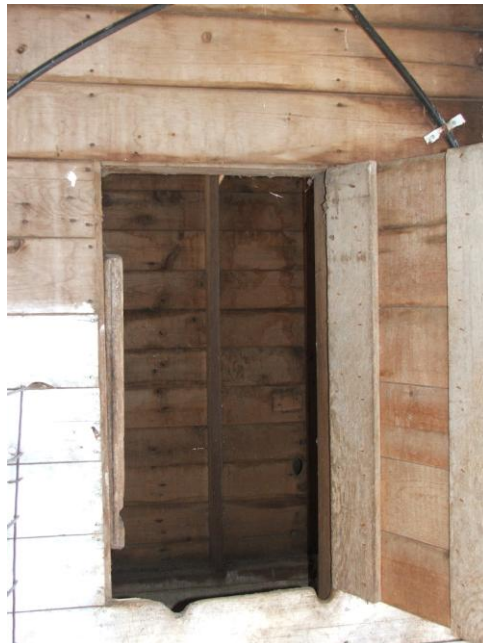
ROLL NUMBER: 8
PHOTO NUMBER: 8
CAMERA DIRECTION: First floor, looking SE

into granary
