SITE INFORMATION

STRUCTURE DETAILS

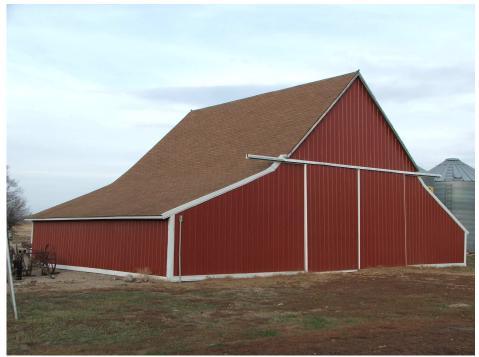
CAMERA DIRECTION: Looking NE, SW corner

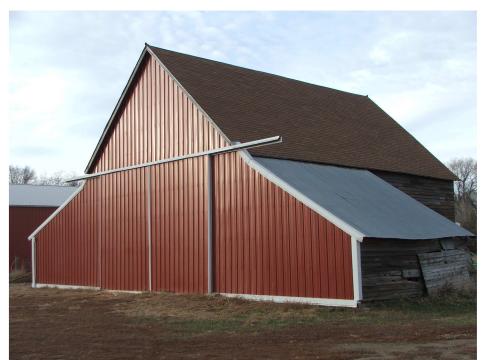
CAMERA DIRECTION: Looking NW, SE corner

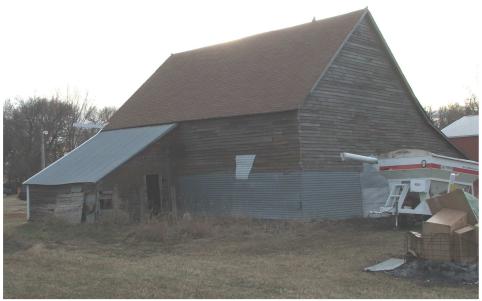
PHOTOGRAPHER: Jim Stone ROLL NUMBER: DATE OF PHOTO: December 5, 2012 PHOTO NUMBER: 3
CAMERA DIRECTION: Looking SW, NE corner

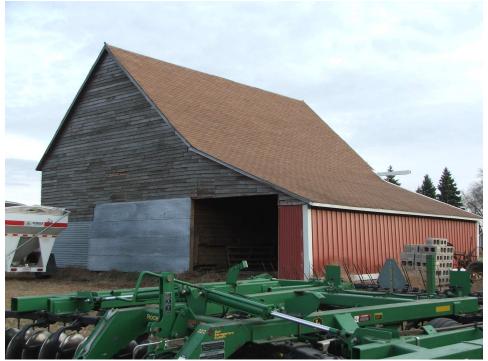
CAMERA DIRECTION: Looking SE, NW corner

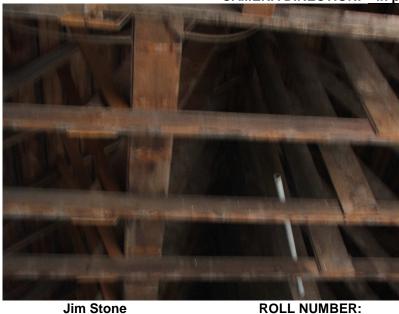
5

First floor, looking North, 2x4 stud wall, 2x6 floor joists raised to 12'-6", rafter to wall bracing still in place.

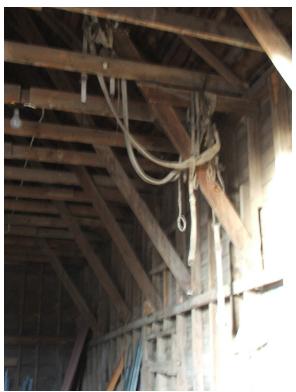
6

First floor, looking North up into rafters, 1x10 shiplap used to truss the rafters to floor joists
