SOUTH DAKOTA STATE HISTORIC PRESERVATION OFFICE
HISTORIC SITES SURVEY STRUCTURE FORM

*ADDRESS: 46186 300th Street

HISTORIC FUNCTION: Livestock barn

NOTES: Barn is in fair condition.

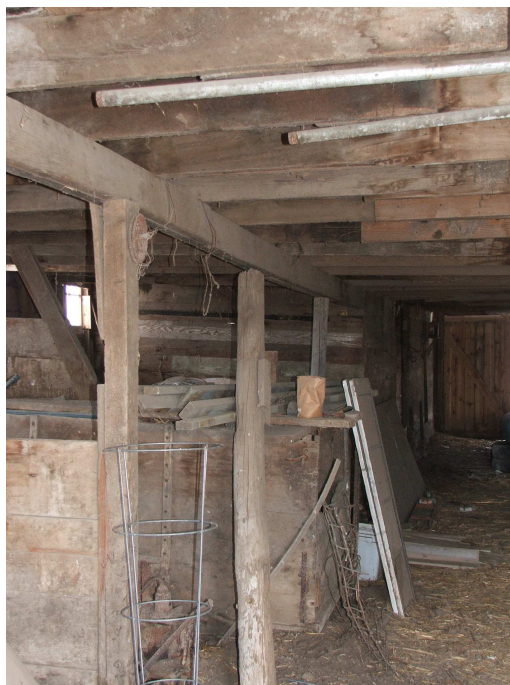
ROLL NUMBER: _____
PHOTO NUMBER: 5

**First floor, looking NW at
6x6 posts, (2) 2x8's
beam and 2x8 floor
joists, horse stalls on
West wall.**

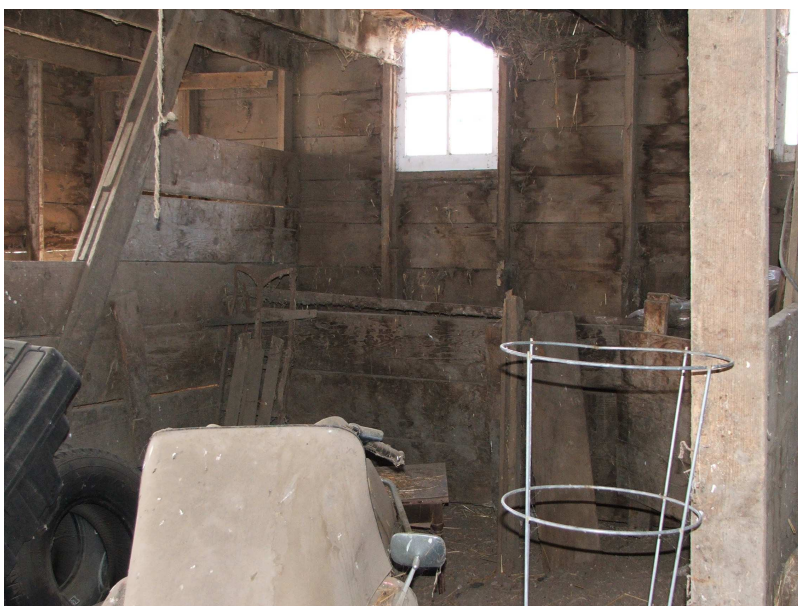
ROLL NUMBER: _____
PHOTO NUMBER: 6

**First floor, looking SW
into a horse stall on
West wall.**

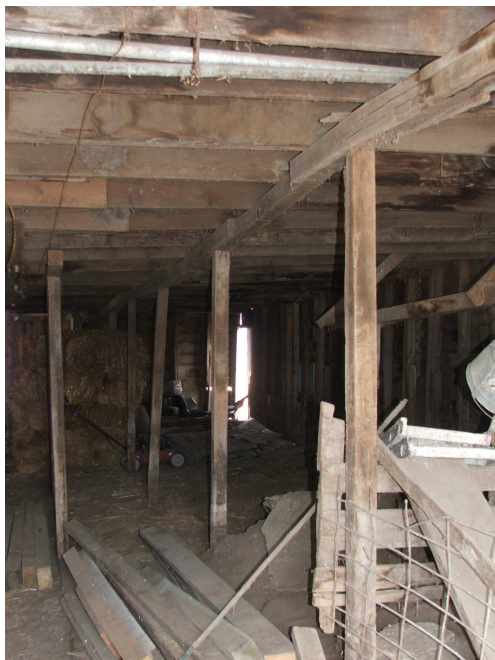
ROLL NUMBER: _____
PHOTO NUMBER: 7

CAMERA DIRECTION: First floor, looking NE into the East side, any evidence of what was there is gone.

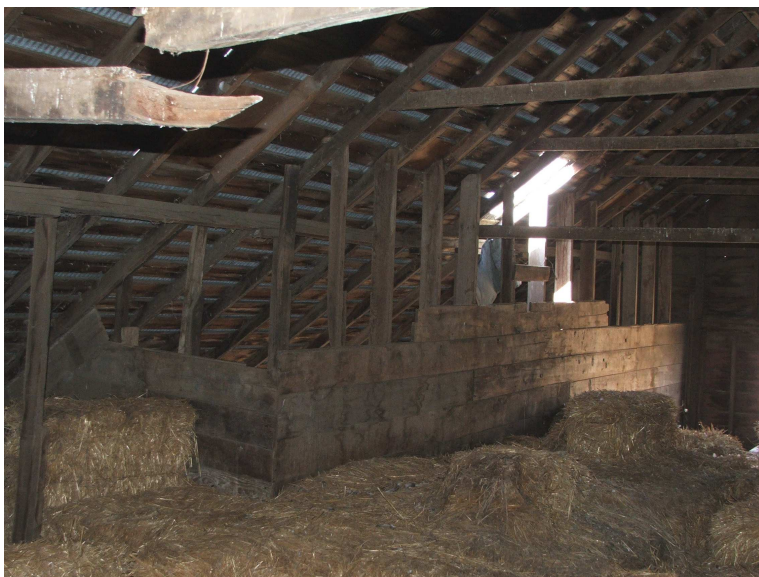
ROLL NUMBER: _____
PHOTO NUMBER: 8

CAMERA DIRECTION: Hayloft, looking NW, 9'-6" x 22' granary extended into the hayloft.

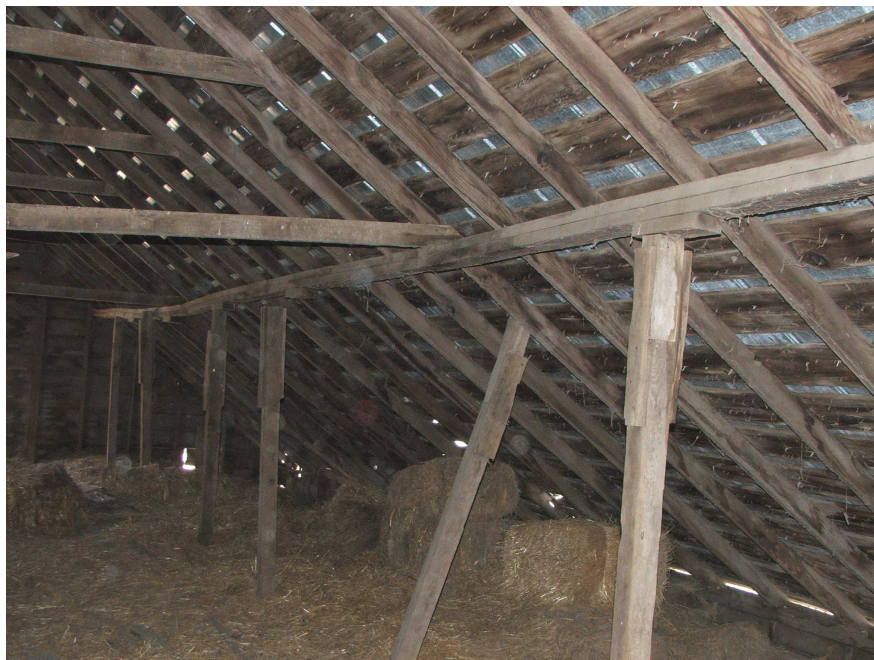
ROLL NUMBER: _____
PHOTO NUMBER: 9

CAMERA DIRECTION: Hayloft, looking NE. 4x4 posts and (2) 2x4's for a beam supporting 2x4 rafters.
