#### **`SITE INFORMATION**

\*SURVEY DATE: April 5, 2012

\*ADDRESS: 30287 Frog Creek Road

STRUCTURE DETAILS				
SHPO ID:		_		
*PROPERTY NAME:	Ben Folvik barn			
OTHER NAME:				
CURRENT FUNCTION:	Livestock	FOUNDA	FION:	Poured Concrete
				Asphalt shingles over cedar
CURRENT SUBFUNCTION:	Storage	ROOF MATE	RIAL:	shingles
HISTORIC FUNCTION:	Livestock	ROOF SHAPE:		Gambrel
HISTORIC SUBFUNCTION:	Hay and grain storage	STRUCTURAL SYS	TEM:	Balloon framing
		ST	YLE:	Gambrel roof barn
OCCUPIED:	Yes	T	YPE:	Livestock barn
	Yes with			2x6, sheathing & <sup>1</sup> ⁄ <sub>2</sub> "x6" cedar lap
ACCESSIBLE:	permission	WA	ALLS:	siding
STORIES:	2	SIGNIFICANT PERSON:	Ben	& Alma Folvik
*DATE OF CONSTRUCTION:	<u>1913</u> CU	LTURAL AFFILIATION:		?

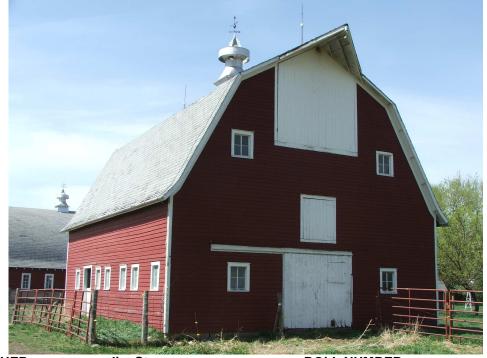
DATE OF PHOTO:
 April 5, 2012
 PHOTO NUMBER:
 3

CAMERA DIRECTION:
 Looking NW, SE corner

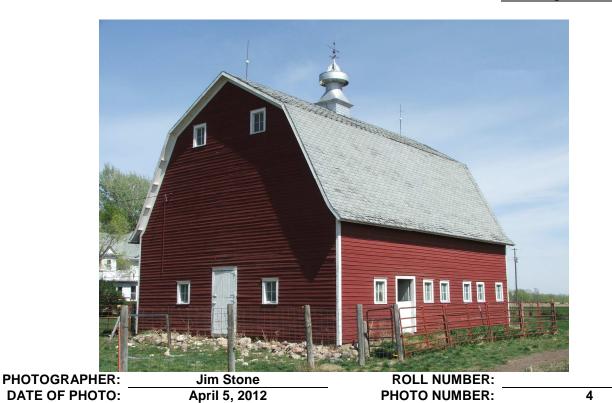
CAMERA DIRECTION: Looking NE, SW corner

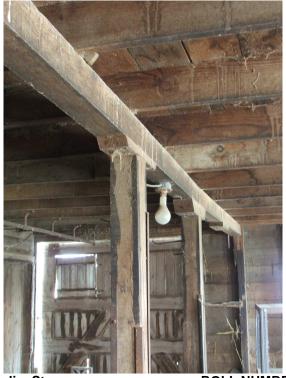
5 First floor, looking East CAMERA DIRECTION: \_posts and beams

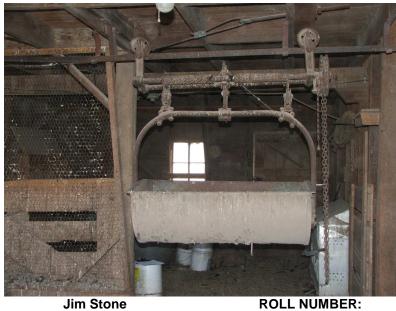
6 First floor, looking North, original manure bucket CAMERA DIRECTION: and manure track

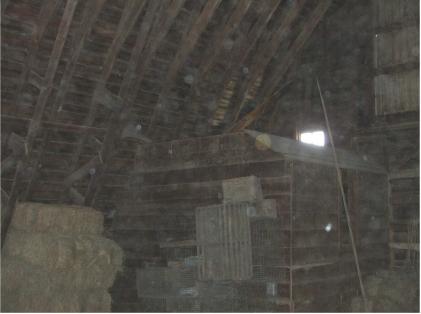
Hayloft, granary in NE corner, floor on top to CAMERA DIRECTION: keep hay out of granary

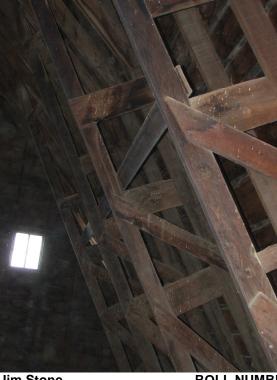
PHOTOGRAPHER:	Jim Stone	ROLL NUMBER:	
DATE OF PHOTO:	April 5, 2012	PHOTO NUMBER:	8

Hayloft, ½ of a ShawverCAMERA DIRECTION:truss, looking East
