SITE INFORMATION

*SURVEY DATE: June 6, 2012	*ADDRESS: Vacant 453 301th Street			
*SURVEYOR: Jim Stone	*COUNTY: Clay			
	*CITY: <u>Wakonda</u>			
	ction of South Dakota Highway 50 bi-pass and South			
Dakota Highway 19, 15 miles North to 302 nd Street, turn left (West, 9 miles to 453 rd Ave, turn right (North)				
1 mile to 301th Street, turn right and about ¼ m	nile, turn left (North), stop in drive as the entrance is gated.			
LEGAL DESCRIPTION: W ½ W ½ SW ¼ & 33	60' of S 593', 29 – 95 – 53 Star Twp.			
*QUARTER 1: SW 1/4	OWNER NAME: James Nelson			
*QUARTER 2:	OWNER ADDRESS: 45307 300 th Street			
*TOWNSHIP: Star	OWNER CITY: Wakonda			
*RANGE: 53	OWNER STATE: South Dakota			
*SECTION: 29	OWNER ZIP: 57073			
ACRES: 43.18	QUAD NAME:			
OWNER CODE 1: P				
OWNER CODE 2: F S L P				
OWNER CODE 3: F S L P				
HISTORIC SIGNIFICANCE				
*DOE:	REGISTER NAME:			
*DOE DATE:	MULTIPLE PROPERTY NAME:			
REASON INELIGIBLE:				
	CATEGORY:

STRUCTURE DETAILS				
SHPO ID:				
*PROPERTY NAME:		_		
OTHER NAME:				
OTTER NAME.				
CURRENT FUNCTION:	Vacant	FOUNDATION:	Poured concrete	
CURRENT SUBFUNCTION:		BOOE MATERIAL.	Steel over cedar	
	Livestock barn	ROOF MATERIAL:		
		ROOF SHAPE:	Gable	
HISTORI

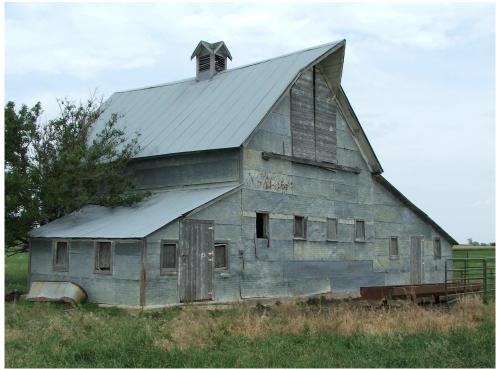
____1

CAMERA DIRECTION: Looking NE, SW corner

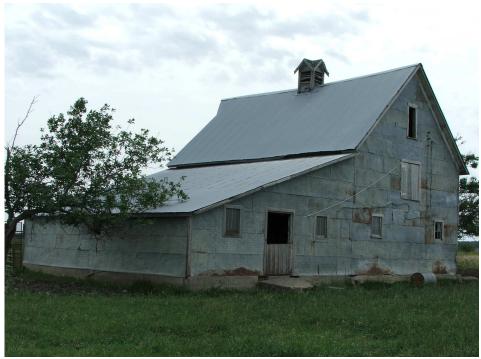
CAMERA DIRECTION: Looking SE, NW corner

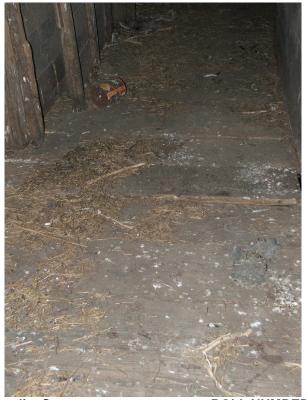
CAMERA DIRECTION: 2x12 plank floor

First floor, looking East,

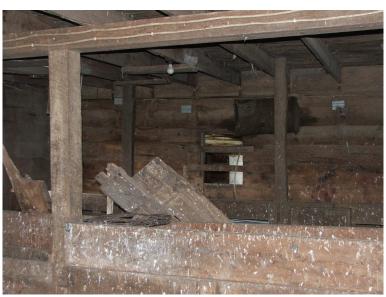
First floor, looking NE, **CAMERA DIRECTION:** remnants of horse stalls

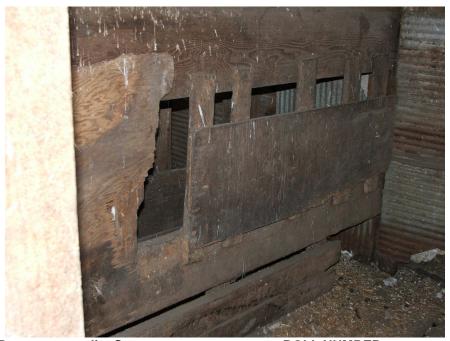
First floor, looking SW into a pen for calves or

CAMERA DIRECTION: sheep

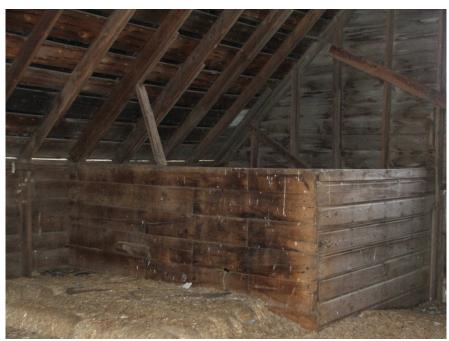
Hayloft, 10'x8' granary in

CAMERA DIRECTION: NW corner

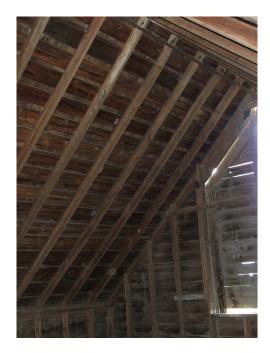
CAMERA DIRECTION: rafters, no bracing

Hayloft, looking SE, 2x4

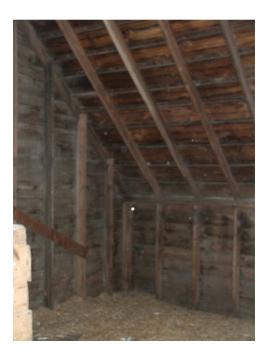
Hayloft, looking NE, 5'

CAMERA DIRECTION: wall and 2x4 rafters
