**SOUTH DAKOTA STATE HISTORIC PRESERVATION OFFICE
HISTORIC SITES SURVEY STRUCTURE FORM**

*SURVEY DATE: February 25, 2013 *ADDRESS: 31176 452nd Ave.
*SURVEYOR: Jim Stone *COUNTY: Clay
*CITY: Gayville

CURRENT FUNCTION: Vacant FOUNDATION: Poured concrete
 CURRENT SUBFUNCTION: Vacant ROOF MATERIAL: Steel roof
 HISTORIC FUNCTION: Horse barn ROOF SHAPE: overcedar shingles
 HISTORIC SUBFUNCTION: Hay & grain storage STRUCTURAL SYSTEM: Gambrel
 OCCUPIED: Yes STYLE: Balloon framing
 TYPE: Gambrel roof barn
 ACCESSIBLE: Yes with permission WALLS: Livestock barn
 2x6 studs, 1x8 sheathing and 1/2"x6" cedar lap siding

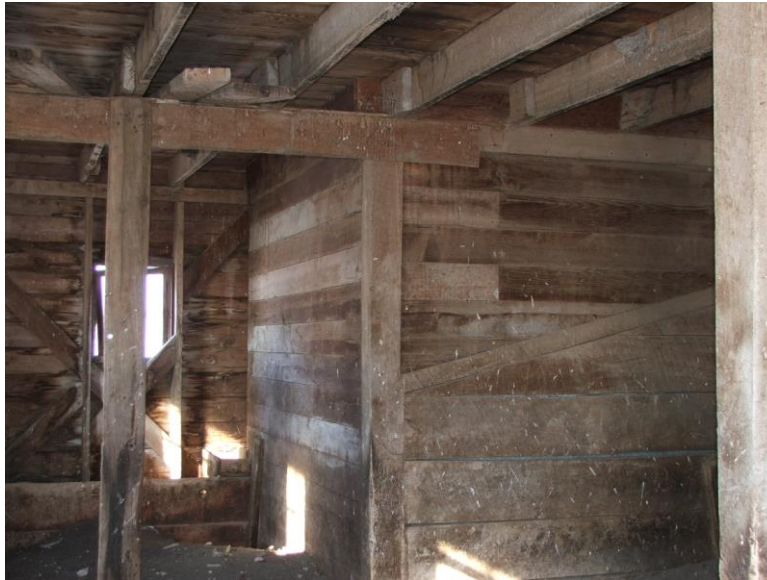
ROLL NUMBER: _____
PHOTO NUMBER: 5

ALTERED/MOVED NOTES: Original site. Granary appears to have been added later. Side of horse stall is the lower wall of the granary. The double horse stall was moved to the North wall between granary and West wall. Roof has been covered with steel roofing.

First floor, looking North, granary added later, note side of horse stall is lower part of granary wall.

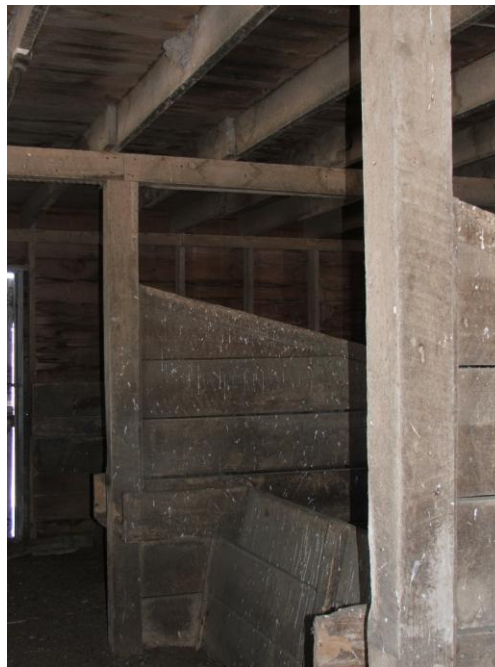
ROLL NUMBER: _____
PHOTO NUMBER: 6

First floor, looking North, double horse stalls on the East side of barn.

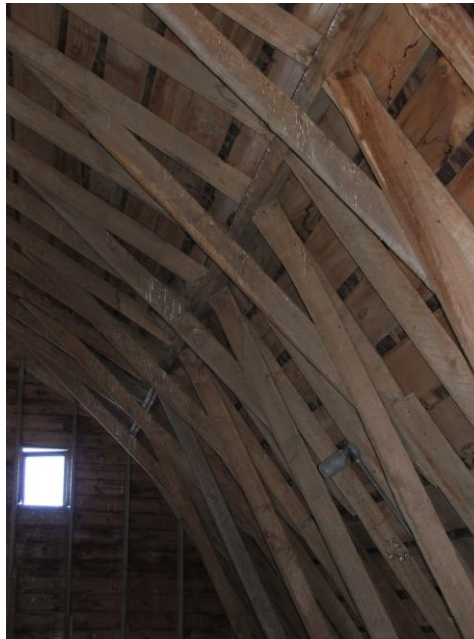
ROLL NUMBER: _____
PHOTO NUMBER: 7

CAMERA DIRECTION: Hayloft, looking SE, 2x6
rafters, 2x6 bracing at
hip, 4' O.C.

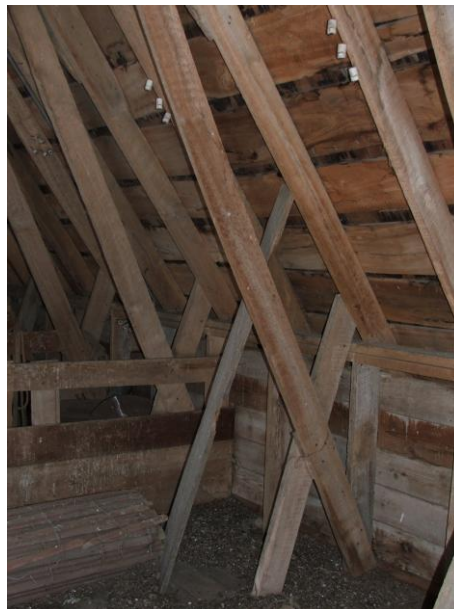
ROLL NUMBER: _____
PHOTO NUMBER: 8

CAMERA DIRECTION: Hayloft, looking SE, 2x6
bracing from hip down to
floor and 2x6 brace from
wall down to floor, 4'
O.C.
