**SOUTH DAKOTA STATE HISTORIC PRESERVATION OFFICE
HISTORIC SITES SURVEY STRUCTURE FORM**

*SURVEY DATE: February 8, 2013
*SURVEYOR: Jim Stone

*ADDRESS: 46970 309th Street
*COUNTY: Clay
*CITY: Beresford

CURRENT FUNCTION: Storage FOUNDATION: Poured concrete
Asphalt shingles
over cedar
shingles
 CURRENT SUBFUNCTION: Storage ROOF MATERIAL: shingles
 HISTORIC FUNCTION: Livestock barn ROOF SHAPE: Gable
 HISTORIC SUBFUNCTION: Hay storage STRUCTURAL SYSTEM: Balloon framing
 OCCUPIED: Yes STYLE: Gable roof barn
 Yes with TYPE: Livestock barn
 ACCESSIBLE: Yes with permission WALLS: 2x6 studs, 1x6 #106
drop siding.

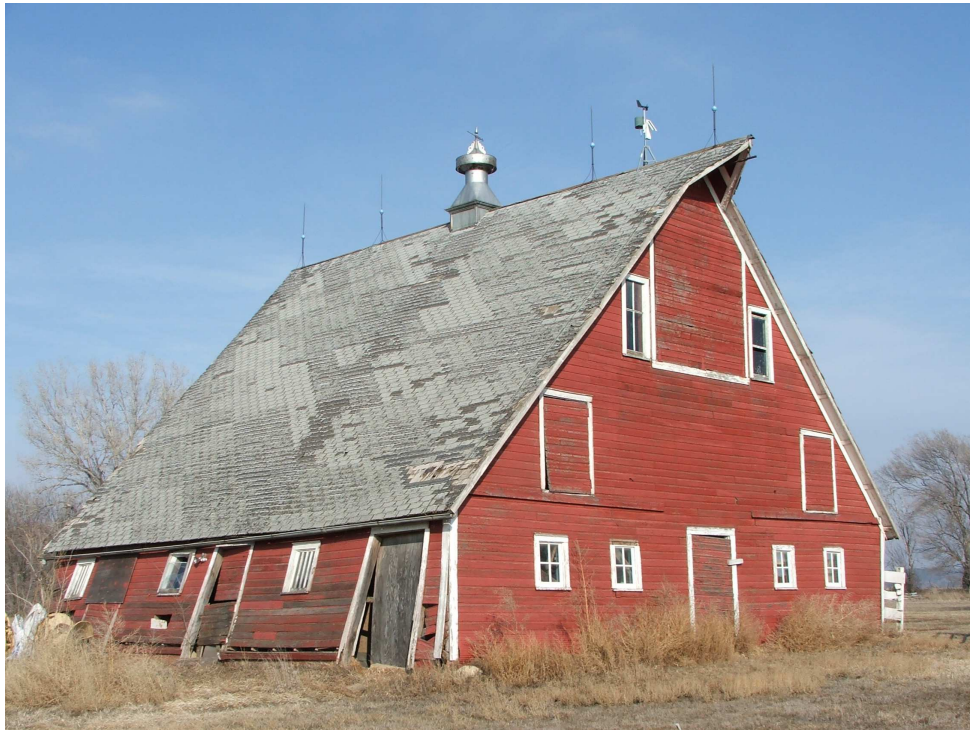
ROLL NUMBER: _____
PHOTO NUMBER: 1
CAMERA DIRECTION: Looking NE, SW corner

***PHYSICAL NOTES:** Barn is in fair condition. Foundation has tipped out on the West and South sides. Barn is leaning to the South. Owner wants to straighten the barn and pour new foundations where needed. Will need to be re-roofed in the near future.

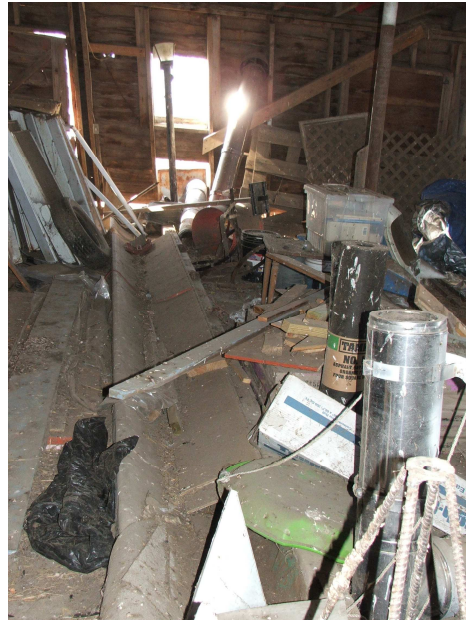
ROLL NUMBER: _____
PHOTO NUMBER: 5

CAMERA DIRECTION: First floor, looking West,
poured concrete feed
trough for milk cows.

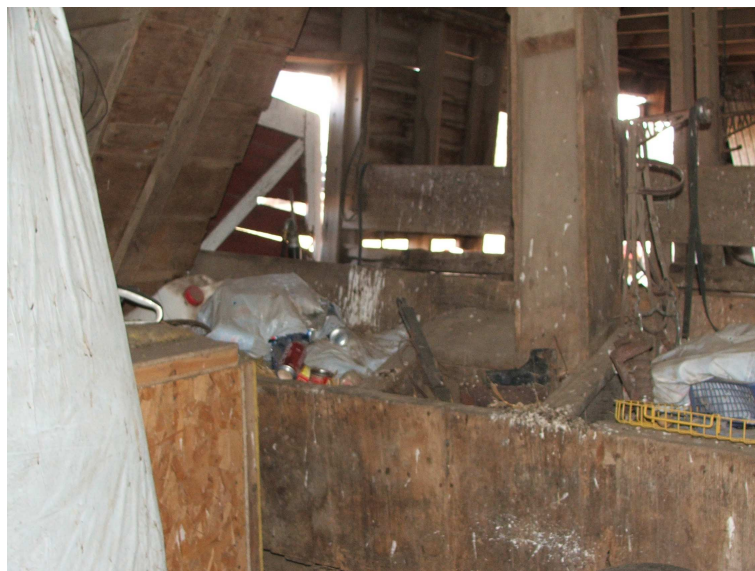
ROLL NUMBER: _____
PHOTO NUMBER: 6

CAMERA DIRECTION: First floor, looking SE,
Double horse stall in the
NE corner, note grain
chute down to feed
boxes, and grain drop on
the left, from granary in
the hayloft

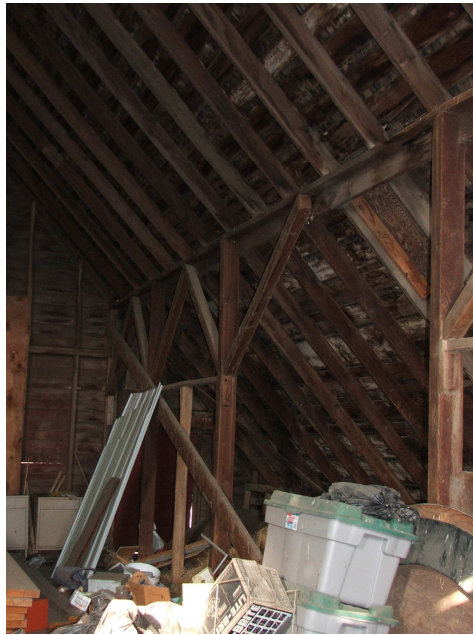
ROLL NUMBER: _____
PHOTO NUMBER: 7

CAMERA DIRECTION: Hayloft, looking NE, 4x4 posts and (2) 2x6 beam supporting rafters.

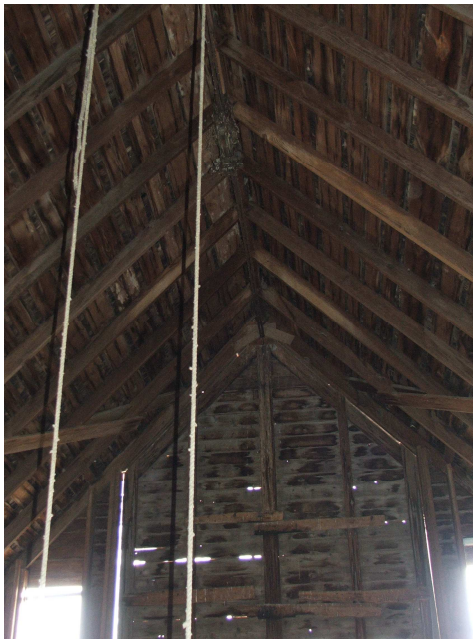
ROLL NUMBER: _____
PHOTO NUMBER: 8

CAMERA DIRECTION: Hayloft, looking South, rafters and gable end.
