SOUTH DAKOTA STATE HISTORIC PRESERVATION OFFICE
HISTORIC SITES SURVEY STRUCTURE FORM

*ADDRESS: 45894 Norway Street

HISTORIC FUNCTION: Draft horse barn

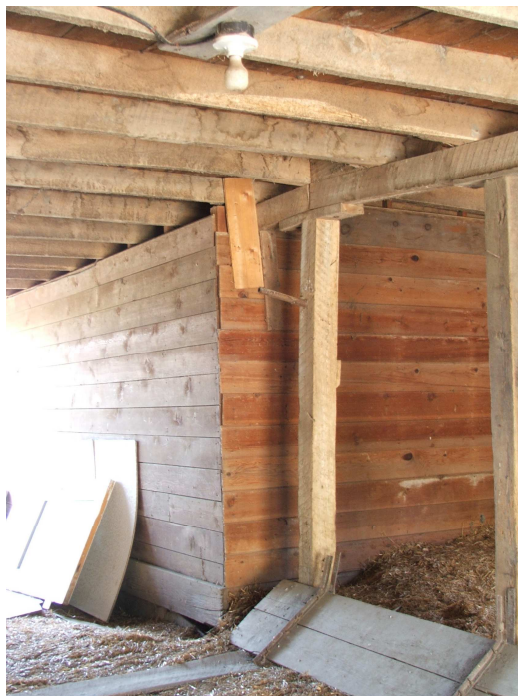
ROLL NUMBER: _____
PHOTO NUMBER: 5

CAMERA DIRECTION: First floor, looking
South, granary in SW
corner

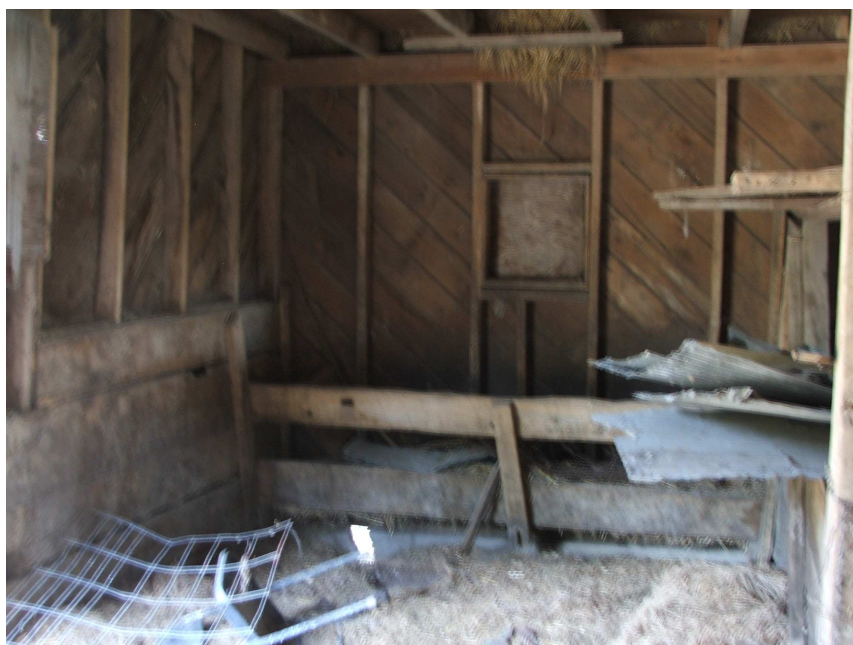
ROLL NUMBER: _____
PHOTO NUMBER: 6

CAMERA DIRECTION: First floor, looking East,
horse stall and manger

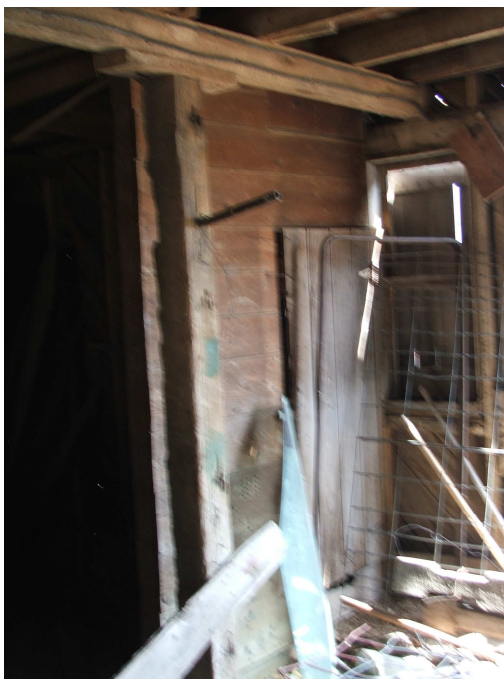
ROLL NUMBER: _____
PHOTO NUMBER: 7

CAMERA DIRECTION: First floor, looking SE,
granary in SE corner

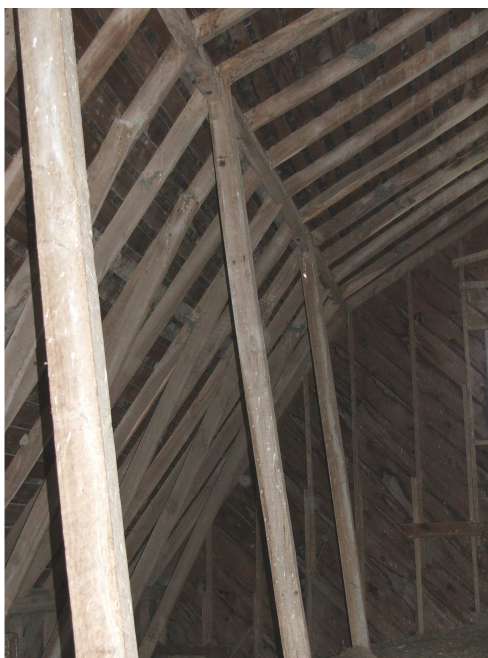
ROLL NUMBER: _____
PHOTO NUMBER: 8

CAMERA DIRECTION: Hayloft, looking North,
4x6's supporting hip

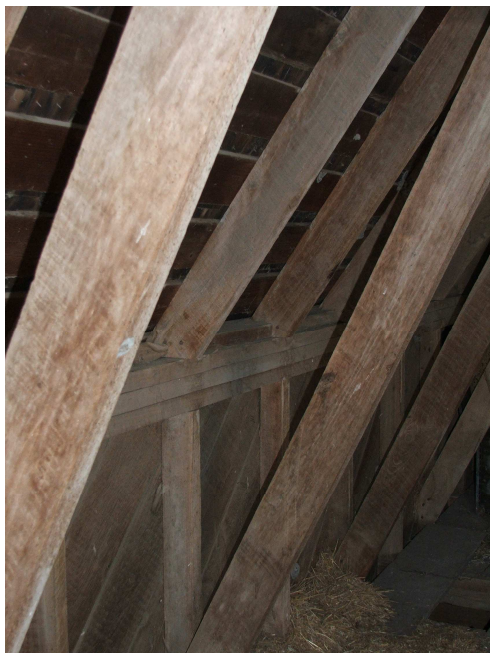
ROLL NUMBER: _____
PHOTO NUMBER: 9

CAMERA DIRECTION: Hayloft, looking North,
2x6 brace 4' O.C. from
hip to floor

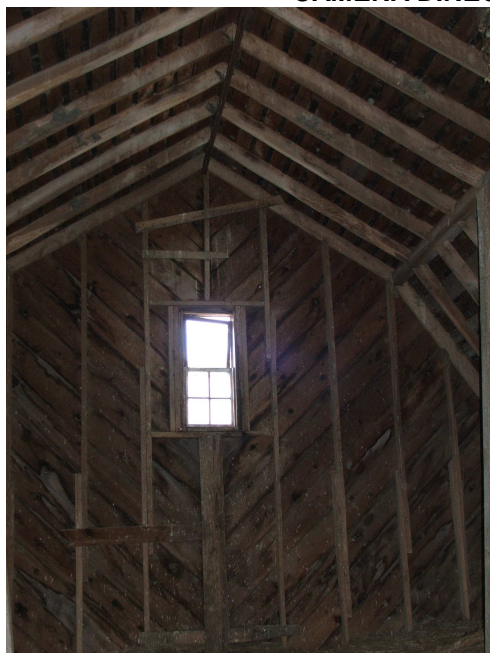
ROLL NUMBER: _____
PHOTO NUMBER: 10

CAMERA DIRECTION: Hayloft, looking North,
North gable end
