**SOUTH DAKOTA STATE HISTORIC PRESERVATION OFFICE
HISTORIC SITES SURVEY STRUCTURE FORM**

*SURVEY DATE: March 10, 2014 *ADDRESS: 46180 Riverside Street
*SURVEYOR: Jim Stone *COUNTY: Clay
*CITY: Centerville

CURRENT FUNCTION: <u>Vacant</u>	FOUNDATION: <u>Poured concrete</u>
CURRENT SUBFUNCTION: <u>Storage</u>	ROOF MATERIAL: <u>Cedar shingles</u>
HISTORIC FUNCTION: <u>Livestock barn</u>	ROOF SHAPE: <u>Gambrel roof</u>
HISTORIC SUBFUNCTION: <u>Hay and grain storage</u>	STRUCTURAL SYSTEM: <u>Balloon framing</u>
	STYLE: <u>Gambrel roof barn</u>
OCCUPIED: <u>Yes</u>	TYPE: <u>Livestock barn</u>
	<u>2x6 studs, 1x10 diagonal sheathing and 1/2"x6" cedar lap siding</u>
ACCESSIBLE: <u>Yes with permission</u>	WALLS: _____
	SIGNIFICANT PERSON: <u>Carl Johan (Charles) Anderson</u>
STORIES: <u>2</u>	CULTURAL AFFILIATION: <u>Swedish</u>
*DATE OF CONSTRUCTION: <u>1890 to 1920</u>

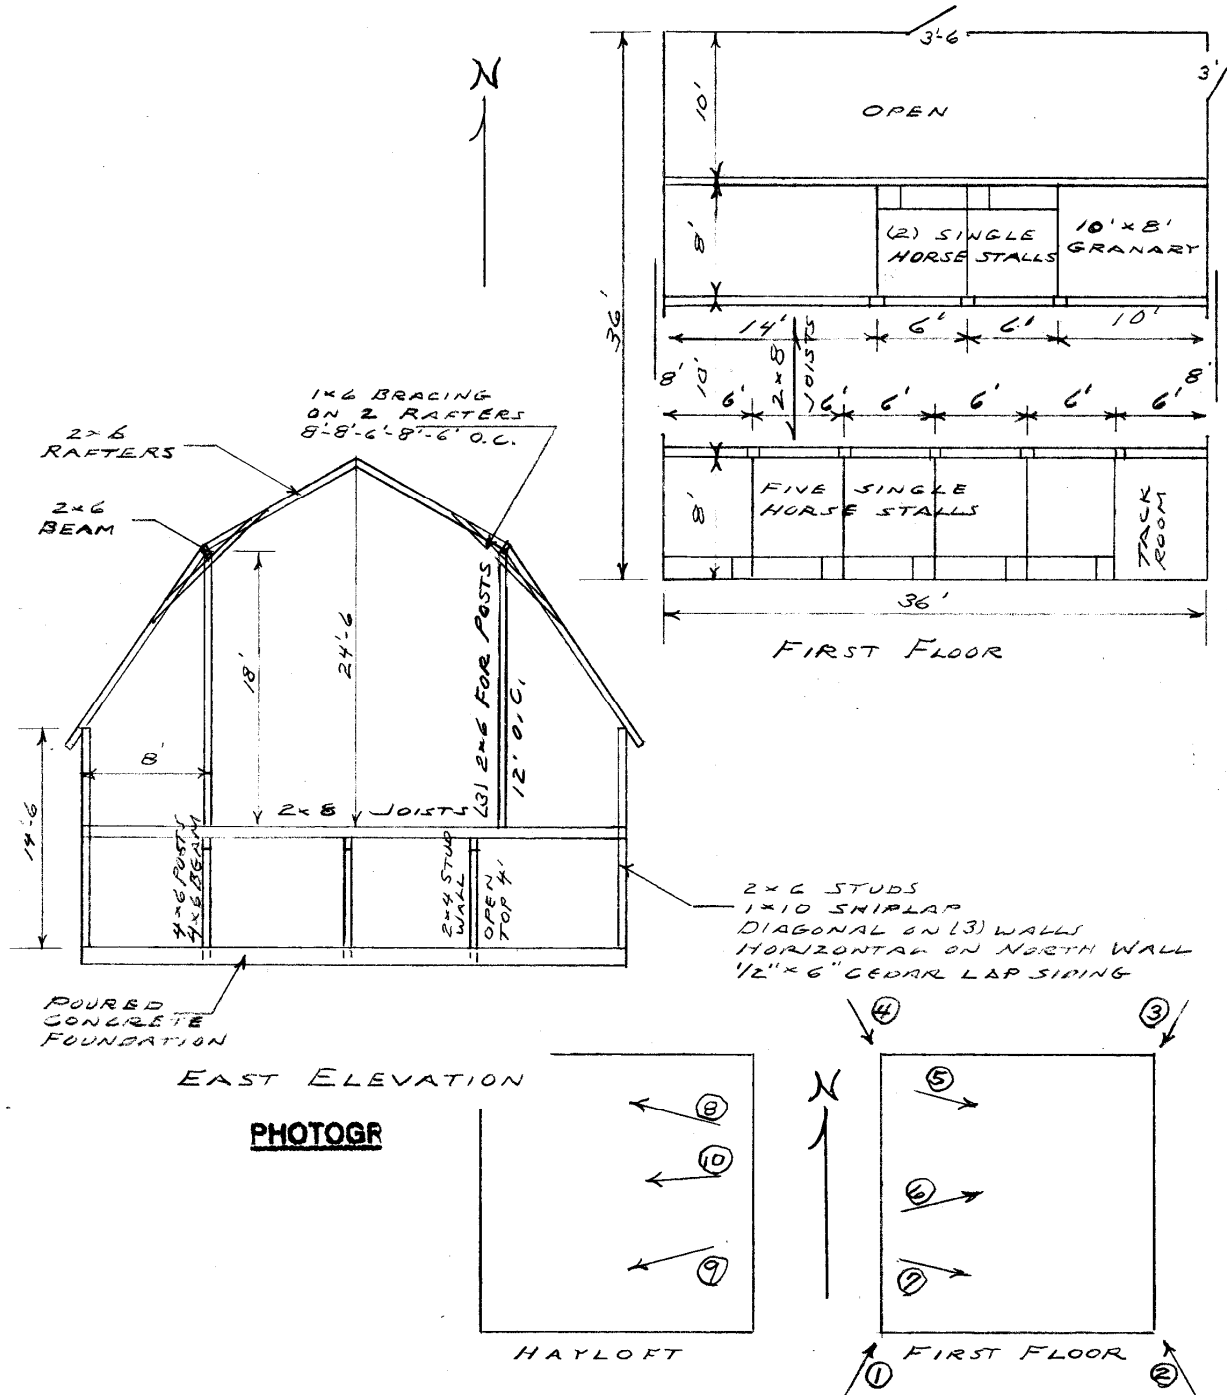
SKETCH MAP

----- DOTTED LINES
ORIGINAL BARN

————— REMODELED
BARN WITH GAMBREL ROOF

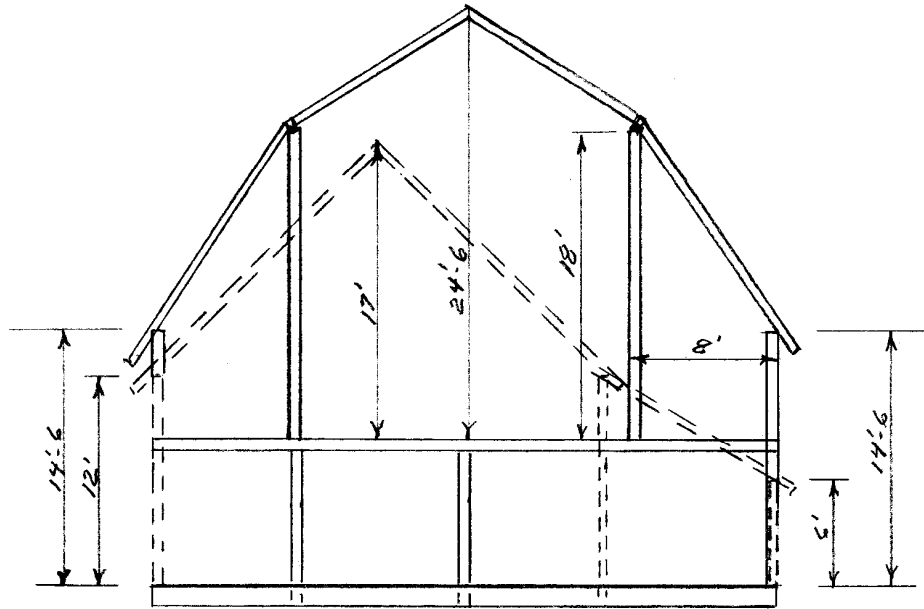
EAST ELEVATION

EXTERIOR PICTURES SHOW
ORIGINAL SIDING AND ADDED
SIDING AFTER REMODEL

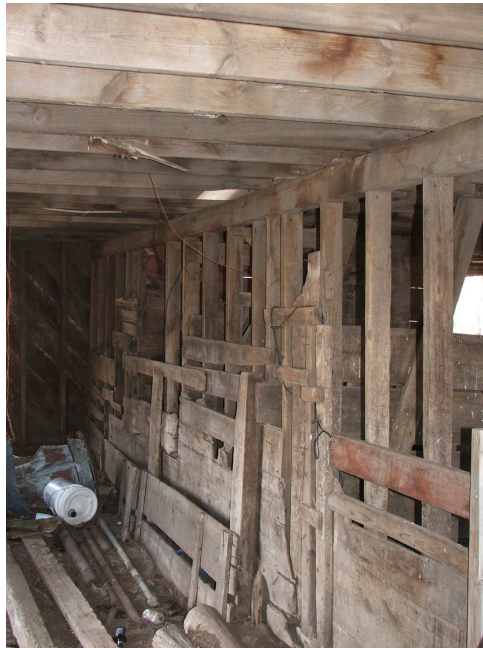
ROLL NUMBER: 5
PHOTO NUMBER: 5

First floor, looking SE at original 2x4 stud wall (shortened) 4x6 beam and 2x8 floor joists.

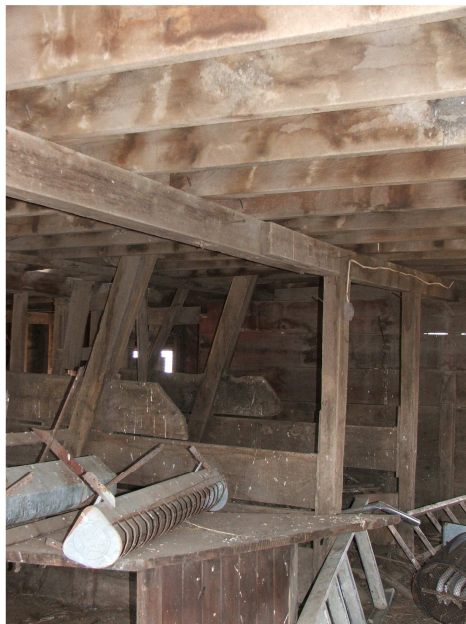
ROLL NUMBER: 6
PHOTO NUMBER: 6

First floor, looking NE, 4x6 posts, 4x6 beam and 2x8 floor joists,

CAMERA DIRECTION: remnants of horse stalls.

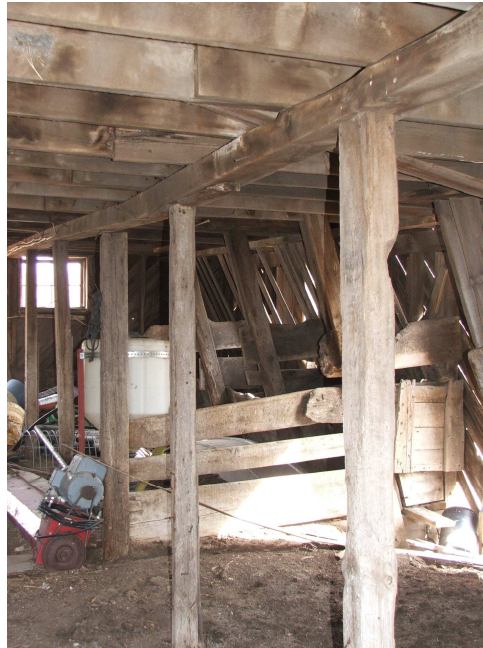
ROLL NUMBER: 7
PHOTO NUMBER: 7

CAMERA DIRECTION: First floor, looking SE,
remnants of single horse
stalls along South wall.

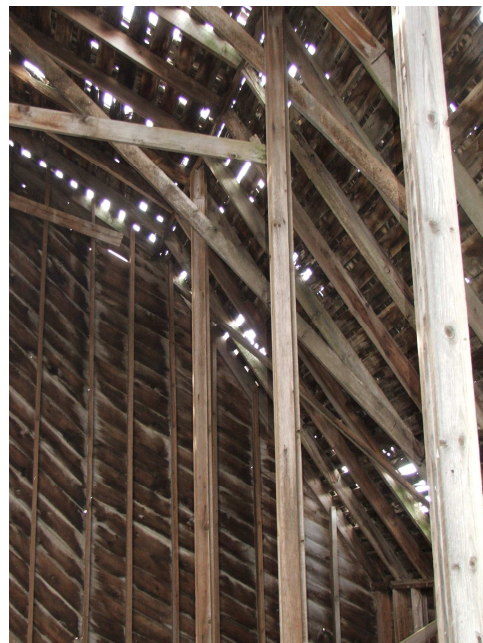
ROLL NUMBER: 8
PHOTO NUMBER: 8

CAMERA DIRECTION: Hayloft, looking NW, (3)
laminated 2x6 posts
supporting hip, 12' O. C.

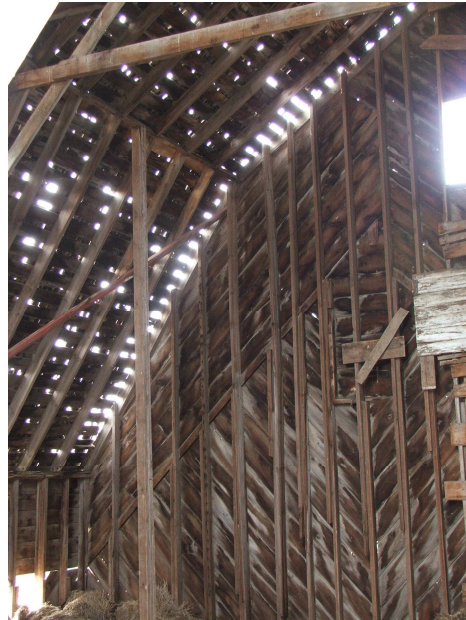
ROLL NUMBER: _____
PHOTO NUMBER: 9

**Hayloft, looking SW, 2x6
rafters, 2x6 posts, note
diagonal sheathing
added with remodel.**

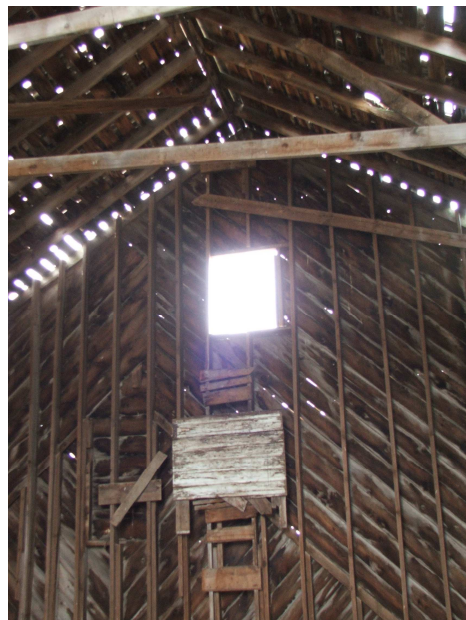
ROLL NUMBER: _____
PHOTO NUMBER: 10

**Hayloft, looking West,
wall and sheathing
extended when barn was
remodeled.**
