**SOUTH DAKOTA STATE HISTORIC PRESERVATION OFFICE  
HISTORIC SITES SURVEY STRUCTURE FORM**

\*SURVEY DATE: March 23, 2012 \*ADDRESS: 31494 453<sup>rd</sup> Ave.  
\*SURVEYOR: Jim Stone \*COUNTY: Clay  
\*CITY: Meckling

\*PROPERTY NAME: Johnsen, Calle Nissen / Hansen farmstead

SCALE - 1/8" = 1'-0" DANISH BRICK BARN  
31494 453RD AVE.  
MECKLING, SO. DAK.

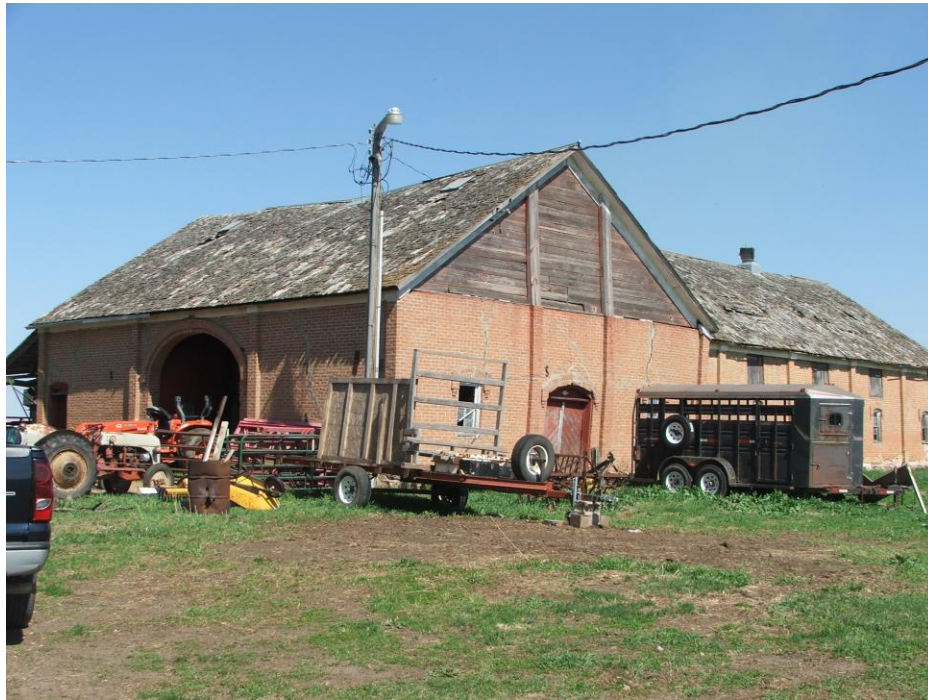
**ROLL NUMBER:** \_\_\_\_\_  
**PHOTO NUMBER:** 1  
**CAMERA DIRECTION:** Looking NE, SW corner

**\*PHYSICAL NOTES:** Barn is in very poor condition. Roof is rotted out on North side and some of the beams are rotting . East wall is bowed out about one half way up. Very ornate brick work with soldier brick arches over each window and a large brick arch doorway on West. This doorway is 12'-3" wide and 11' tall and has two doors 6'-6" wide which swing in. These doors are in good condition. There was no hay track to lift hay into the hayloft. There are three awning hayloft doors on the South and North sides and one on the East side. All of the hay had to be manually pitched up into the hayloft.

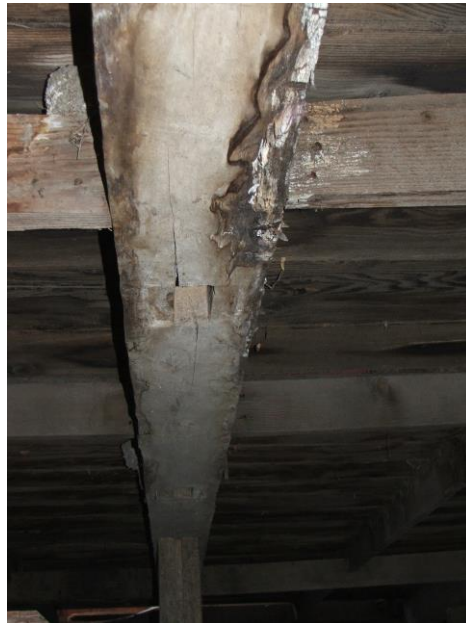
**ROLL NUMBER:** \_\_\_\_\_  
**PHOTO NUMBER:** 15

**First floor, looking North,  
bottom of 8"x9" hand  
hewn beam, note mortis  
where two posts have  
been removed, mold on  
beam from leaking roof.**

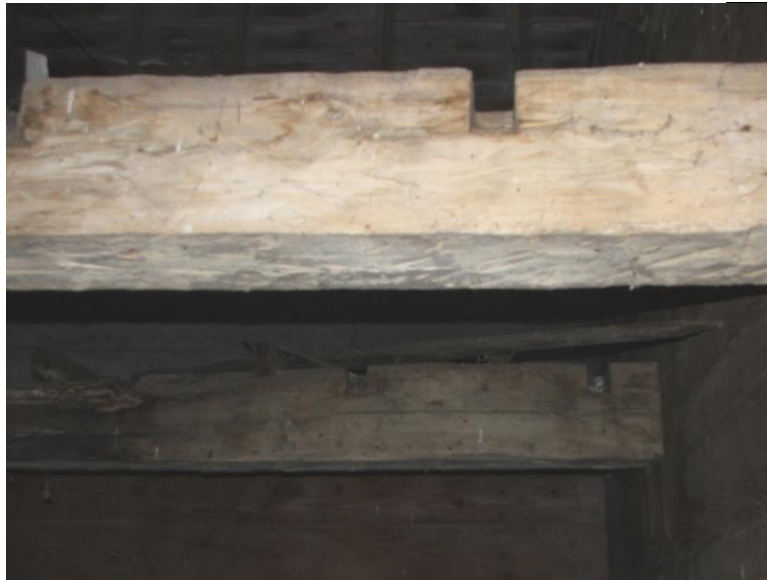
**ROLL NUMBER:** \_\_\_\_\_  
**PHOTO NUMBER:** 18

**First floor, looking North  
in West wing, hand hewn  
beams with notching for  
floor joists (removed)**

The floor joists have been replaced with double milled 2x8's and five granaries have been built above on the South side. It is believed that the South side above the horse stalls was a hayloft and the beams supporting were 8' O.C. There are two granaries in the center of the North side, with a 9' space for haylofts on the East and West sides. The granaries on the North have been rebuilt with milled 2x6's and 1x10 shiplap. The original floor joists have been removed to make the granaries go up through the hayloft floor to make these granaries about 14' high. The beams still are in place and have the notches where the original floor joists were

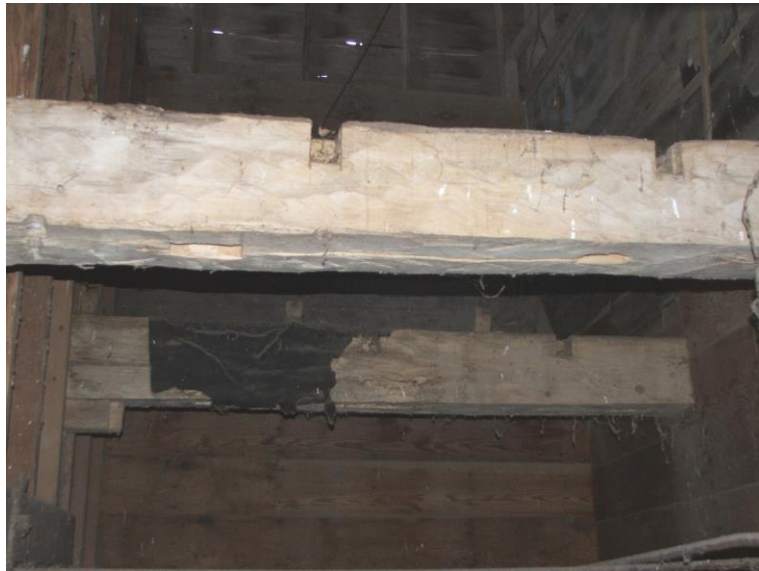
ROLL NUMBER: \_\_\_\_\_  
PHOTO NUMBER: 19

CAMERA DIRECTION: First floor, looking North in West wing, hand hewn beams with notching for floor joists (removed)
