SITE INFORMATION

*SURVEY DATE: December 20, 2012

*ADDRESS: 31494 453rd Ave.

CALLE NISSEN LOG CABIN 31494 453Rd AVE. MECKLING, SO.DAK.

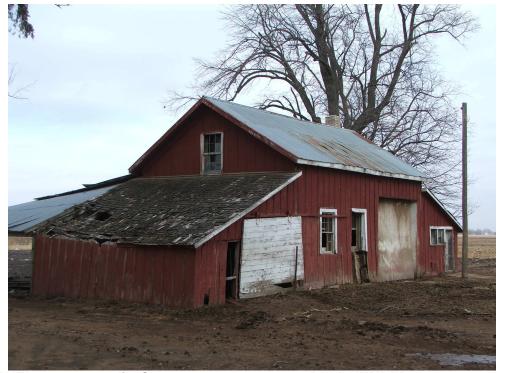
PHOTO NUMBER:
 1

CAMERA DIRECTION:
 Looking NE, SW corner

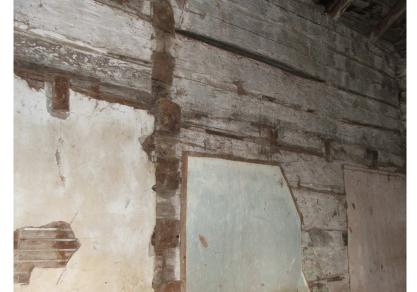
10 First floor, looking NE, logs cut out to remove log wall, note floor joists cut off in wall.

CAMERA DIRECTION: cut off in wall.

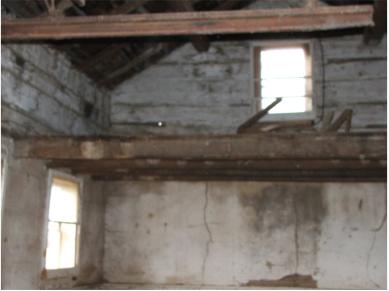
11 First floor, looking West,

floor joists and second

CAMERA DIRECTION:
 floor at West end.

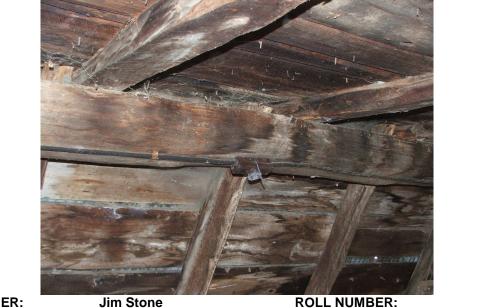
PHOTO NUMBER: 14 Second floor, looking NE, 10" log ridge pole, note top cut to roof slope, 4" x 3" hand hewn CAMERA DIRECTION: rafters

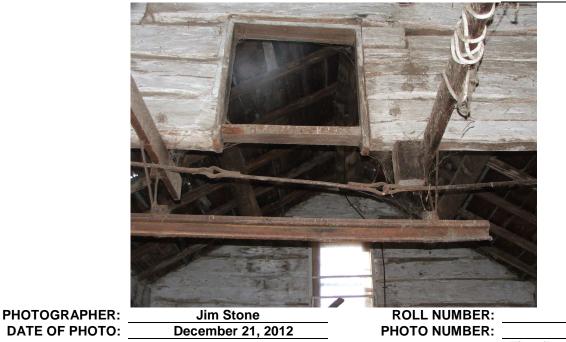
18 First floor, looking West, bottom of center log wall and 1" steel rod, steel track below is for O.H.

CAMERA DIRECTION: door.
