**SOUTH DAKOTA STATE HISTORIC PRESERVATION OFFICE
HISTORIC SITES SURVEY STRUCTURE FORM**

*SURVEY DATE: February 25, 2013 *ADDRESS: 31176 452nd Ave.
*SURVEYOR: Jim Stone *COUNTY: Clay
*CITY: Gayville

CURRENT FUNCTION: Vacant FOUNDATION: Poured concrete
 CURRENT SUBFUNCTION: Vacant ROOF MATERIAL: Steel roof over cedar shingles
 HISTORIC FUNCTION: Horse barn ROOF SHAPE: Gambrel
 HISTORIC SUBFUNCTION: Hay & grain storage STRUCTURAL SYSTEM: Balloon framing
 OCCUPIED: Yes STYLE: Gambrel roof barn
 TYPE: Livestock barn
2x6 studs, 1x8 sheathing and 1/2"x6" cedar lap siding
 ACCESSIBLE: Yes with permission WALLS: _____

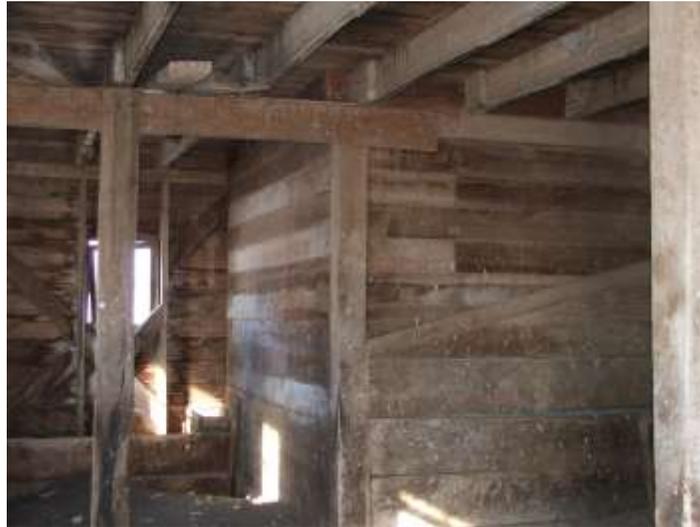
ROLL NUMBER: _____
PHOTO NUMBER: 5

ALTERED/MOVED NOTES: Original site. Granary appears to have been added later. Side of horse stall is the lower wall of the granary. The double horse stall was moved to the North wall between granary and West wall. Roof has been covered with steel roofing.

**First floor, looking North,
granary added later, note
side of horse stall is
lower part of granary
wall.**

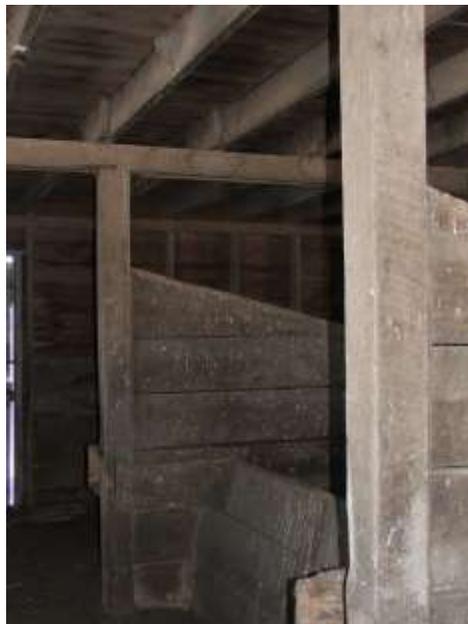
ROLNUMBER: _____
PHOTO NUMBER: 6

INTERIOR NOTES: Has two rows of 6x6 posts and a three 2x6's for a beam. The floor joists for the hayloft floor are 2x8's. Five of the double horse stalls are still in place. The sixth double horse stall was moved to the North wall between the granary and the West wall, when the granary was added.

CAMERA DIRECTION: First floor, looking North,
double horse stalls on
the East side of barn.

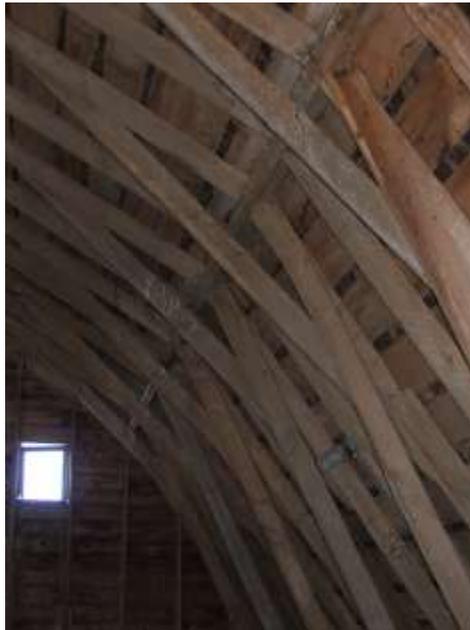
ROLL NUMBER: _____
PHOTO NUMBER: 7

CAMERA DIRECTION: Hayloft, looking SE, 2x6
rafters, 2x6 bracing at
hip, 4' O.C.

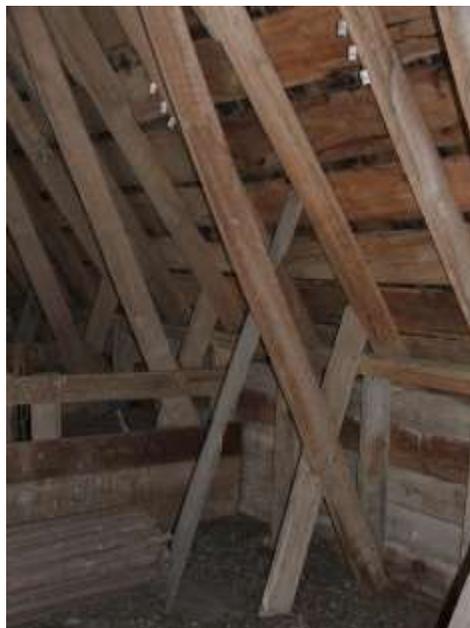
ROLL NUMBER: _____
PHOTO NUMBER: 8

CAMERA DIRECTION: Hayloft, looking SE, 2x6
bracing from hip down to
floor and 2x6 brace from
wall down to floor, 4'
O.C.
