**SOUTH DAKOTA STATE HISTORIC PRESERVATION OFFICE
HISTORIC SITES SURVEY STRUCTURE FORM**

*SURVEY DATE: October 19, 2012 *ADDRESS: 46958 307th Street
*SURVEYOR: Jim Stone *COUNTY: Clay
*CITY: Beresford

CURRENT FUNCTION:	<u>Horse barn</u>	FOUNDATION:	<u>Poured concrete foundation</u>
CURRENT SUBFUNCTION:	<u>Storage</u>	ROOF MATERIAL:	<u>Steel roofing over cedar shingles</u>
HISTORIC FUNCTION:	<u>Livestock barn</u>	ROOF SHAPE:	<u>Gable</u>
HISTORIC SUBFUNCTION:	<u>Hay and grain storage</u>	STRUCTURAL SYSTEM:	<u>Balloon framing</u>
		STYLE:	<u>Gable roof barn</u>
OCCUPIED:	<u>Yes</u>	TYPE:	<u>Livestock barn</u>
	<u>Yes with</u>		<u>2x6 stud with 1x6</u>
ACCESSIBLE:	<u>permission</u>	WALLS:	<u>#106 drop siding.</u>

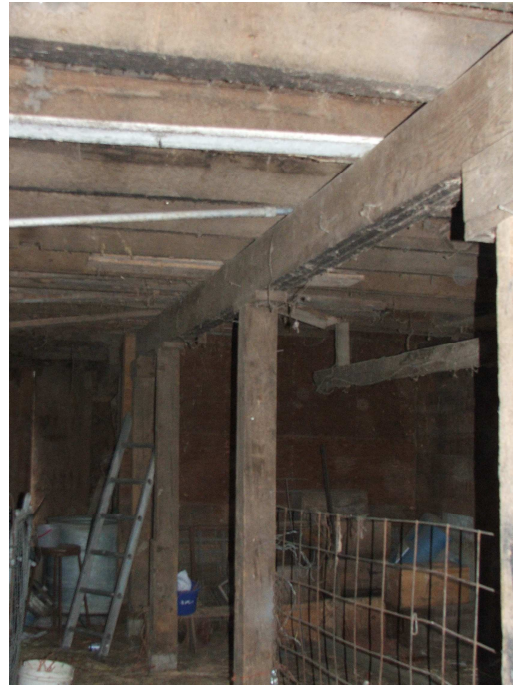
ROLL NUMBER: _____
PHOTO NUMBER: 5

INTERIOR NOTES: Has two rows of 6x6 posts with (3) 2x10's for beams. 2x8 floor joists. Granary is still in place in the NE corner. Walls lined with boards on inside.

CAMERA DIRECTION: First floor, looking North, posts, re-built beam and floor joists

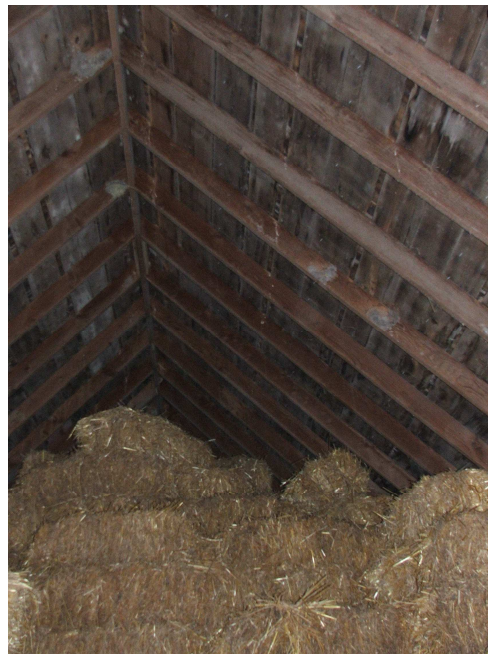
ROLL NUMBER: _____
PHOTO NUMBER: 6

OTHER NOTES: 2x6 stud walls with 1x6 #106 drop siding. Rafters are 2x6 with no bracing in hayloft. Windows are 9"x12" four light windows.

CAMERA DIRECTION: Hayloft, looking South, 2x6 rafters and hay track

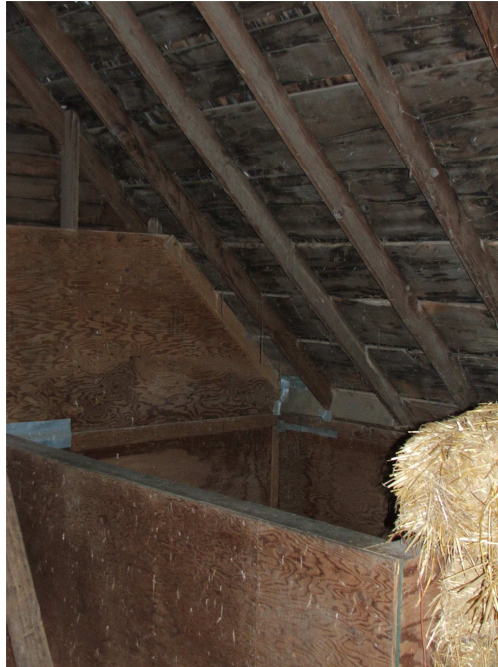
ROLL NUMBER: _____
PHOTO NUMBER: 7

CAMERA DIRECTION: Hayloft, looking NE,
granary in NE corner
from the first floor up
into hayloft.
