SITE INFORMATION

*SURVEY DATE: Octob	*ADDRESS: 46958 307th Street								
*SURVEYOR: _Jim S	*COUNTY: Clay								
		*CITY:	Beresford						
LOCATION DESCRIPTION: FI	rom Vermillion, Sout	h Dakota Highway	, 50, East	2 mile	s to	Gree	nfield	d Road,	
turn left (North) 10-1/2 miles to 307th Street, turn right (East) 1-2/3rd miles, on the Left (North) side of 307th									
Street.									
LEGAL DESCRIPTION: SE 1/4	, 24 – 94 - 51

STRUCTURE DETAILS

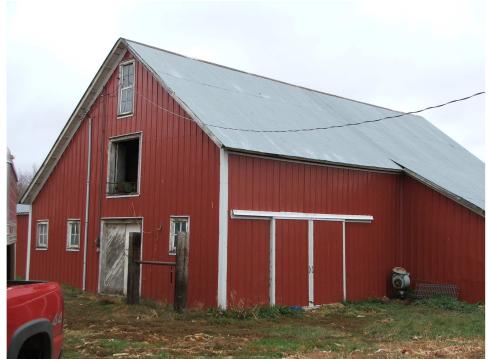
CAMERA DIRECTION: Looking NE, SW corner

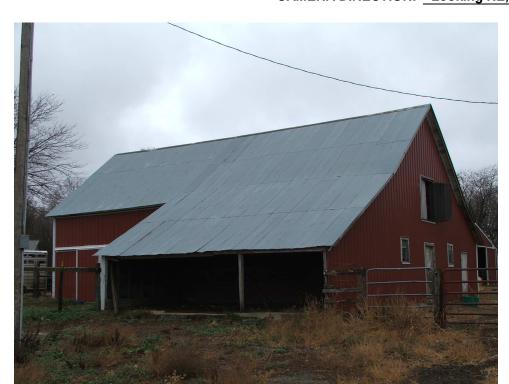
CAMERA DIRECTION: Looking NW, SE corner

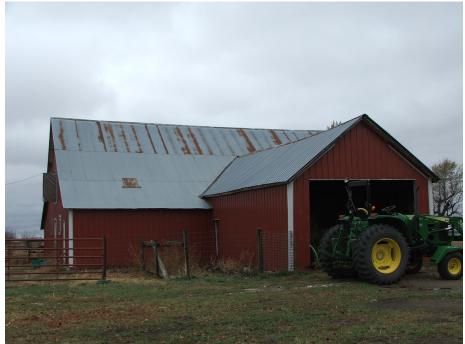
PHOTOGRAPHER: Jim Stone ROLL NUMBER: DATE OF PHOTO: October 19, 2012 PHOTO NUMBER: 3
CAMERA DIRECTION: Looking SW, NE corner

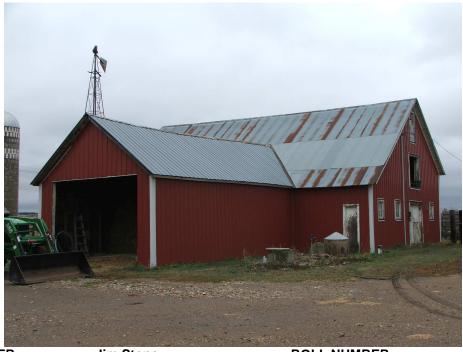
CAMERA DIRECTION: Looking SE, NW corner
