SITE INFORMATION

STRUCTURE DETAILS

SHPO ID:	16 CL 00000583	_											
*PROPERTY NAME:	Cecil Schultz barn												
OTHER NAME:													
CURRENT FUNCTION:	Saddle horses	FOUNDATION:	Poured concrete										
CURRENT SUBFUNCTION:	Storage	ROOF MATERIAL:	Asphalt shingles										
HISTORIC FUNCTION:	Livestock	ROOF SHAPE:	Gothic round										
HISTORIC SUBFUNCTION:	Grain & hay storage	STRUCTURAL SYSTEM:	Balloon framing										
		STYLE:	Gothic round roof										
OCCUPIED:	YES	TYPE:	Livestock barn										
400E00IDI E-	VEC	WALL C.	2x4 w/ 1x6 drop										
ACCESSIBLE:	YES	WALLS:	siaing										
STORIES:	2	SIGNIFICANT PERSON: Ce	ecil Shultz										
*DATE OF CONSTRUCTION:	1965 CU	LTURAL AFFILIATION:	German										
ALTERED/MOVED NOTES:	Original site. Four box	stalls, one calf pen and a tack i	room have been										
installed. Walls have been c	overed with steel roofing	. 0riginal windows 4x24 four li	te have been										
replaced with 9x12 four lite windows. South sliding door and hayloft door have been replaced with

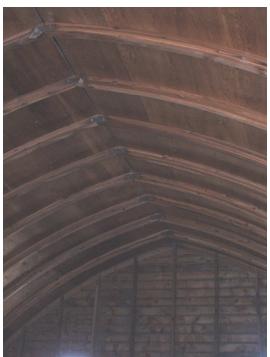
Hayloft peak, looking

CAMERA DIRECTION: North

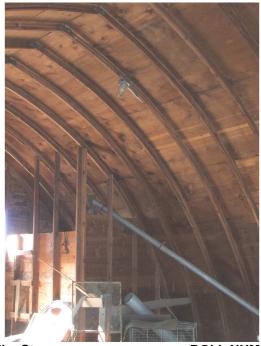
CAMERA DIRECTION: looking SW

Hayloft & granary,

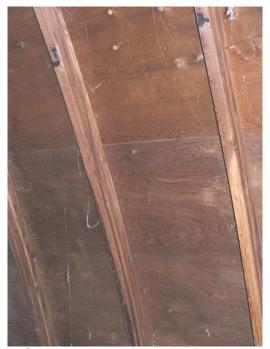
CAMERA DIRECTION: 1-1/2" x 5", five ply

Hayloft, laminated rafter

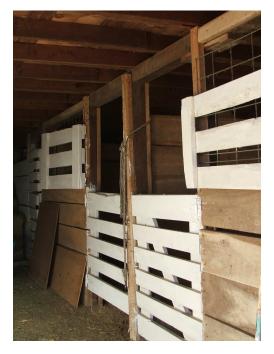
First floor, looking North,

CAMERA DIRECTION: box stalls on East wall

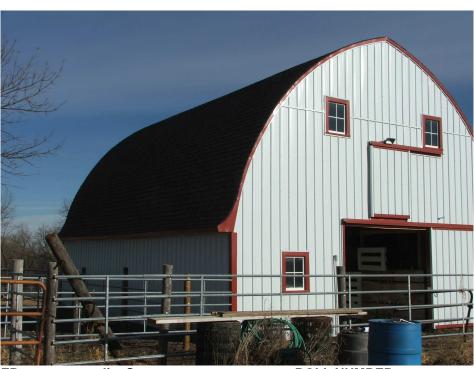
6

CAMERA DIRECTION: Looking NE, SW corner

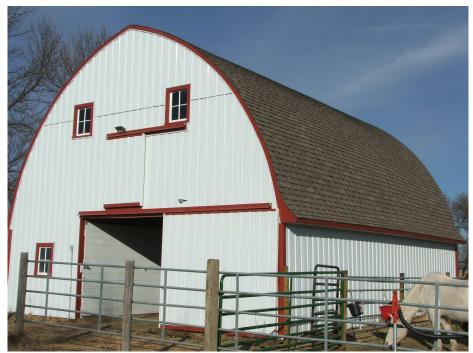
CAMERA DIRECTION: Looking NW, SE corner
