SITE INFORMATION

*SURVEY DATE: November 6, 2012

*ADDRESS: 4704 East Main Street

SHPO ID:		_	
*PROPERTY NAME:			
OTHER NAME:			
CURRENT FUNCTION:	Vacant	FOUNDATION:	Poured concrete foundation
CURRENT SUBFUNCTION:	Storage	ROOF MATERIAL:	Asphalt shingles over cedar shingles
HISTORIC FUNCTION:	Livestock barn	ROOF SHAPE:	Gable
HISTORIC SUBFUNCTION:	Hay and grain storage	STRUCTURAL SYSTEM:	Balloon framing
		- STYLE:	Western feeder barn
OCCUPIED:	No	TYPE:	Livestock barn
ACCESSIBLE:	Yes with permission	WALLS:	2x6 stud with 1x6 #106 drop siding
STORIES:	2	SIGNIFICANT PERSON: C	harles Chaussee
*DATE OF CONSTRUCTION:	1900 to 1915 CU	ILTURAL AFFILIATION:	French

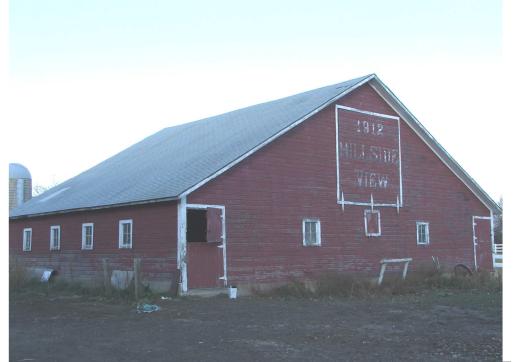
1
Looking NE, SW corner

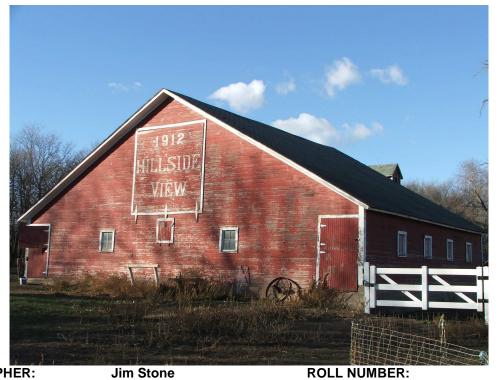
DATE OF PHOTO:
 November 6, 2012
 PHOTO NUMBER:
 2

CAMERA DIRECTION:
 Looking NW, SE corner

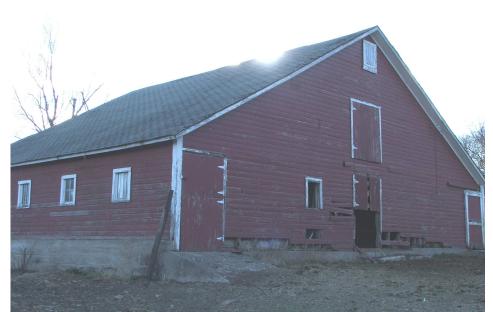
DATE OF PHOTO:
 November 6, 2012
 PHOTO NUMBER:
 3

CAMERA DIRECTION:
 Looking SW, NE corner

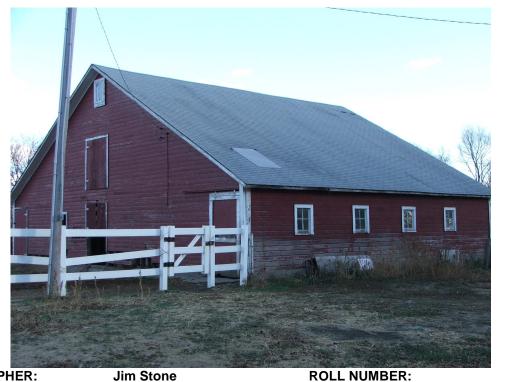
PHOTO NUMBER: 4 CAMERA DIRECTION: Looking SE, NW corner

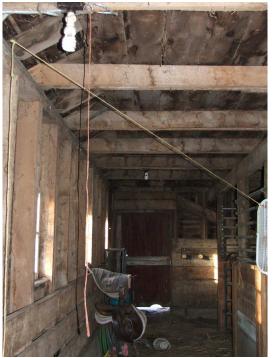
5 Looking North in West side, double 2x6 ceiling CAMERA DIRECTION: _joists 4' O.C.

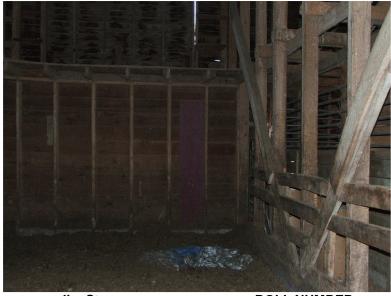
PHOTO NUMBER: 7 Looking South in center of barn, 10' of hayloft still in place, granary on South wall and hay feed CAMERA DIRECTION: rack on side.

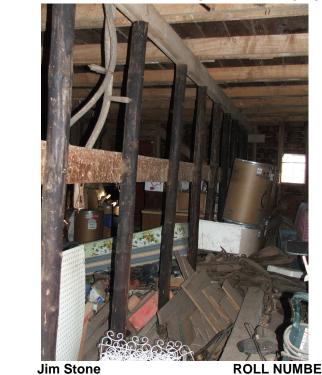
PHOTO NUMBER: 8 Looking South in East side, concrete feed CAMERA DIRECTION: trough for milk cows.
