<b>"SITE INFORMATION</b>						
*SURVEY DATE:	July 11, 2013	*ADDRESS:	45685 301th Street			
*SURVEYOR:	Jim Stone	*COUNTY:	Clay			
		*CITY:	Wakonda			
LOCATION DESCRIPTION:	From Vermillion	, the intersection of Sou	th Dakota Highway 50 bi-pass and			
South Dakota Highway 19, North 15 miles to 302 <sup>nd</sup> Street, turn left (West) about 4miles to 458 <sup>th</sup> Ave., turn						
right (North) 1 mile to 301st Street, turn left (West) about 1/4 mile, on the left (South) side.						
LEGAL DESCRIPTION: NE ¼, 26 – 95 – 53 Star Twp.						
*QUARTER 1: NE 1/	4	OWNER NAME:	James & Ruth Williams Living Trust			
*QUARTER 2:		•	45694 301 <sup>nd</sup> Street			
*TOWNSHIP: Star	<u></u> r	OWNER CITY:				
*RANGE: 53		OWNER STATE:	South Dakota			
*SECTION: <u>26</u>		OWNER ZIP:	57073			
ACRES: <u>166.28</u>		QUAD NAME:				
OWNER CODE 1: P						
OWNER CODE 2:						
OWNER CODE 3:						
HISTORIC SIGNIFICAN	CE					
		DEGISTED NA	DECICTED NAME.

#### STRUCTURE DETAILS

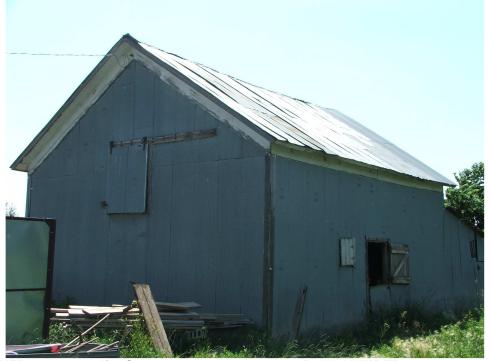
PHOTOGRAPHER: Jim Stone ROLL NUMBER: DATE OF PHOTO: July 11, 2013 PHOTO NUMBER: 2

CAMERA DIRECTION: Looking NW, SE corner

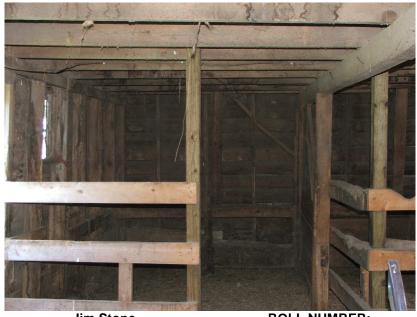
First floor, looking East, 4x6 post, 4x6 beam, 2x6 joists, one of three double horse stalls on

CAMERA DIRECTION: East wall.

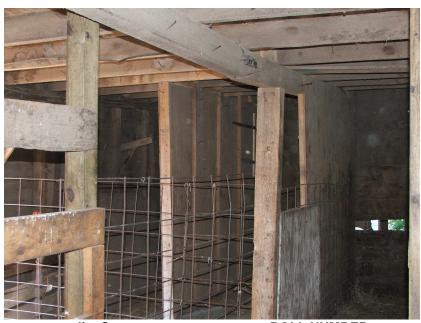
First floor, looking SW, can not tell what was on

CAMERA DIRECTION: the West wall.
