**SOUTH DAKOTA STATE HISTORIC PRESERVATION OFFICE
HISTORIC SITES SURVEY STRUCTURE FORM**

*SURVEY DATE: March 7, 2013 *ADDRESS: 46975 309th Street
*SURVEYOR: Jim Stone *COUNTY: Clay
*CITY: Beresford

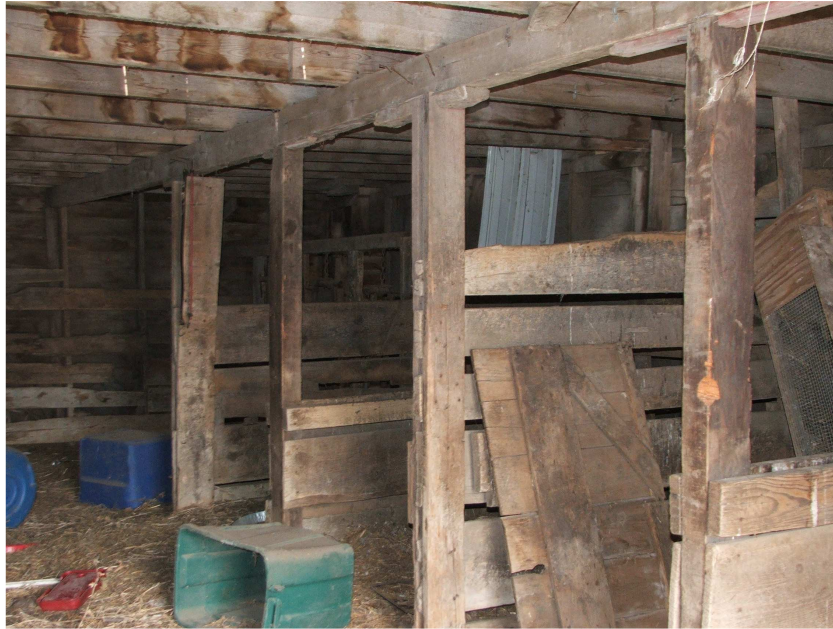
ROLL NUMBER: _____
PHOTO NUMBER: 5

**First floor, looking NE, 4'
milk cow stalls on East
wall in center area of
barn**

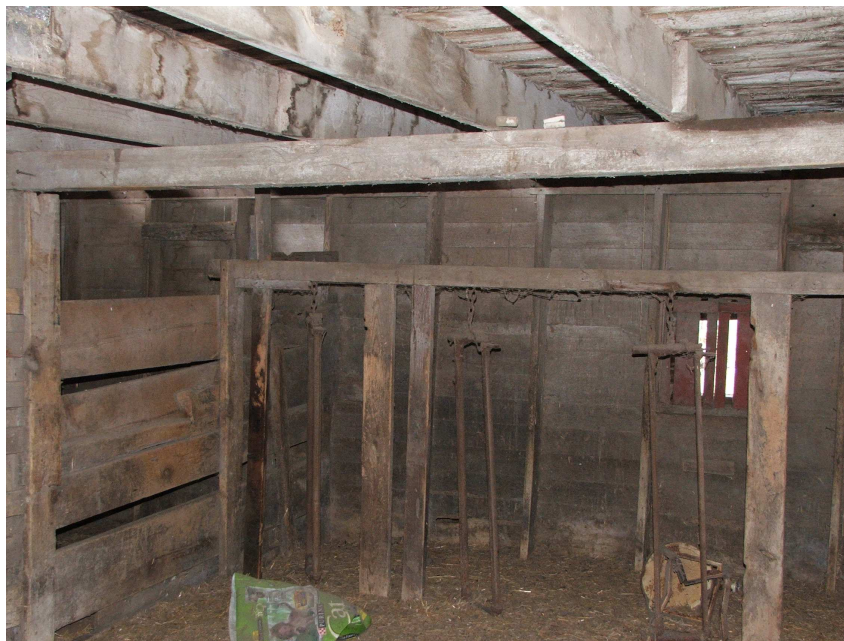
ROLL NUMBER: _____
PHOTO NUMBER: 6

**First floor, looking West,
milk cow stanchions on
West wall in center area
of barn**

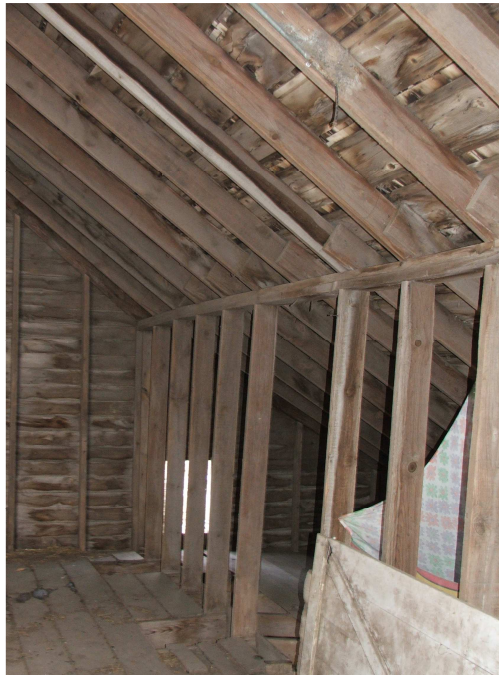
ROLL NUMBER: 7
PHOTO NUMBER: 7

CAMERA DIRECTION: Hayloft, looking NE,
80" high 2x6 stud wall,
2x6 rafters

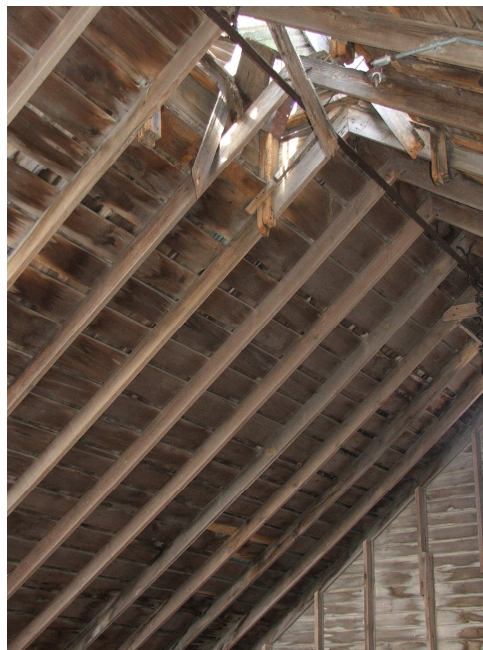
ROLL NUMBER: 8
PHOTO NUMBER: 8

CAMERA DIRECTION: Hayloft, looking NW, 4' x
4' wooden cupola, 2x6
rafters
