"SITE INFORMATION	<u>ON</u>										
*SURVEY DATE:	Novembe	er 8, 2013	*ADDRESS:	: 31186 456 th Ave.							
*SURVEYOR: Jim Stone			*COUNTY:	Clay							
	*CITY:	Meckl	Meckling								
LOCATION DESCRIPTION: From Vermillion, South Dakota Highway 50 west to Meckling and 457 th											
Ave., turn right (North) about 1-1/2 miles to 312 th Street, turn left (West) 1 mile to 456 th Ave., turn right ((North) about ¼ mile on the right (East side).											
((North) about ¼ mile o	n the right (Eas	t side).									
LEGAL DEGODIDATION	0144/ 44	00 50 14 - 11	· 								
LEGAL DESCRIPTION:	SW 14 -	93 – 53 Mecki	ng Iwp.								
		Linda C	. Chris	stianse	n						
*QUARTER 1:					LE - Lola M. & Charles H. Johnson Jr.						
*QUARTER 2:				31186 456 th Ave.							
*TOWNSHIP:N	Meckling		OWNER CITY:								
*RANGE:	53		WNER STATE:								
*SECTION:	14		OWNER ZIP:	57069							
ACRES:	163.01		QUAD NAME:								
OWNER CODE 1: P	1

STRUCTURE DETAILS									
SHPO ID:									
*PROPERTY NAME:		-							
OTHER NAME:									
_									
CURRENT FUNCTION:	Vacant	FOUNDATION:	Poured concrete						
CURRENT SUBFUNCTION:	Storage	ROOF MATERIAL:	Asphalt shingles over cedar shingles						
HISTORIC FUNCTION:	Livestoc

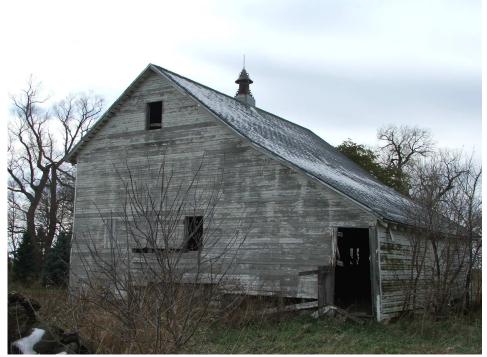
PHOTOGRAPHER: Jim Stone ROLL NUMBER: DATE OF PHOTO: November 8, 2013 PHOTO NUMBER: 2

CAMERA DIRECTION: Looking NW, SE corner

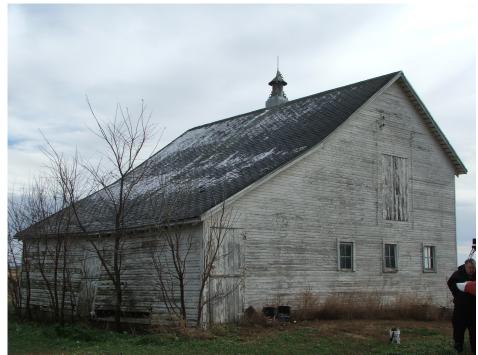
Looking SW, NE corner

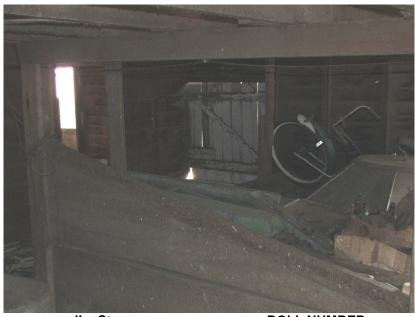
Looking SE, NW corner

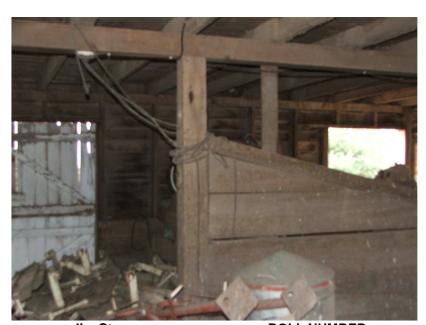
CAMERA DIRECTION: to granary on East side

First floor, looking SE in
