SITE INFORMATION

STRUCTURE DETAILS											
SHPO ID:											
*PROPERTY NAME:			•								
OTHER NAME:											
CURRENT FUNCTION:	Vacant		FOUNDA	TION:	Poured concrete						
CURRENT SUBFUNCTION:			ROOF MATERIAL:		Cedar shingles						
HISTORIC FUNCTION:	Livestock barn		ROOF SHAPE:		Gambrel						
HISTORIC SUBFUNCTION:	Hay and grain storage		STRUCTURAL SYS	STRUCTURAL SYSTEM:							
			S	Gambrel roof barn							
OCCUPIED:	No			Livestock barn							
ACCESSIBLE:	Yes with permission		w	2x6, sheathing & ½"x6" cedar lap siding							
STORIES:	2	S	SIGNIFICANT PERSON:	Chris	stian Larson						
	Late 1800's to										
*DATE OF CONSTRUCTION:		CU	LTURAL AFFILIATION:	N	lorwegian						
ALTERED/MOVED NOTES:	Original site.										
_											
INTERIOR NOTES: 4x6 pos	ts and (3) 2x8's h	neam to	support havloft floor F	our nos	sts at the North end						
			_ · · _ ·	•							
were 6x6 posts. Joists were 2x8. Horse stalls, milk cow stanchions, calf pen and granary are still in place. 2x6's for studs, rafters and bracing, 2x8 floor joists, 4x6 and 6x6 posts and 2x8 beams were rough

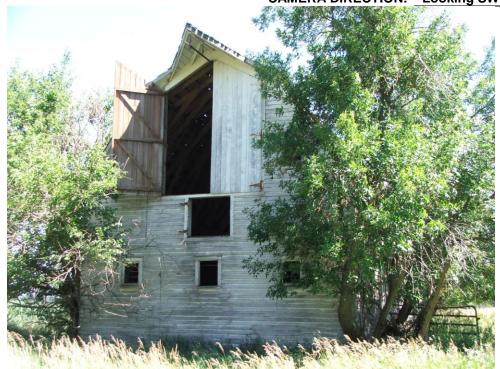
CAMERA DIRECTION: Looking SW, NE corner

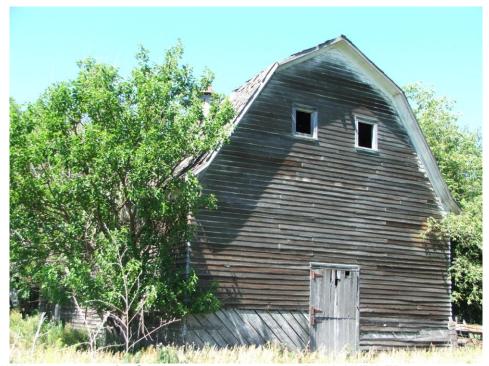
CAMERA DIRECTION: Looking SE, NW corner

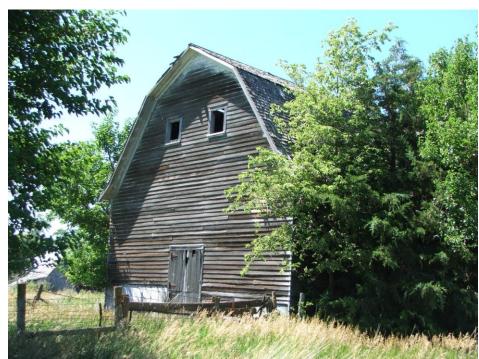
CAMERA DIRECTION: Looking NE, SW corner

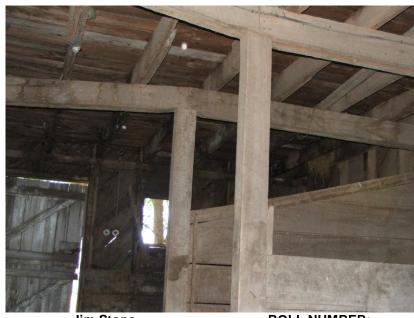
CAMERA DIRECTION: Looking NW, SE corner

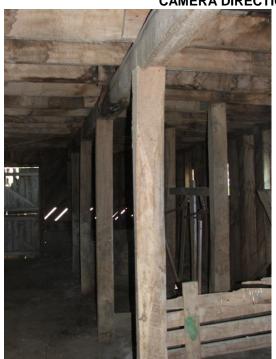
First floor, looking West, horse stalls facing North

CAMERA DIRECTION: wall

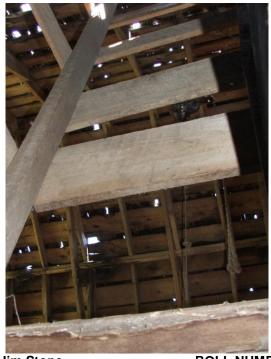
Hayloft, looking North,upper braced

CAMERA DIRECTION: rafter system

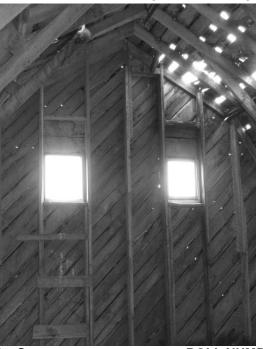
Hayloft, looking North lower braced rafter

CAMERA DIRECTION: system
