**SOUTH DAKOTA STATE HISTORIC PRESERVATION OFFICE
HISTORIC SITES SURVEY STRUCTURE FORM**

*SURVEY DATE: June 3, 2013 *ADDRESS: 45838 298th Street
*SURVEYOR: Jim Stone *COUNTY: Clay
*CITY: Centerville

CURRENT FUNCTION: Shop & Storage FOUNDATION: Poured concrete
Asphalt shingles over
 CURRENT SUBFUNCTION: Combine Storage ROOF MATERIAL: cedar shingles
 HISTORIC FUNCTION: Livestock barn ROOF SHAPE: Gambrel
 HISTORIC SUBFUNCTION: Hay storage STRUCTURAL SYSTEM: Balloon framing
 STYLE: Gambrel roof barn
 OCCUPIED: Yes TYPE: Livestock barn
2x6 studs, 1x10
sheathing, 12"x7"
 ACCESSIBLE: Yes with permission WALLE: embossed cut stone
steel siding

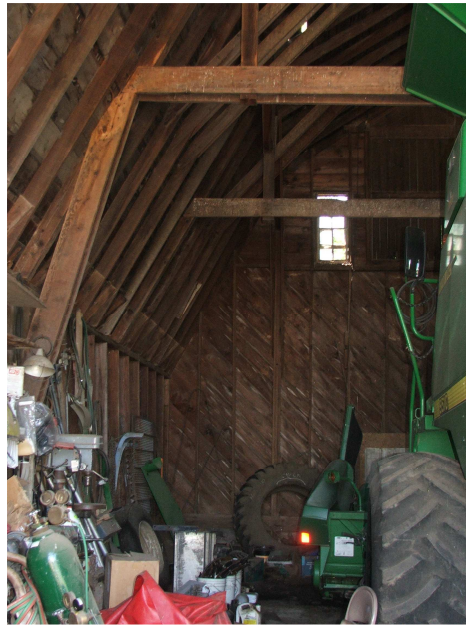
ROLL NUMBER: _____
PHOTO NUMBER: 5

ALTERED/MOVED NOTES: Barn moved in 1970, from Section 18, Riverside Township, about 1-1/2 miles South. Barn has been remodeled into a shop and combine storage. Hayloft floor removed. Two 2x8 floor joists raised to 16', 14'-12'-12'-12' O. C. from the East wall. 6x6 posts in hayloft supporting the hip are cut off just below the two 2x8's. 20'- 4" x 16' opening cut in the East wall, with no door.

**First floor, looking West,
Two 2x8's bracing raised
to 16', note diagonal
sheathing on West wall.**

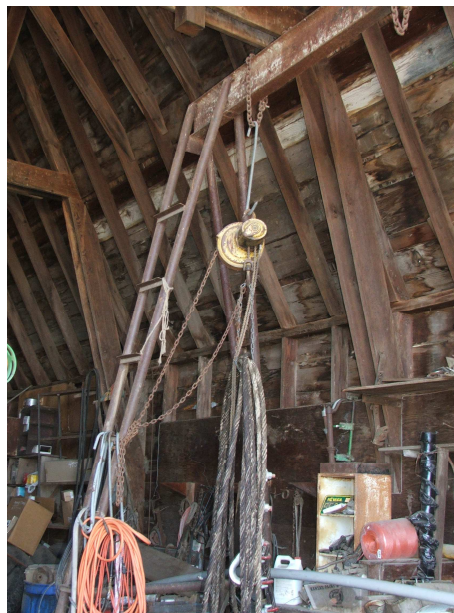
ROLL NUMBER: _____
PHOTO NUMBER: 6

**First floor, looking NW,
note 1x10 horizontal
sheathing on North wall.**

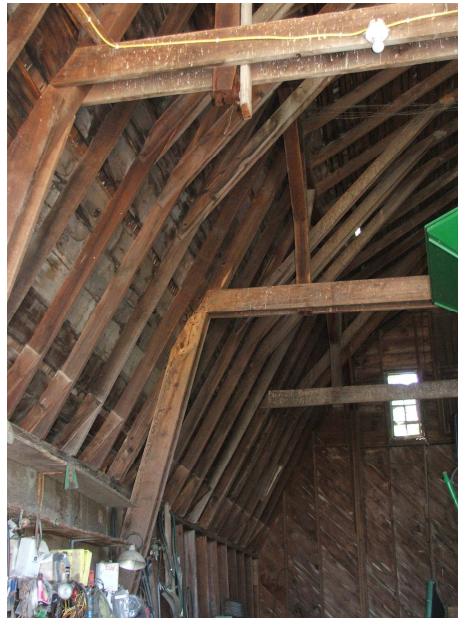
ROLL NUMBER: 7
PHOTO NUMBER: 7

Hayloft, looking SW, 6x6 rafters behind 6x6 posts, double 2x8's at 16' and two 2x10's from the 6x6 rafter down to center of first floor wall.

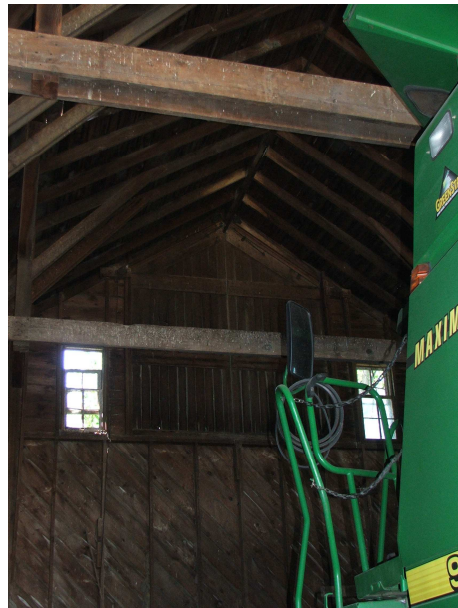
ROLL NUMBER: 8
PHOTO NUMBER: 8

Hayloft, looking West, hayloft door and west gable end.
