SITE INFORMATION

*SURVEY DATE: January 8, 2013

*ADDRESS: <u>46913 303rd Street</u> *COUNTY: Clay

SHPO ID:			
*PROPERTY NAME:			
OTHER NAME:			
CURRENT FUNCTION:	Storage	FOUNDATION	Poured concrete foundation
CURRENT SUBFUNCTION:	Storage	ROOF MATERIAL	Steel roofing over
HISTORIC FUNCTION:	Livestock barn	ROOF SHAPE	Gable
HISTORIC SUBFUNCTION:	Hay storage	STRUCTURAL SYSTEM	: Balloon framing
		STYLE	: Gable roof barn
OCCUPIED:	Yes	TYPE	: Livestock barn
ACCESSIBLE:	Yes with permission	WALLS:	2x6 R.S. studs, 1x6 #106 drop siding and ½"x 6" cedar lap siding
STORIES:	2	SIGNIFICANT PERSON:	Claus Frick
*DATE OF CONSTRUCTION:	1920's	CULTURAL AFFILIATION:	Swedish

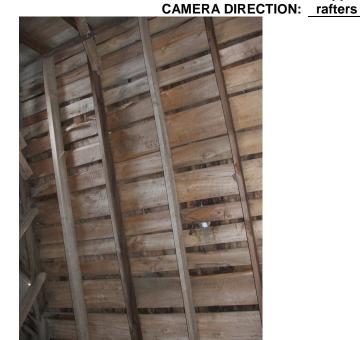
PHOTO NUMBER: 8 Hayloft, looking South and up, 2x6 rafters and roof sheathing, all rough sawn cottonwood.
