```SITE INFORMATION

*SURVEY DATE: March 29, 2014

*ADDRESS: 29720 463rd Ave.

| | _ | | |
|---|---|---|---|
| /es | Т | YPE: | Livestock barn |

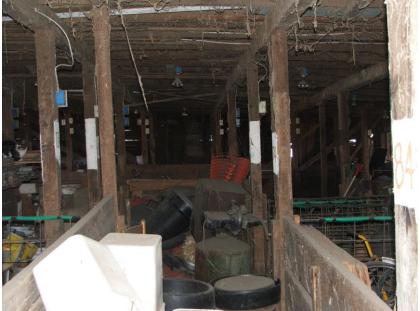
5 First floor looking East into single horse stall remodeled into two lambing pens

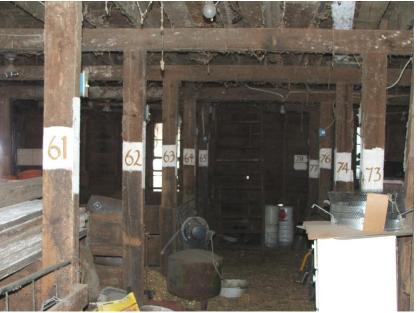
7 First floor, looking South into feed alley, note stairs to hayloft on the south wall

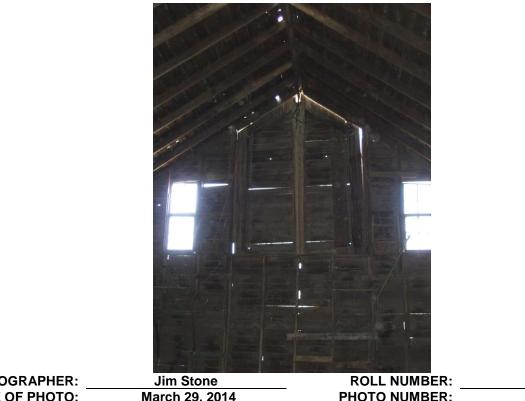
| PHOTOGRAPHER: | Jim Stone | ROLL NUMBER: | |
|---|---|---|---|
| DATE OF PHOTO: | March 29, 2014 | PHOTO NUMBER: | 8 |

Hayloft, looking NE, 4x6 posts supporting double 2x6 at the roof hip.
