#### **SITE INFORMATION**

*SURVEY DATE: May 2	*ADDRESS:	30035 Frog Creek Road					
*SURVEYOR: Jim Stone		*COUNTY:	*COUNTY: Clay				
		*CITY:	Wakonda				
LOCATION DESCRIPTION: <u>F</u>	rom the intersect	ion of South Dakota I	ا-lighway 50 bi	oass and	South	h	
Dakota Highway 19, North 15 m	iles to 302 <sup>nd</sup> Stre	et, turn left (West) 3 n	niles to Frog C	reek Roa	ıd, turr	n right	
(North) 1-1/2 miles on the left (\	Nest) side.						
LEGAL DESCRIPTION: <u>S 1,4</u>	12' of E 617' of N	$E \frac{1}{4} 19 - 95 - 52$ Rive	erside Twp				
*QUARTER 1: NE 1/4		OWNER NAME:	Colin Olsen				
*QUARTER 2:			S: 30035 Frog Creek Road				
*TOWNSHIP: Riverside		OWNER CITY:	-				
*RANGE: 52		OWNER STATE:					
*SECTION: 19		OWNER ZIP:					
ACRES: 18.66		QUAD NAME:					
OWNER CODE 1: P							
OWNER CODE 2: F S L	Р						
OWNER CODE 3: F S L	Р						
HISTORIC SIGNIFICANCE							
*DOE:		REGISTER NA	REGISTER NAME:				
*DOE DATE:		MULTIPLE PR	MULTIPLE PROPERTY NAME:

STRUCTURE DETAILS								
SHPO ID:								
*PROPERTY NAME:		_						
OTHER NAME:								
CURRENT FUNCTION:	Ultra-Light airplane hanger	FOUNDATION:	Poured concrete					
		_	Steel over cedar					
CURRENT SUBFUNCTION:	Shop and storage	_ ROOF MATER

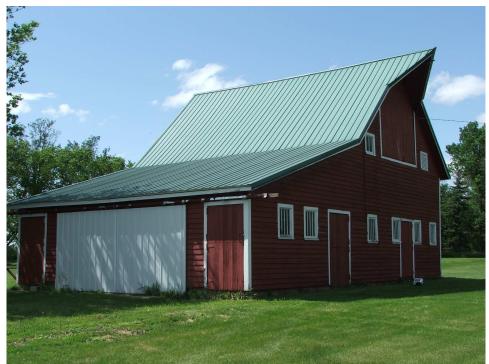
PHOTOGRAPHER: Jim Stone ROLL NUMBER: DATE OF PHOTO: March 7, 2012 PHOTO NUMBER: 1
CAMERA DIRECTION: Looking NW, SE corner

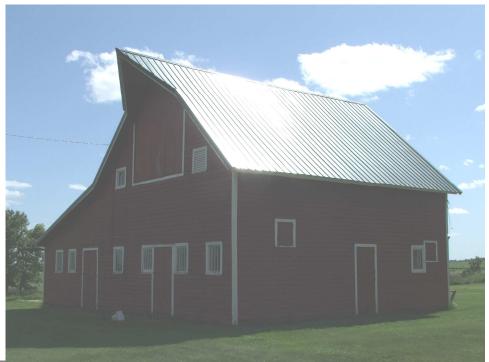
PHOTOGRAPHER: Jim Stone ROLL NUMBER: DATE OF PHOTO: March 7, 2012 PHOTO NUMBER: 2
CAMERA DIRECTION: Looking SW, NE corner

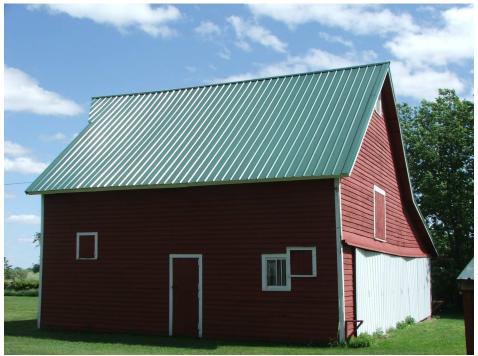
CAMERA DIRECTION: Looking SE, NW corner

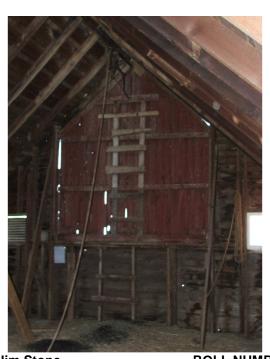
CAMERA DIRECTION: Hayloft, looking East, rafters & hayloft door

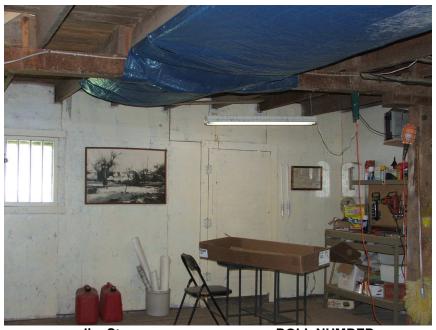
First floor, looking NE,

CAMERA DIRECTION: shop area

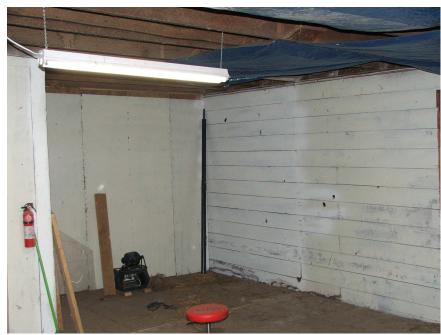
First floor, looking SE, where milk cow

**CAMERA DIRECTION: stanchions were**

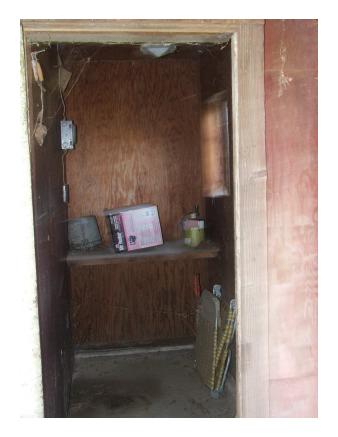
CAMERA DIRECTION: into 4' x 9' milk room

First floor, looking North
